25 June 2020

Mauao - Additional Works Optioneering

2-9b463.02

Site Inspection Photos

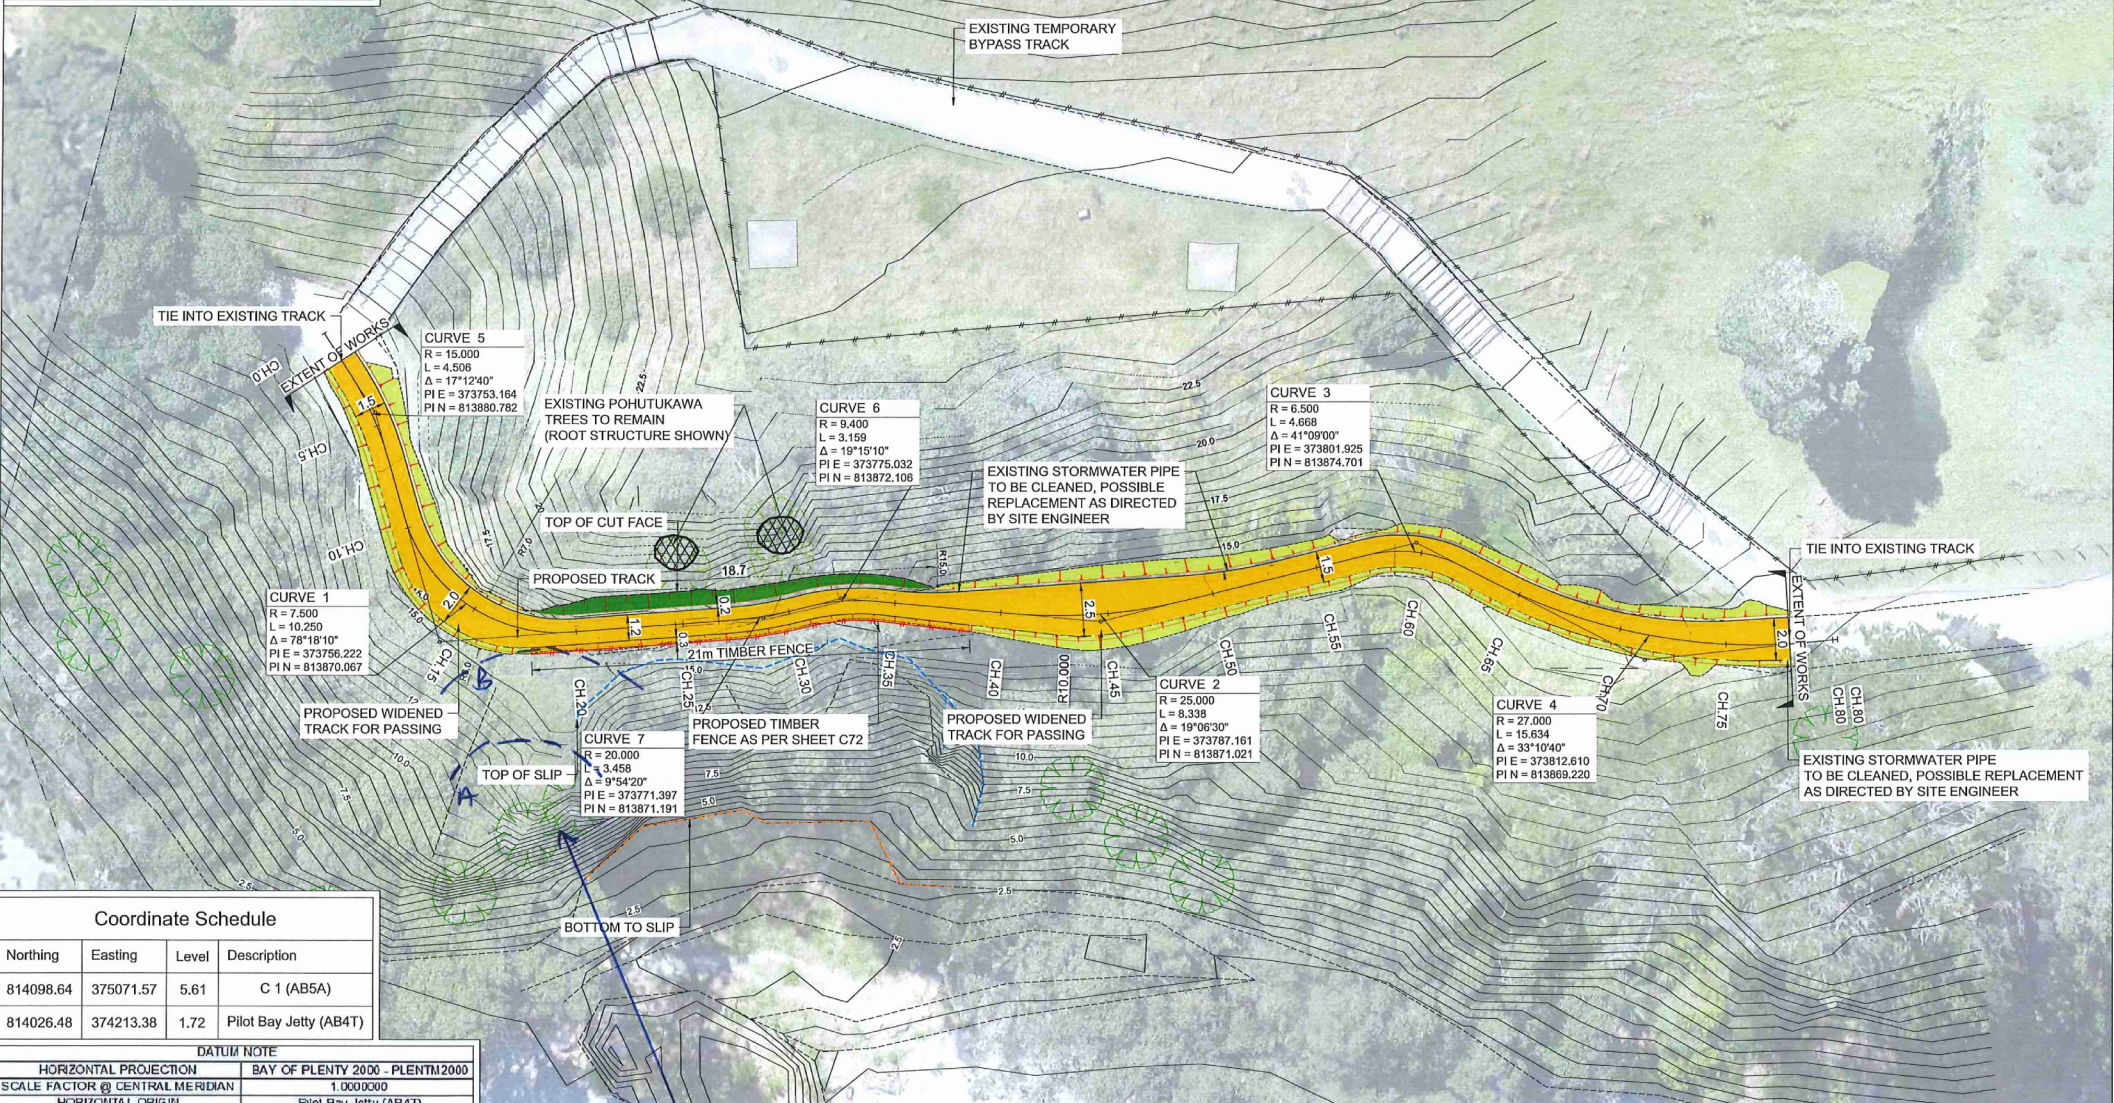
That said, if a failure occurred along a tension crack at the top of the lobe where it drops down 1.2m, then the current track would still be approximately 2.5m away from the failure surface, however a larger, deeper failure surface may still be possible which could encroach into the current track alignment. We have sketched these scenarios on the attached annotated drawings C01 and C22. Although it is hard to predict the depth of the failure surface, we believe failure surface B which could affect the track would be much less likely than A.

Therefore, the consequence of a failure would either result in the loss of the tree and the formation of a scarp in front of the track or a deeper failure which would result in the possible encroachment of a slip scarp into the track at its western extent resulting in a reduction of the track width and possible closure of the track while repairs are undertaken.

This option would involve installing soil nails and bored horizontal drains to the west of the current repair to improve the stability of the bank in which the Pohutukawa is situated on. The soil nail pattern, length and spacing would need to be confirmed by modelling the

existing slope. This option assumes that the tree is currently stable and will not prevent failure of the tree due to inadequate structural roots etc. This option would be a high cost option, however would provide the best resilience against future slips and potential closure of the base track. Due to the location, the works may be able to be undertaken with the track open however this would need to be confirmed with a contractor.
