Archaeological Site Condition Monitoring Report –
Authority no. 2023/244
Mauao Historic Reserve, Tauranga

ARCHAEOLOGICAL SITE
CONDITION MONITORING REPORT
AUTHORITY NO. 2023/244
MAUAO HISTORIC RESERVE
TAURANGA

29 February 2024

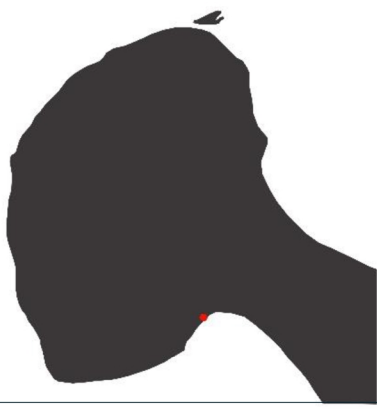
Monitoring Site 1

Stone Jetty surrounds – stone walls

Notes: The monitoring site has been extended to include the walkway connection to the 4WD track, as there is some exposed midden which requires monitoring. Monitoring site also includes the bank down to the jetty steps entrance, which now has a well-established sward of flax. Grass and other vegetation cover significantly advanced since 2018. The karaka tree may need to be reduced in weight if it becomes an issue. Wall condition has significantly stabilised since 2018.

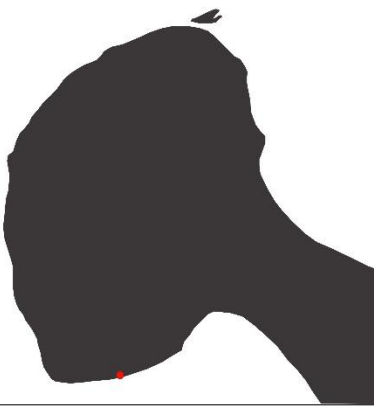
Monitoring Site 2

Iron Jetty and surrounds

Notes: Vegetation on the bank has reduced, but there is on-going invasion by sycamore as well as rabbit burrowing activity (location of survey pole in 2024 image), karaka growth has improved. On going active management of the trees on the concrete face of the jetty is required, although much improved since 2018. The view shaft to the iron debris has been well maintained.

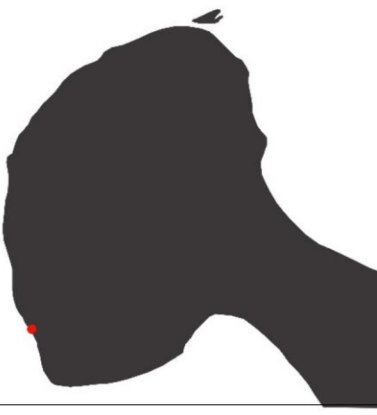
Monitoring Site 3

Base Track midden erosion

Notes: Significant advance in vegetation cover over the monitoring period and the eroded face is covered by flax. Very little shell is actively eroding onto the path. The weight of the flax should be monitored.

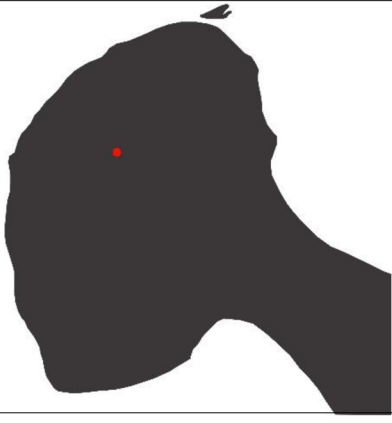
Monitoring Site 4

The Lower Summit

Notes: Newly added monitoring point. Interpretation place on lower summit. There is some wear on the grass from informal visitor tracks to get to the bench, as well as rabbit damage in the grass and some loss of the capping material which has exposed the edge of the concrete plinth.

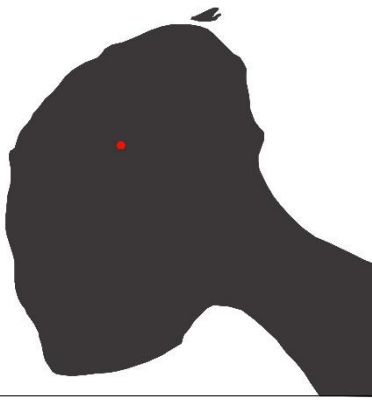
Monitoring Site 5

Repairs to summit terraces

Notes: Repair to terraces completed in 2013. The aggregate at the base of the slope was not moved as recommended as in 2019 but is now less visible. Grass cover much more robust than in 2018. Encroaching vegetation has been managed to keep terraces visible but requires on-going monitoring. There is evidence of rabbit damage which will require active management.

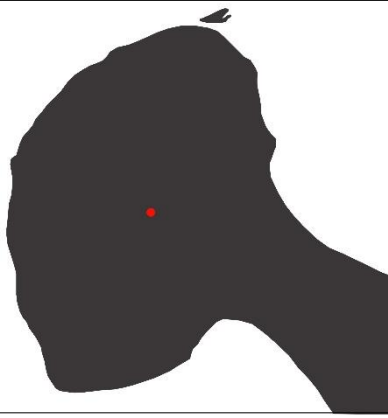
Monitoring Site 6

Terrace back scarp on summit

Notes: Newly added monitoring point. Monitoring the capping, as the terrace back scarp has visitor wear and there is also rabbit damage.

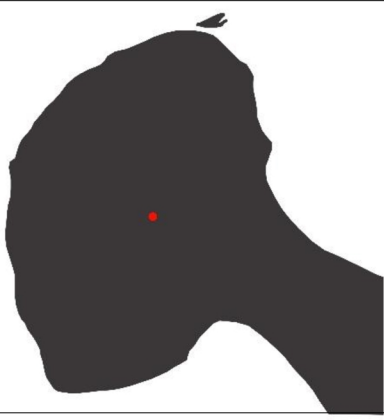
Monitoring Site 7

General monitoring of summit wear

Notes: The summit area has been redeveloped as part of the interpretation and placemaking project and has resulted in greater ground cover, but there is on-going wear of the imported armouring material on the summit and on-going recapping is required by bringing in additional material from the stockpile. Monitoring should continue. Trig was removed in June 2021, replaced with touchstone.

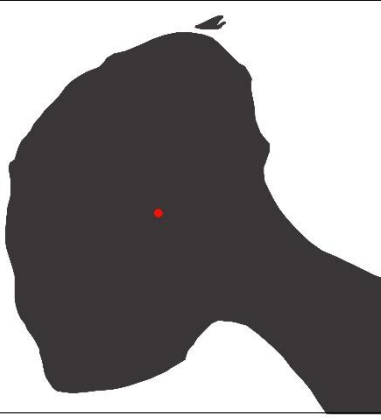
Monitoring Site 8

Desire line tracking on summit

Notes: Action to block access with planting and a fence installed in 2023 has seen a significant reduction in wear to the intact archaeological deposit. Additional fill material which was placed around the tree remains intact.

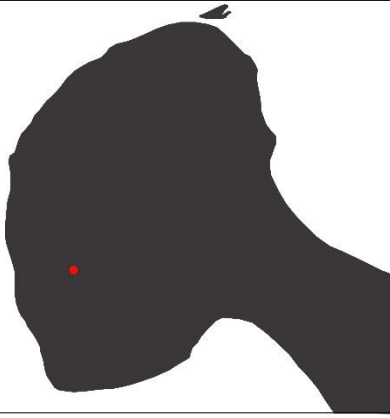
Monitoring Site 9

Erosion on Shell Mound – Stock and Vegetation Management

Notes: The temporary exclusion of stock from the shell mound in 2019/20 successfully established a good grass sward which has been maintained. The mound is significantly more stable now than when monitoring started in 2018. Rabbits are attracted to the shell, and so it is important that the dense sward and low numbers of rabbits are maintained.

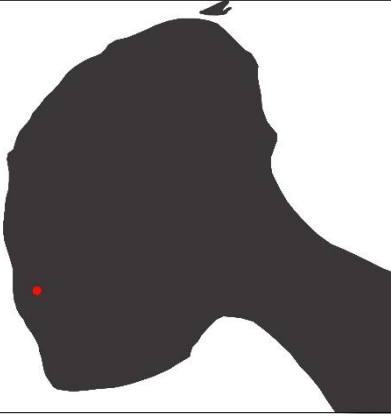
Monitoring Site 10

Rabbit Damage (active)

Notes: Vegetation cover has improved as greater rabbit control measures are in place, but this should be closely monitored as there are still active rabbit burrows and accessways visible along the fence line which has exposed midden. Monitoring should be ongoing as rabbit control is still required.

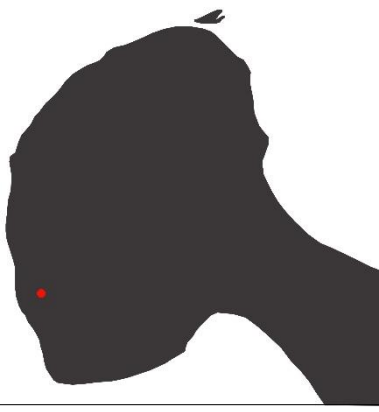
Monitoring Site 11

Midden exposure west end of the Ditch

Notes: Newly added monitoring point. There is a large midden exposure at the western end of the ditch on site U14/173 (Pā). There is active exposure and slope erosion, possible slope failure risk.

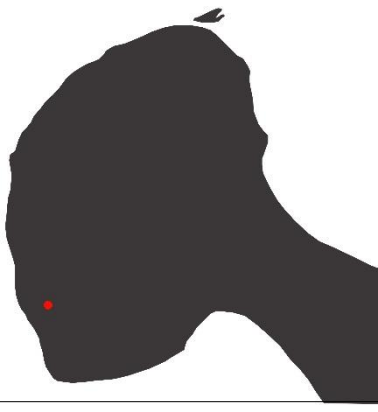
Monitoring Site 12

Rabbit damage eastern slope of Pā

Notes: Newly added monitoring site. Rabbit damage (burrows and accessways) on eastern slope of site U14/173 (Pā), in location of survey pole. Further rabbit control needed and will require monitoring to its conclusion.

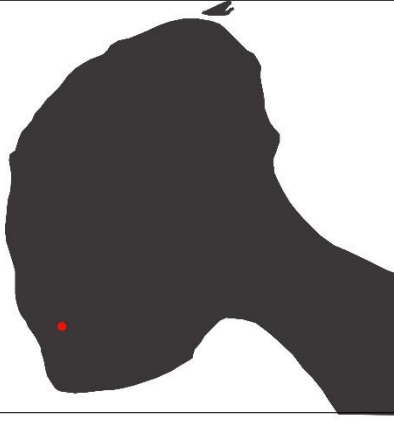
Monitoring Site 13

Pā U14/173 condition/grass cover

Notes: General views across pā to demonstrate grass cover. Site is stable with good ground cover being maintained. Rabbits are active on the eastern side of the pā, requires monitoring and control.

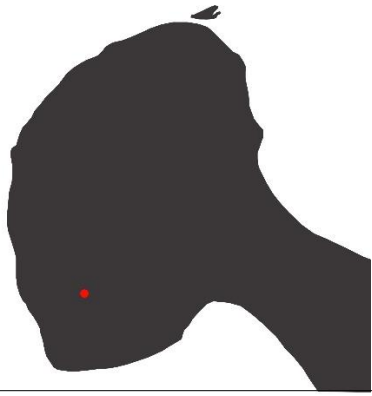
Monitoring Site 14

Midden and vegetation management – Pōhuehue growth

Notes: Pōhuehue cover on midden mounds above water reservoir is stable but has not spread to other mounds since monitoring began in 2018. The grass sward is kikuyu; stock have had access to the mound since December 2019. Stock numbers should continue to be closely monitored and reduced if necessary.

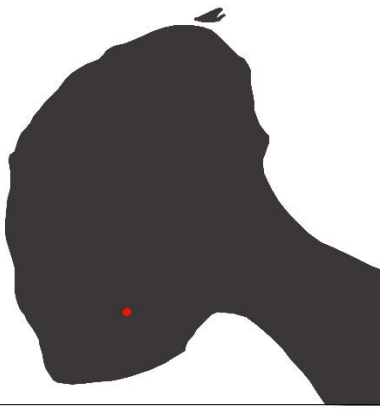
Monitoring Site 15

Land slip on southern slope

Notes: Temporary fencing has failed, the midden is still exposed and the erosion is still active, but not significantly different from the erosion and exposure seen in 2022. Recommend trying netting fencing. Rabbits have damaged parts of features nearby, including in a kūmara pit, needs control.

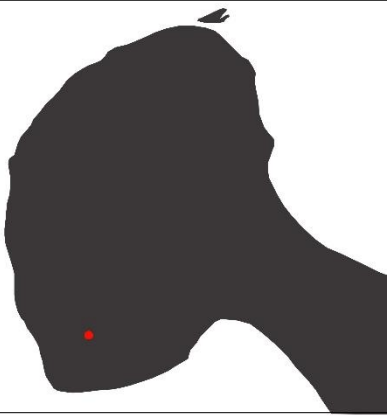
Monitoring Site 16

4WD Track maintenance issues – tailings management

Notes: Built up tailings were removed from terraces with archaeological supervision, although there is still a significant issue with road metal being distributed onto terraces below the track and on-going archaeological monitoring and metal removal is required. The distance between culverts, their function and the treatment of tailings needs further management attention.

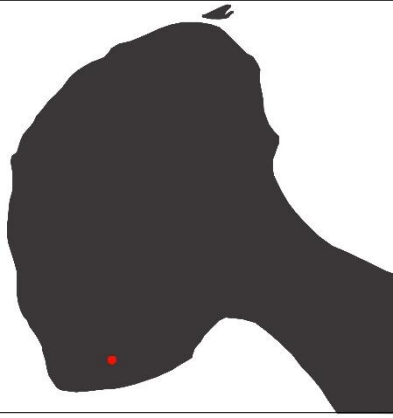
Monitoring Site 17

Fence around Midden on southern slope

Notes: Fence around midden that was installed in 2003 was removed in 2018. Ground cover around karaka and midden on slope well developed.

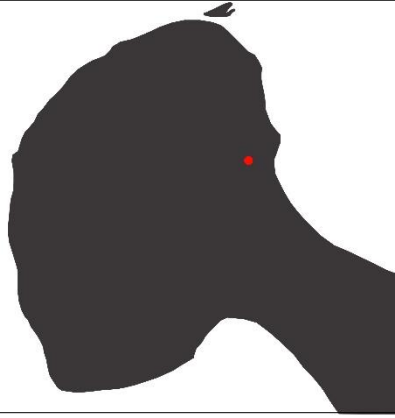
Monitoring Site 18

Area of Military Camp, helicopter pad, pits and terraces retired from grazing in 2018

Notes: Management of vegetation and site visibility has significantly improved following cessation of grazing. The length of weed eating needs to be monitored especially in summer as patches of the grass sward on the pit are broken by 'scalping'.

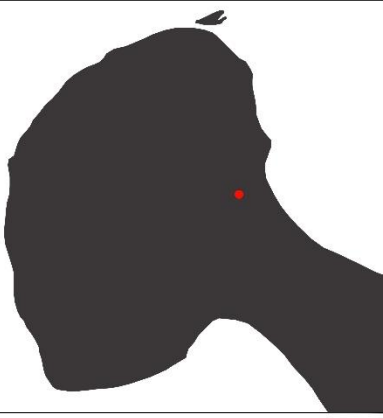
Monitoring Site 19

Stone Steps condition and erosion

Notes: Stonework stable at present, but erosion from desire line is still apparent. Weed spraying corridor needs to be reduced as this is encouraging desire lines. Action needed at the top of the stairs to reduce water flow and erosion, which was resolved in 2021 but has re-occurred.

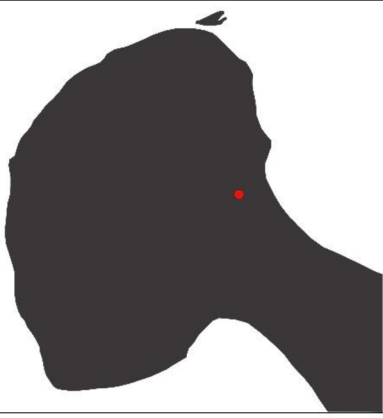
Monitoring Site 20

Base of Stone Steps condition and erosion
