**MAUAO, MOUNT
MAUNGANUI**

**GEOHAZARD
REVIEW REPORT**

PROJECT NO: HD3639
TAURANGA CITY COUNCIL
REFERENCE: CAR
6 JUNE 2025

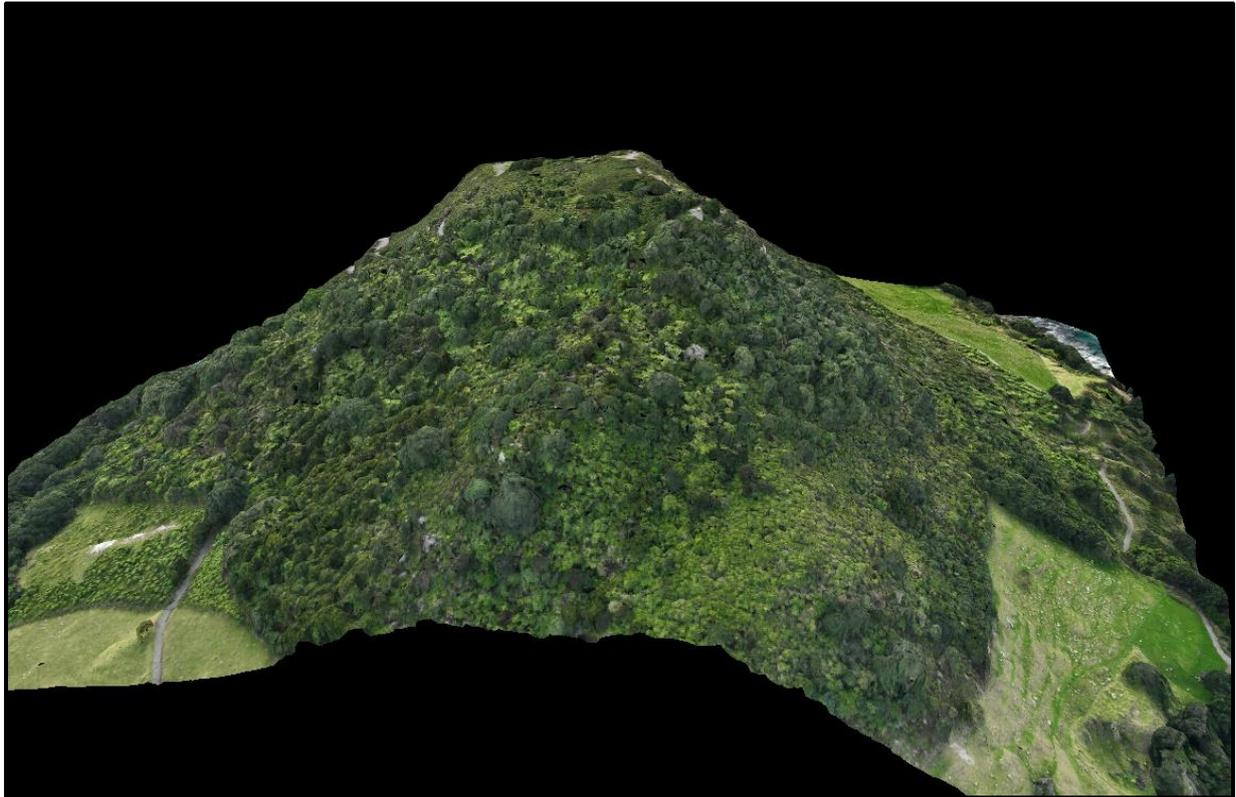
Figure 2: Incomplete drone 3D model of Mauao looking south-west, date taken 02/05/25.
