17 December 2007

Our Ref: 3203964/100
T1:71117-ST57DL02.DOC

Mt Maunganui Beachside Holiday Park Slip Assessment

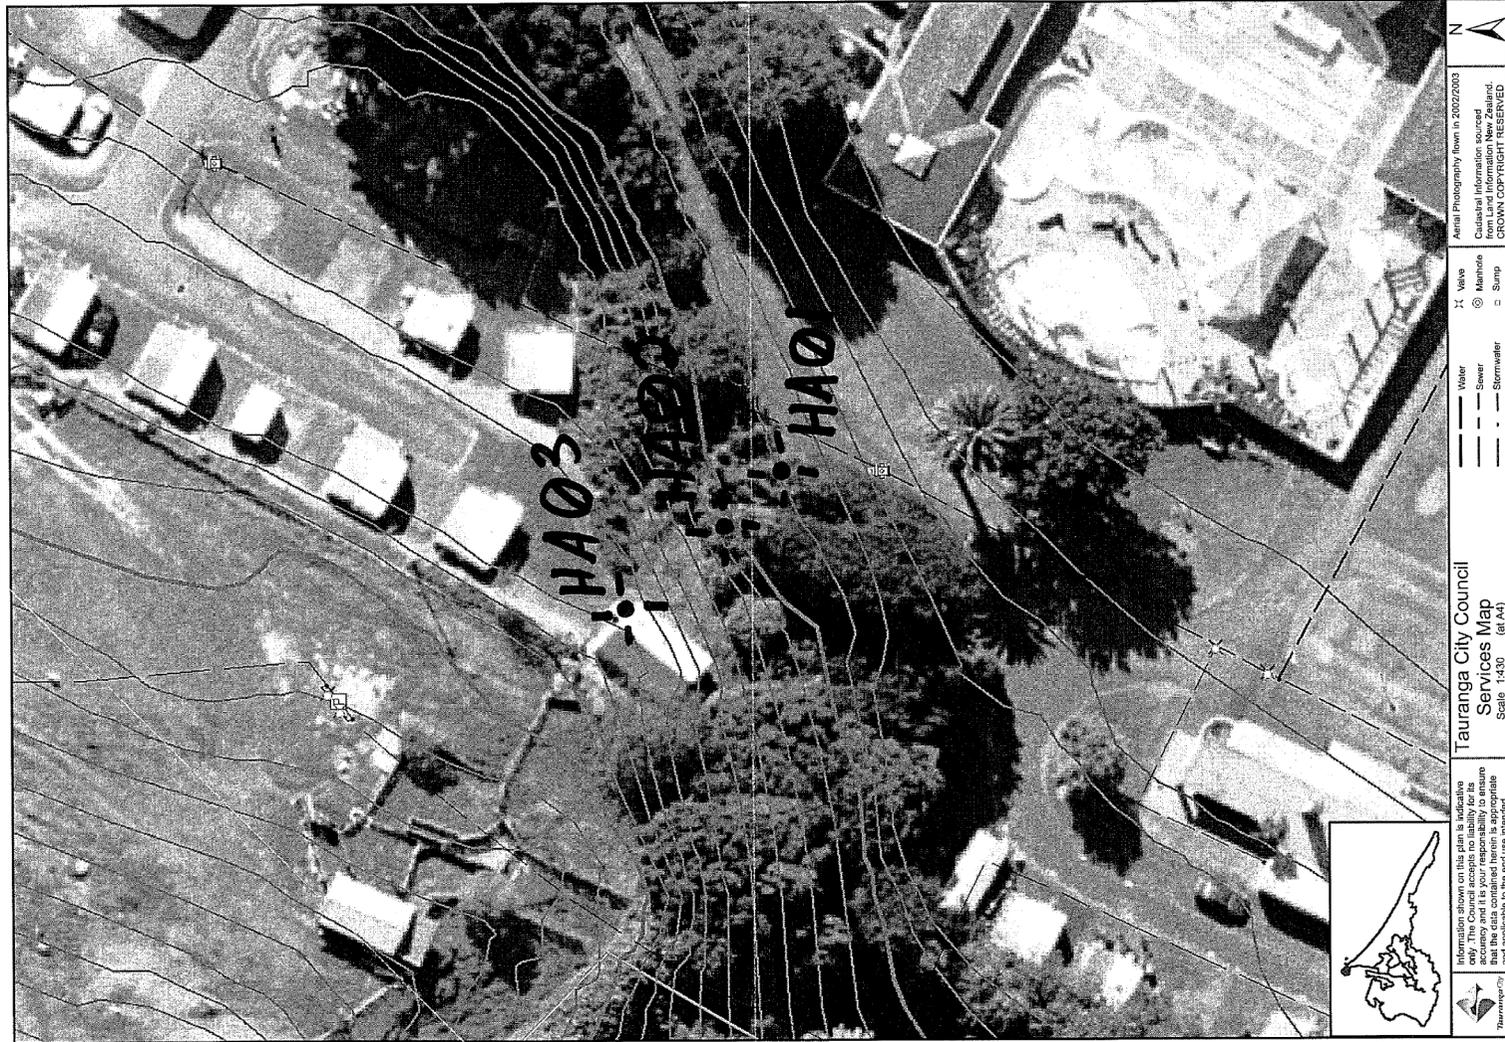
The upper section of the slope has slumped with a vertical headscarp forming along the top of the slope. No evidence of movement has been noted within the lower section of the slope.

Photo 1: Looking along the top of the failure slope from the western side, recent movement indicated by the near vertical scarp.
