GEOTECHNICAL

15 April 2021
Avalon Project #21212

Mauao Slopes; Final Report for March 2021

The rock bluff survey benchmark monitoring was carried out on the 23rd March.

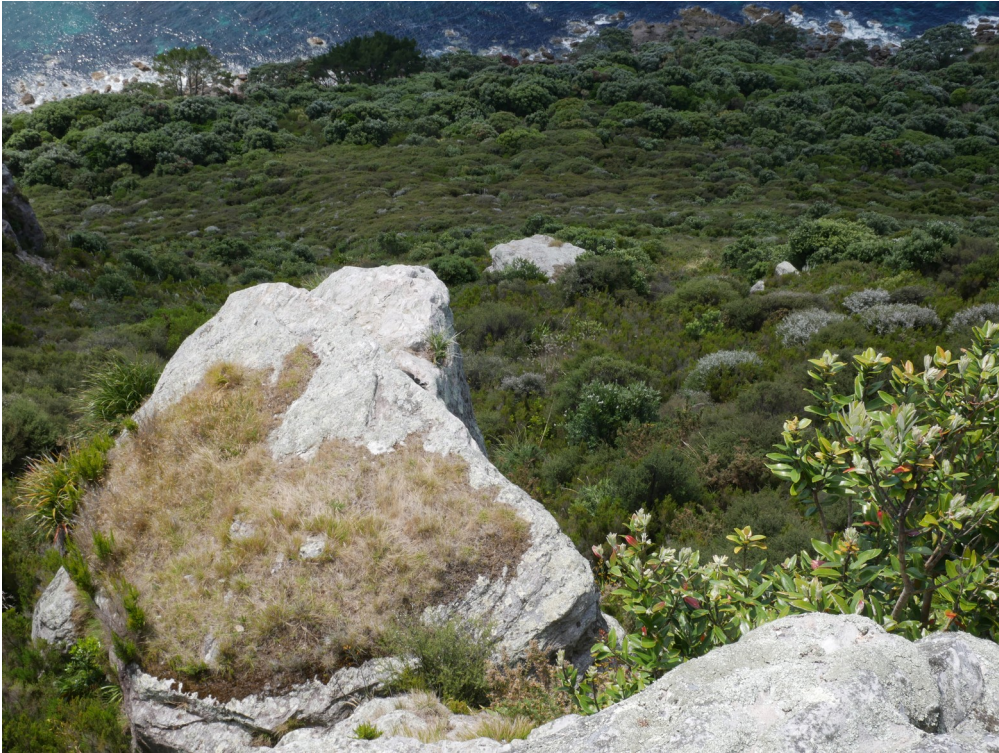
Photo 18; 2018

The detail in the following dhow examples of small scale natural changes as vegetation grows and erosion removes soil, exposing rock fragments, some of which then disappear as they are washed over/fall down the slopes.

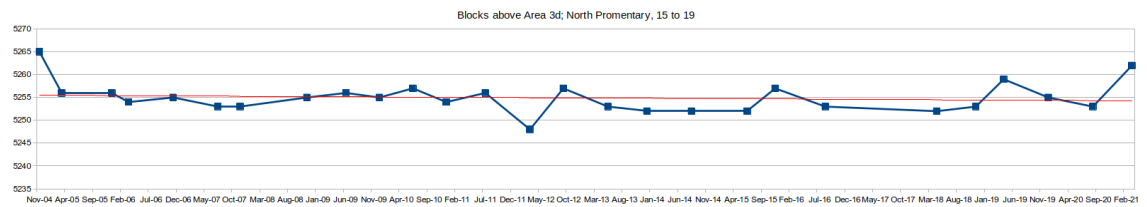
Blocks above Area 3d; North Promentary, 20 to 15

The benchmark survey found no significant recent movement on the high bluffs which are monitored. The ongoing very slow movement of some bluffs continues. Plotted data is appended to this report.
