Report on:

Mauao Slopes: May 2006

Rockfall & Landslide Risk Review

Avalon Report No: 0627 A

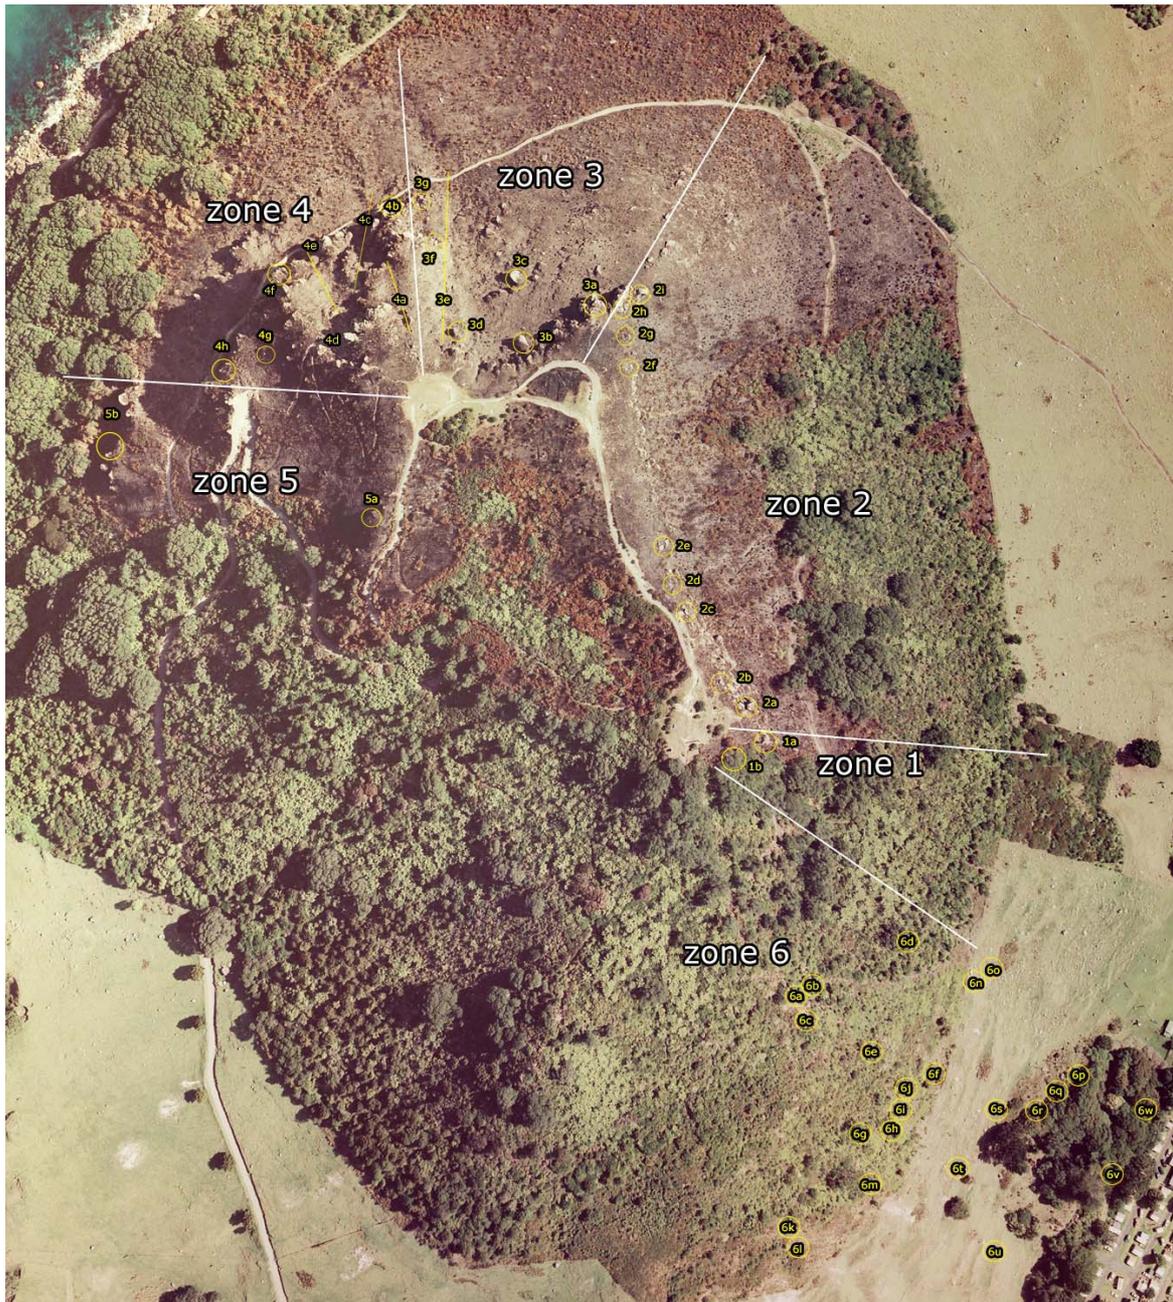
Photo' 27: The slope Zones.

The colluvial slopes and outcrops/bluff ledges are littered with loose rock of various sizes, much of which could relatively easily be triggered to fall.

Previous reports have described the topography and likely rockfall modes in detail, for each slope Zone as well as identifying specifically hazardous boulders or marginally stable areas.

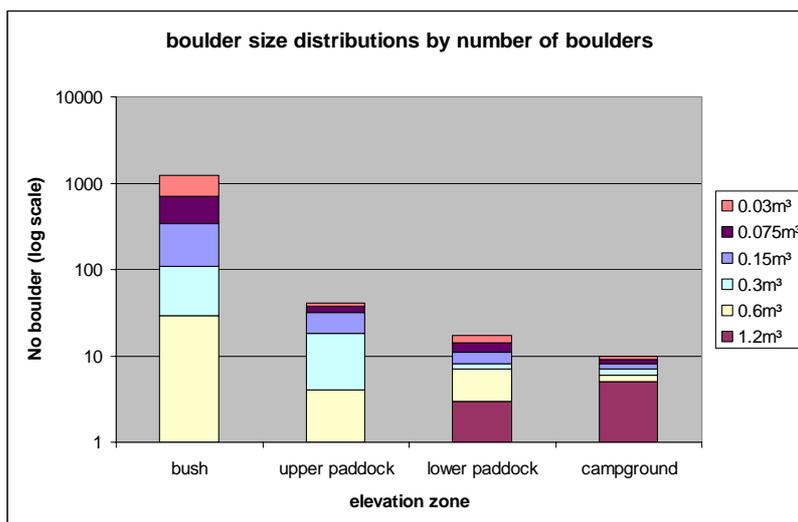
Chart 1; Rock travel distances in Camp Bluff Blast in 2003.

An analysis of rock volume vs. resting elevation is shown in the following graph. As would be expected the larger rocks travel furthest.

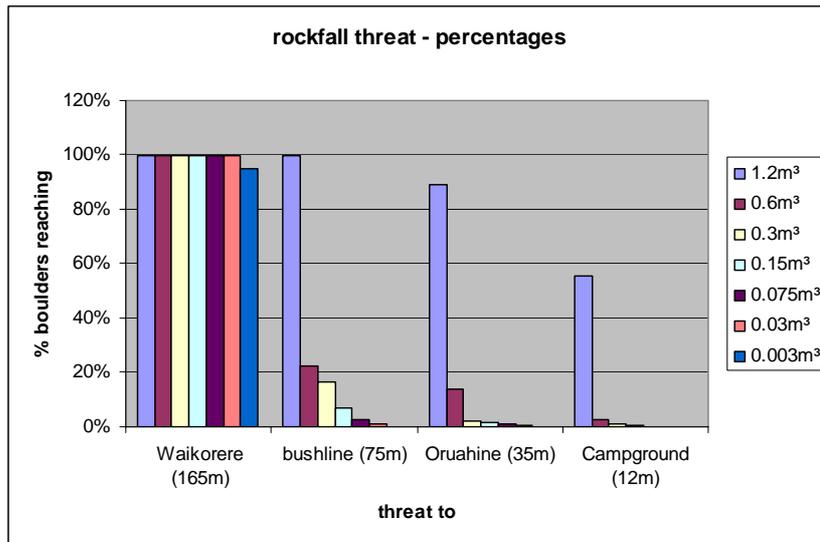
Chart 2; % of boulders of different sizes stopping at various levels.

The data was then used to give an approximate probability that a given boulder of a certain size would reach a certain elevation on the slopes:
