# Mauao Base Track Reinstatement

Design Report

## Geotechnical Completion Report

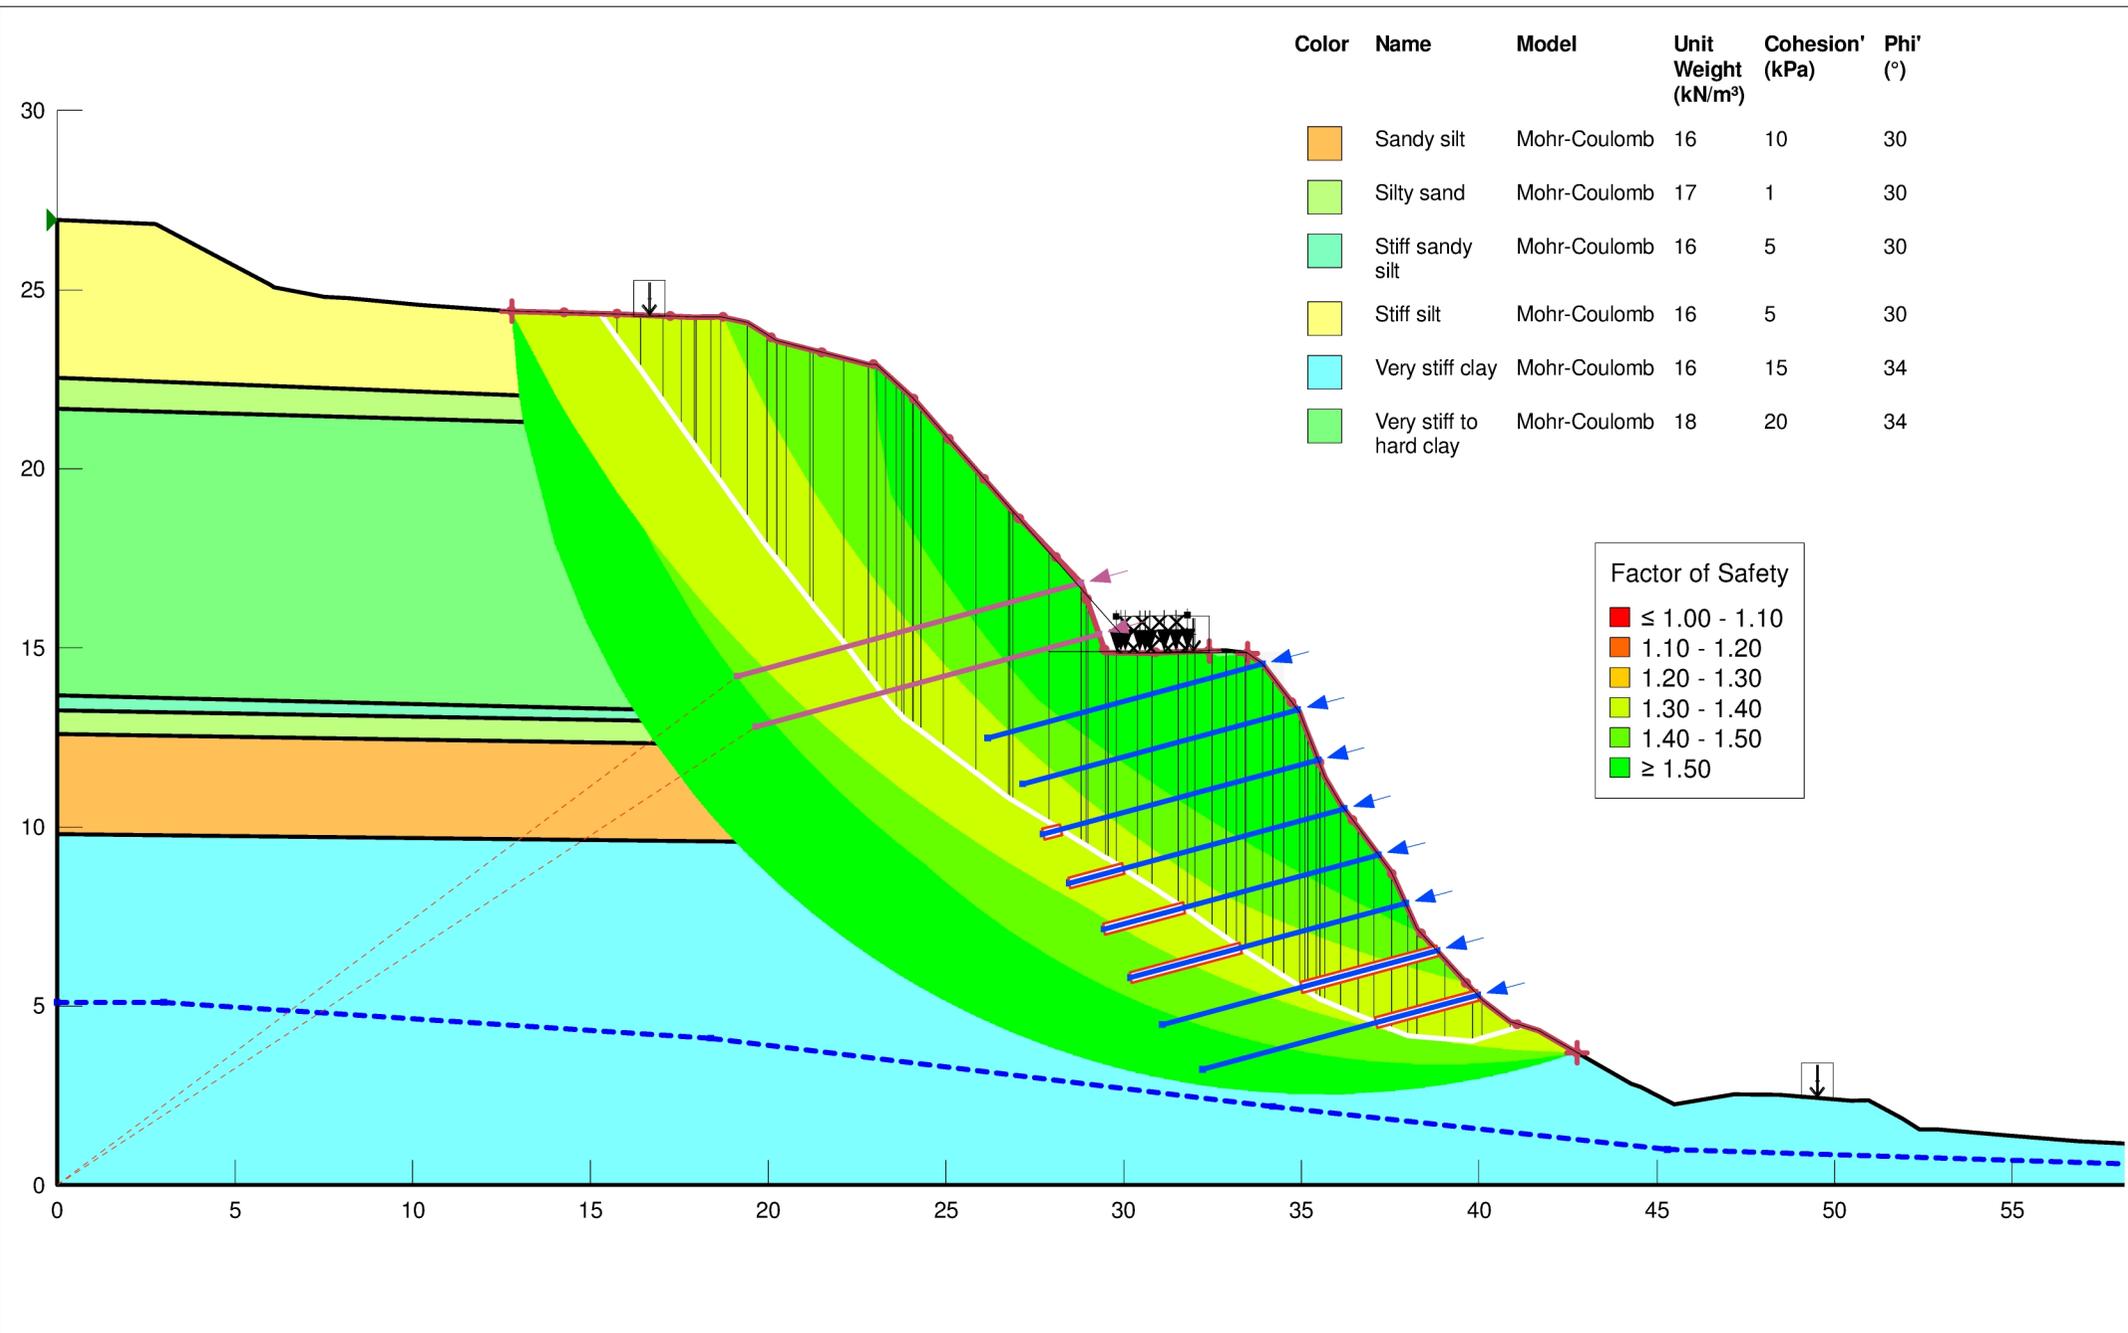
Project: <b>2-9B463.00 - Mount Base Track</b> Analysis: <b>CH37.5_Final Model 141119 back analysis</b> Modelled By: [Redacted] s 7(2)(a) † Privacy Checked By: [Redacted] s 7(2)(a) † Privacy	Model	SLOPE/W	Proj No.	2-9B463.00
	Method	Morgenstern-Price	Date:	10/12/2019
	PGA	g	Scale	1:150
	FOS	1.01	Sheet No.

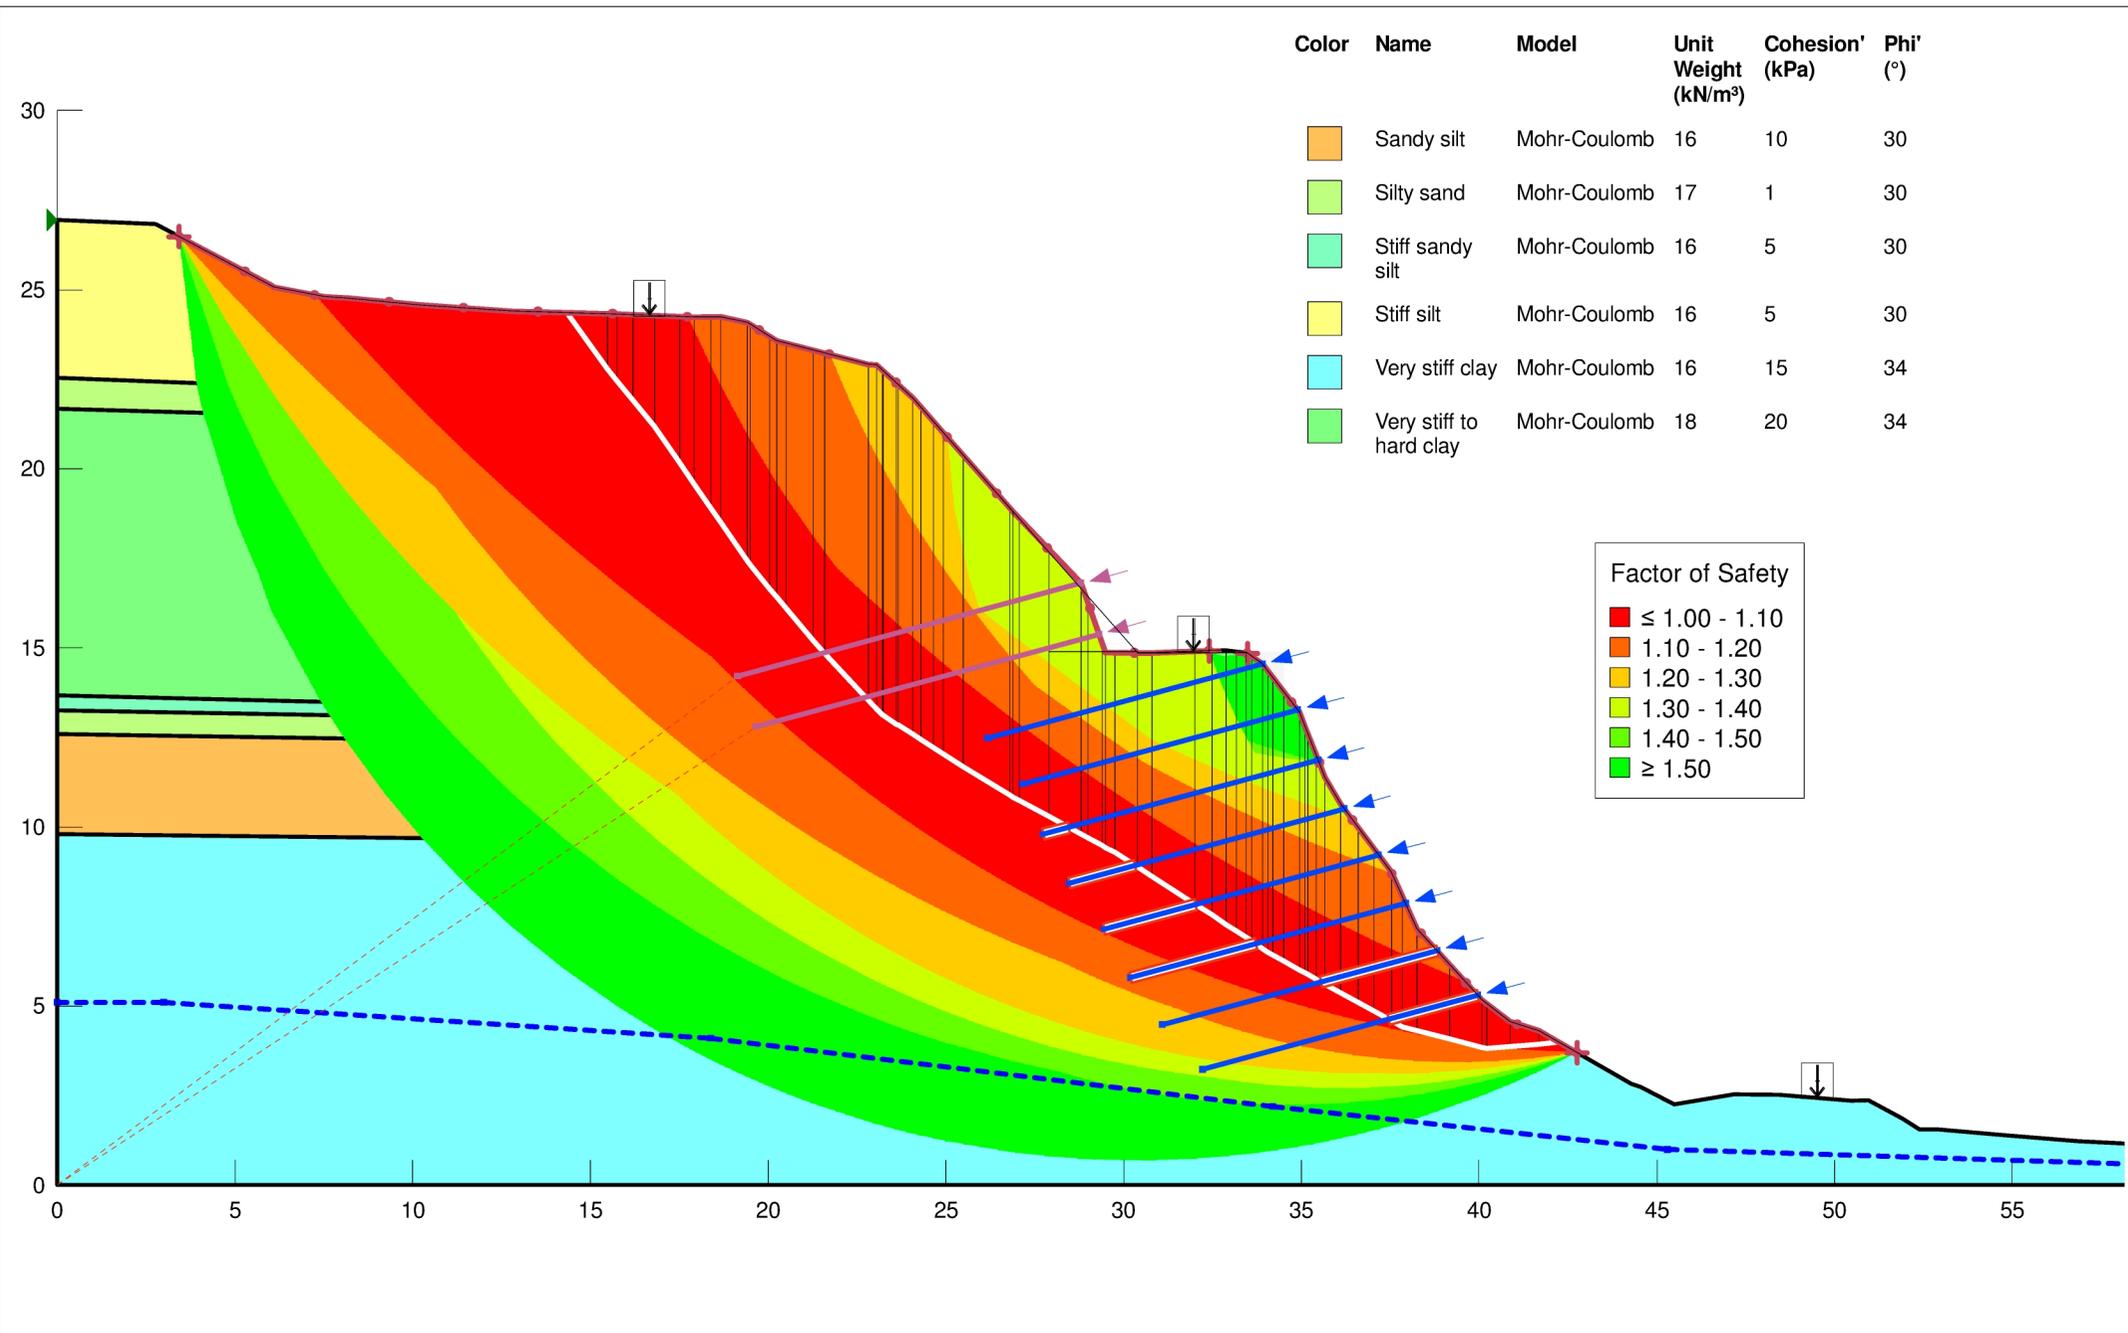
Project: <b>2-9B463.00 - Mount Base Track</b> Analysis: <b>CH37.5_Soil Nail Design Rev.A Normal GW all nails</b> Modelled By: s 7(2)(a) † Privacy Checked By: s 7(2)(a) † Privacy	Model	SLOPE/W	Proj No.	2-9B463.00
	Method	Morgenstern-Price	Date:	10/12/2019
	PGA	g	Scale	1:150
	FOS	1.31	Sheet No.

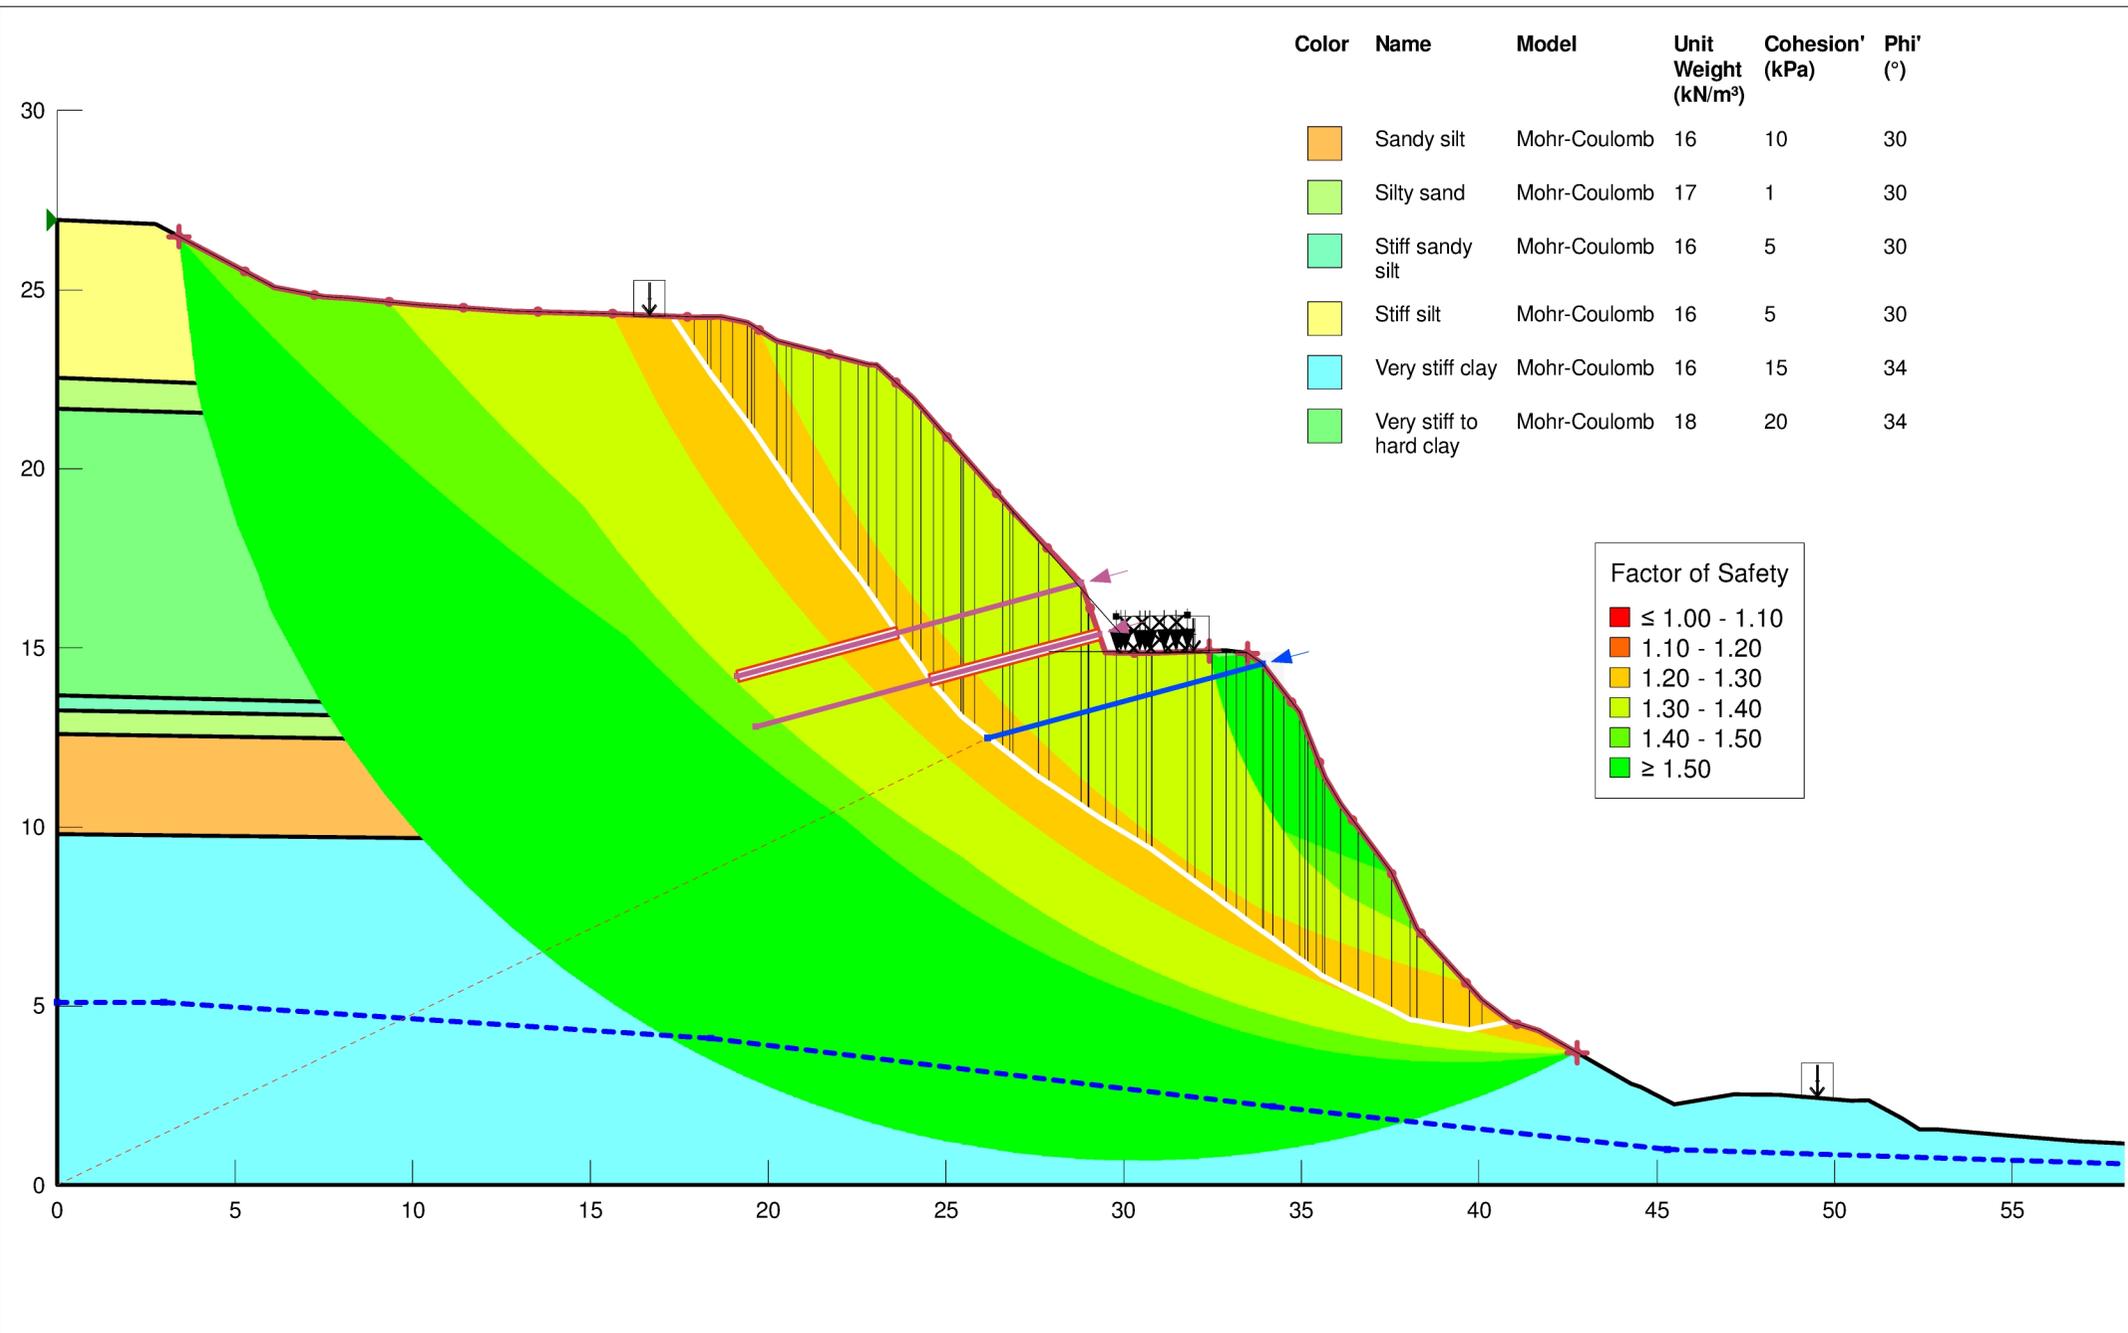
Project:	<b>2-9B463.00 - Mount Base Track</b>	Model	SLOPE/W	Proj No.	2-9B463.00
	Analysis:	<b>CH37.5_Soil Nail Design Rev.A Normal GW seismic</b>	Method	Morgenstern-Price	Date:	10/12/2019
	Modelled By:	§ 7(2)(a) † Privacy	PGA	0.17g	Scale	1:150
	Checked By:	§ 7(2)(a) † Privacy	FOS	1.01	Sheet No.

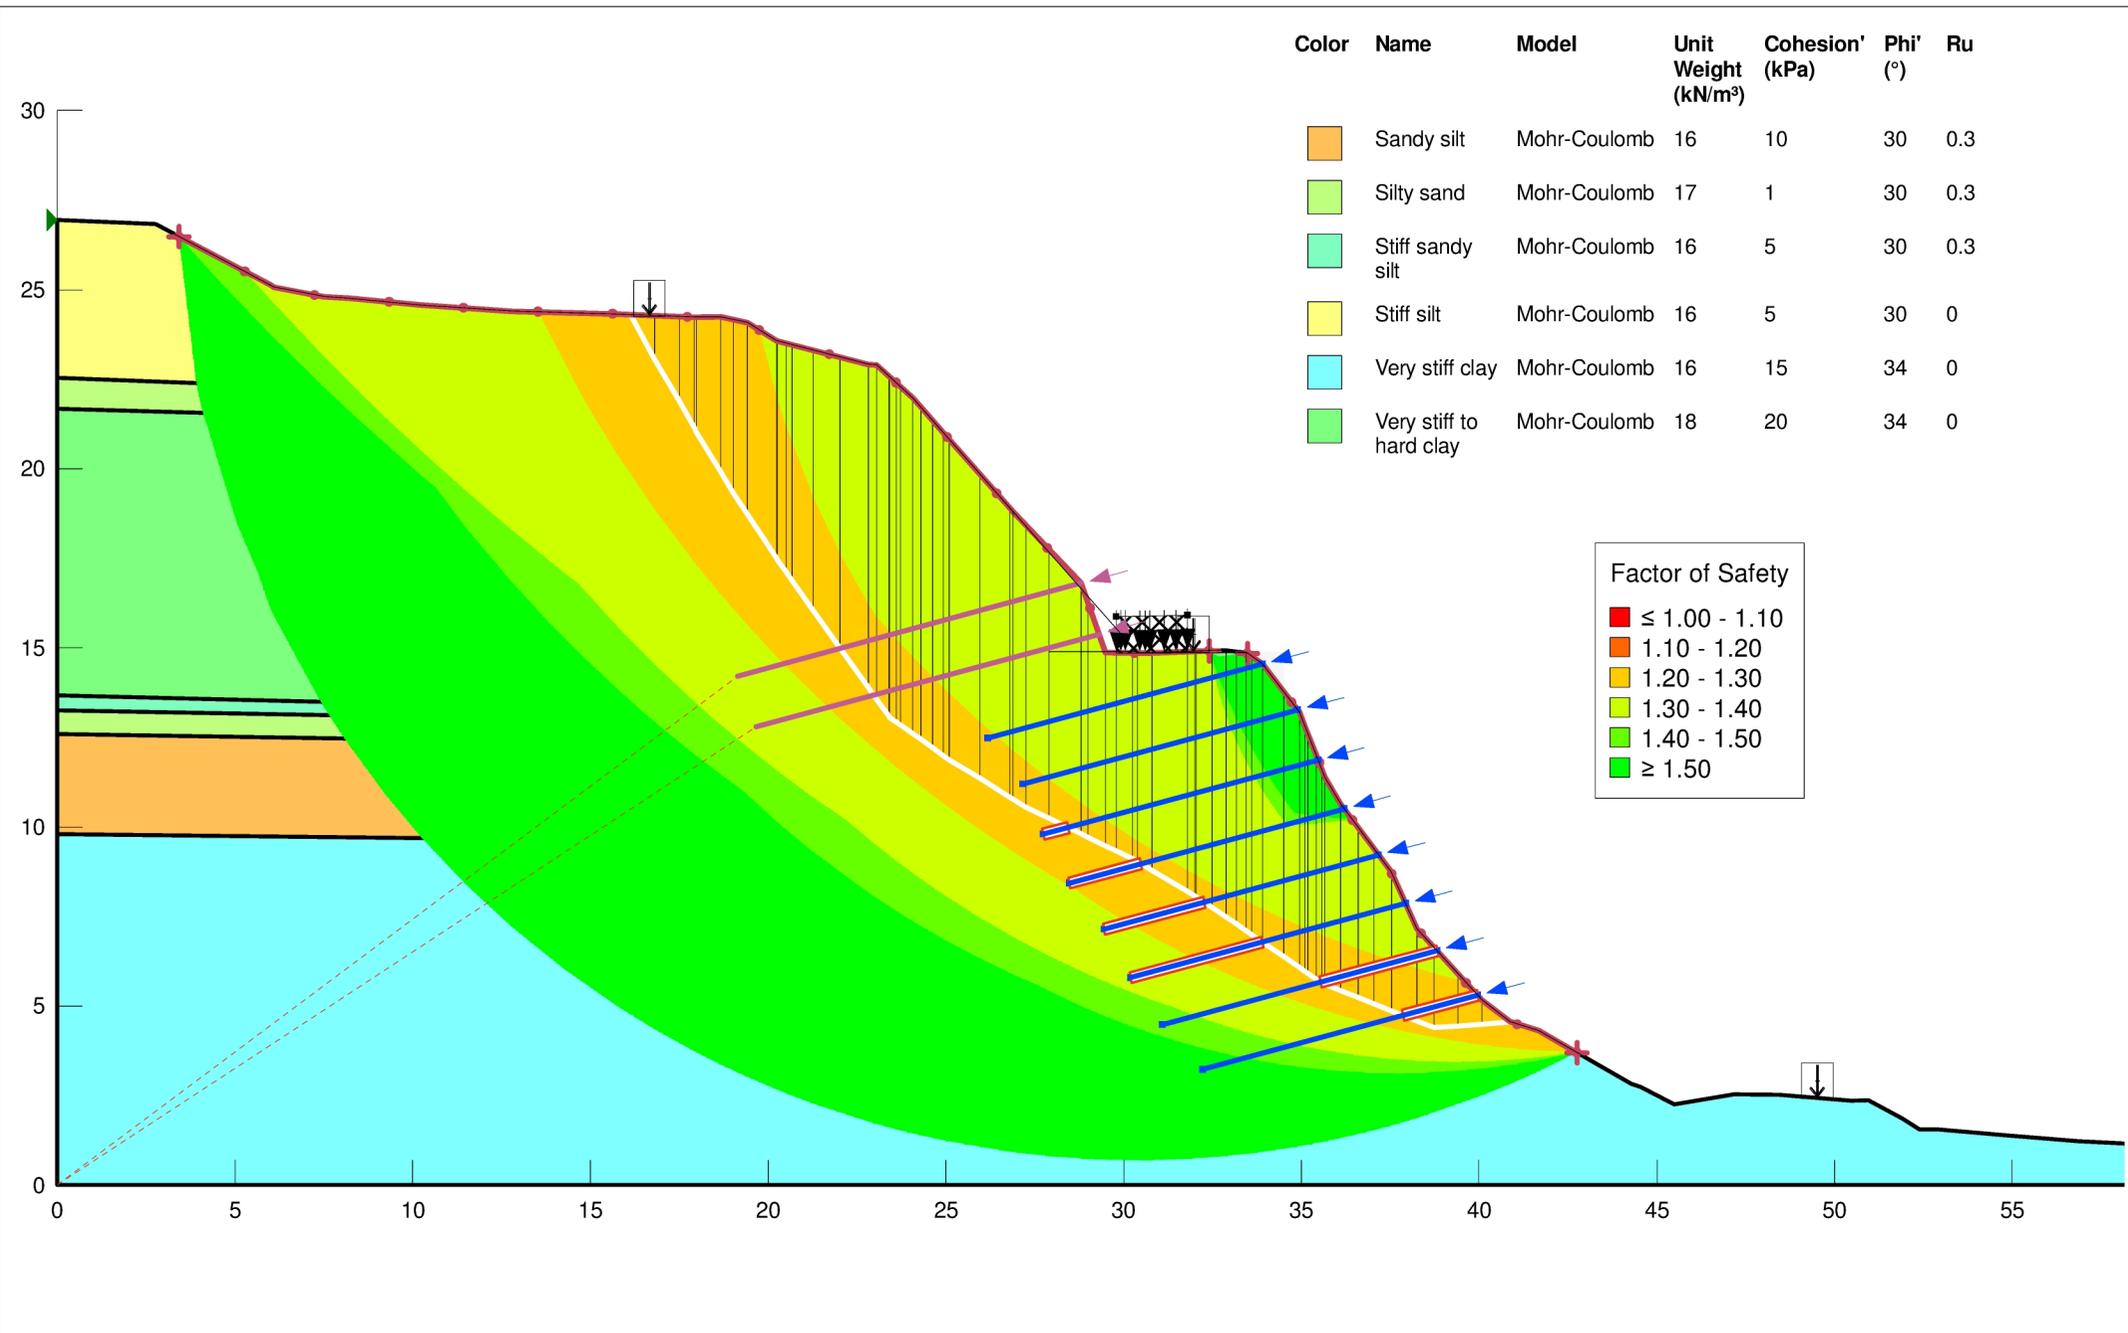
Project: <b>2-9B463.00 - Mount Base Track</b> Analysis: <b>CH37.5_Soil Nail Design Rev.A Normal GW upper nails only</b> Modelled By: [Redacted]	Model: SLOPE/W Method: Morgenstern-Price PGA: g FOS: 1.22	Proj No.: 2-9B463.00 Date: 10/12/2019 Scale: 1:150 Sheet No.:
	Checked By: [Redacted]

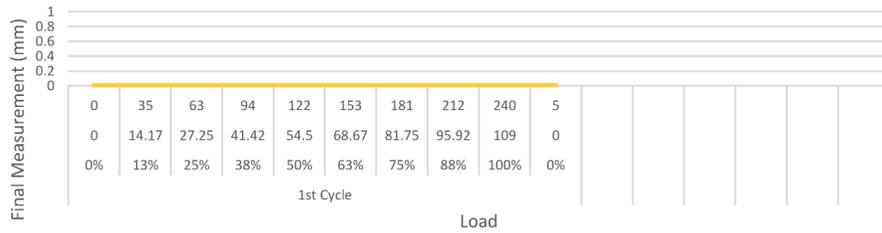
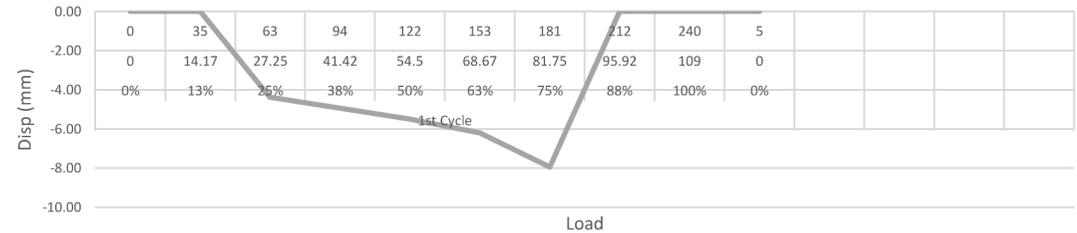
s 7(2)(a) - Privacy pumped to maintain pressure hence 0.2mm creep

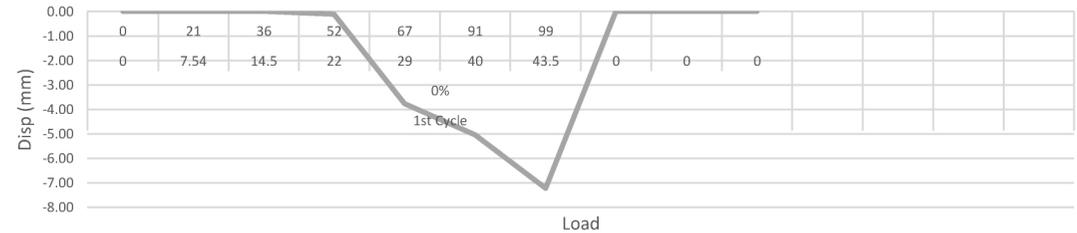
Loads changed on site as per s 7(2)(a) instruction - new loads on spreadsheet

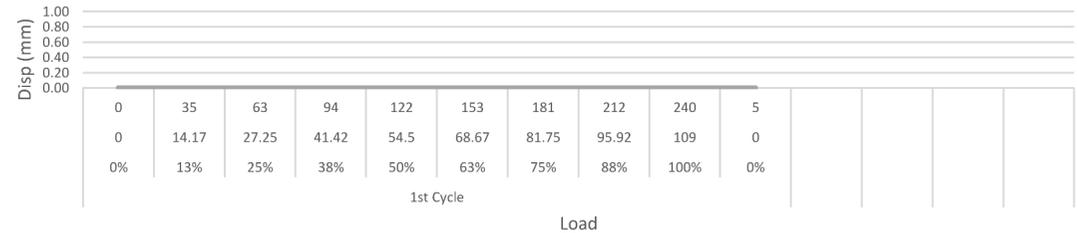
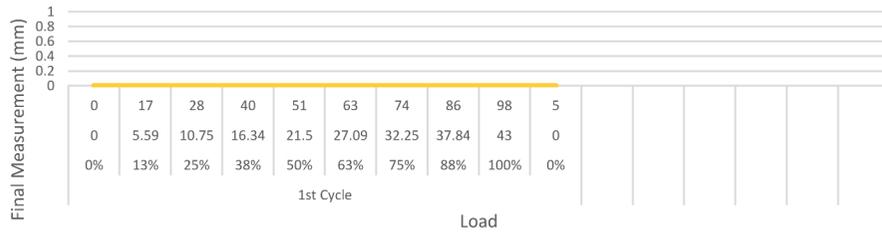
Anchor #	Bottom Slope Test Anch	§ 7(2)(a) – Privacy	30t
Date	9/12/2019	DTL (Kn)	43

▲ Took anchor to failure which was 190 bar

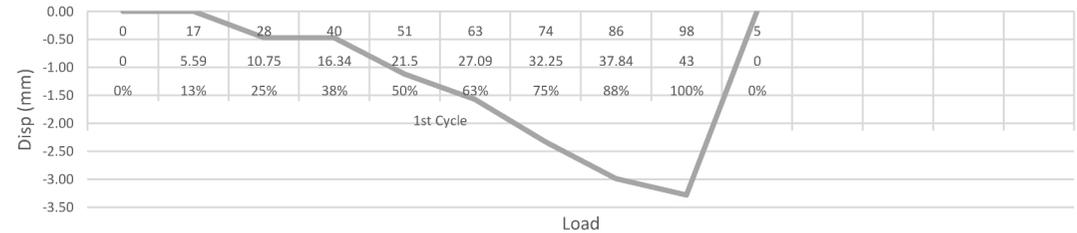
Anchor #	TEST 1 - SAC
Date	2/12/2019

Loads given on site.

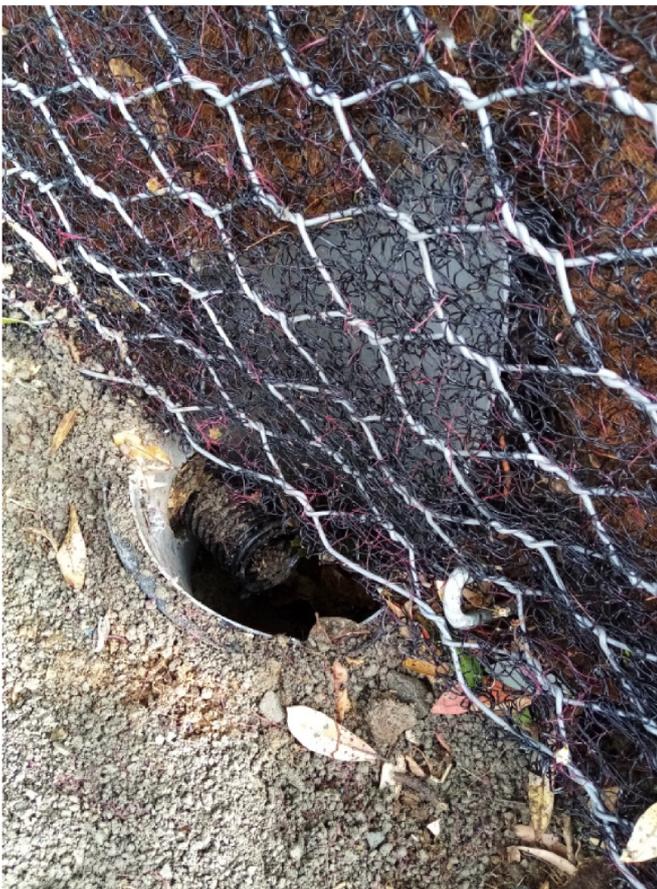
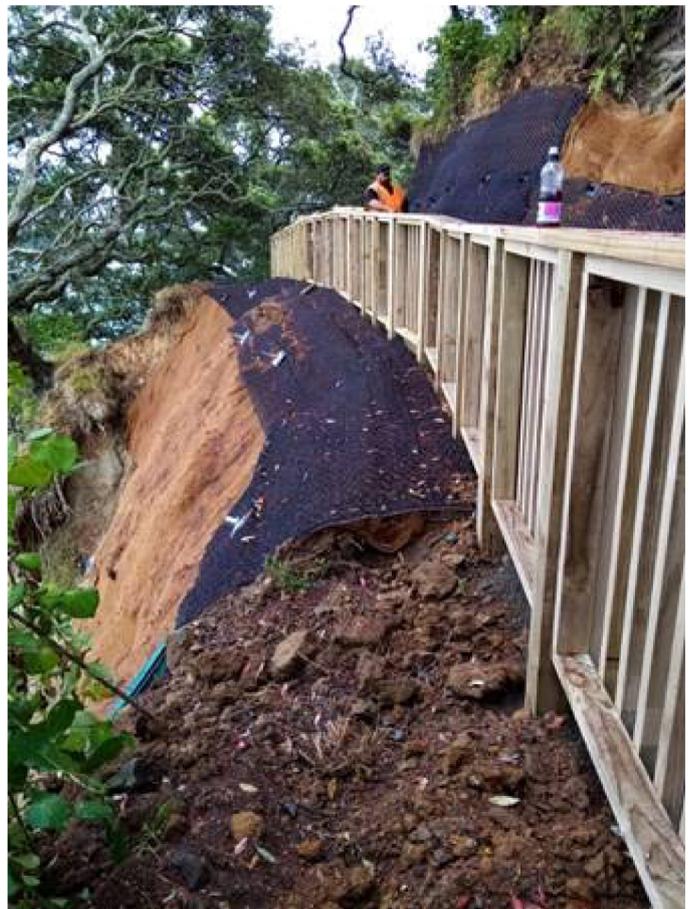
- Anchors below track need to be tightened with a large spanner to align the base plate to the face and ensure it is snug against the face. There appeared to be at least one anchor nut that was loose towards the Matakana side.
- Further to my email regarding the track width, with the fence now installed the narrowest section is 1.7m wide which may be a bit tight for the surf quad bike. At this section the fence is the closest allowable distance to the slip so to widen would require some more cutting into the toe of the bank and relaying Macmat. I would suggest we revisit this in the new year?
- The slot for the subsoil drain that is picked up by the culvert needs to be deepened to ensure the drain coil/metal has enough fall to flow into the culvert inlet.
- The lower anchor nuts have been covered with Macmat so do not require caps.
- Everything else looking pretty tidy.
