Geotechnical Assessment Report

Whare Manaaki Mauao Project

MAUAO TRUST
1 ADAMS AVENUE, MOUNT MAUNGANUI

9 DECEMBER 2025

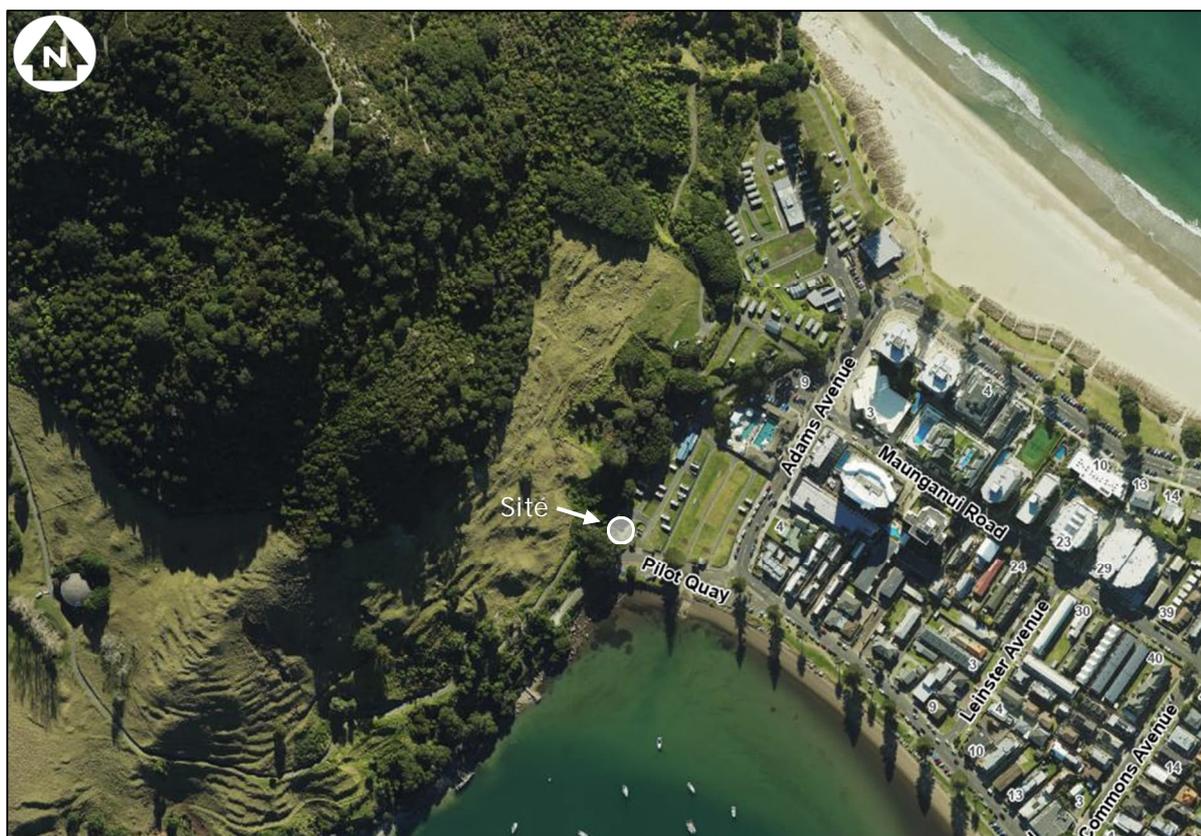
Figure 1 | Site overview showing the subject site location (TCC Mapi)¹.

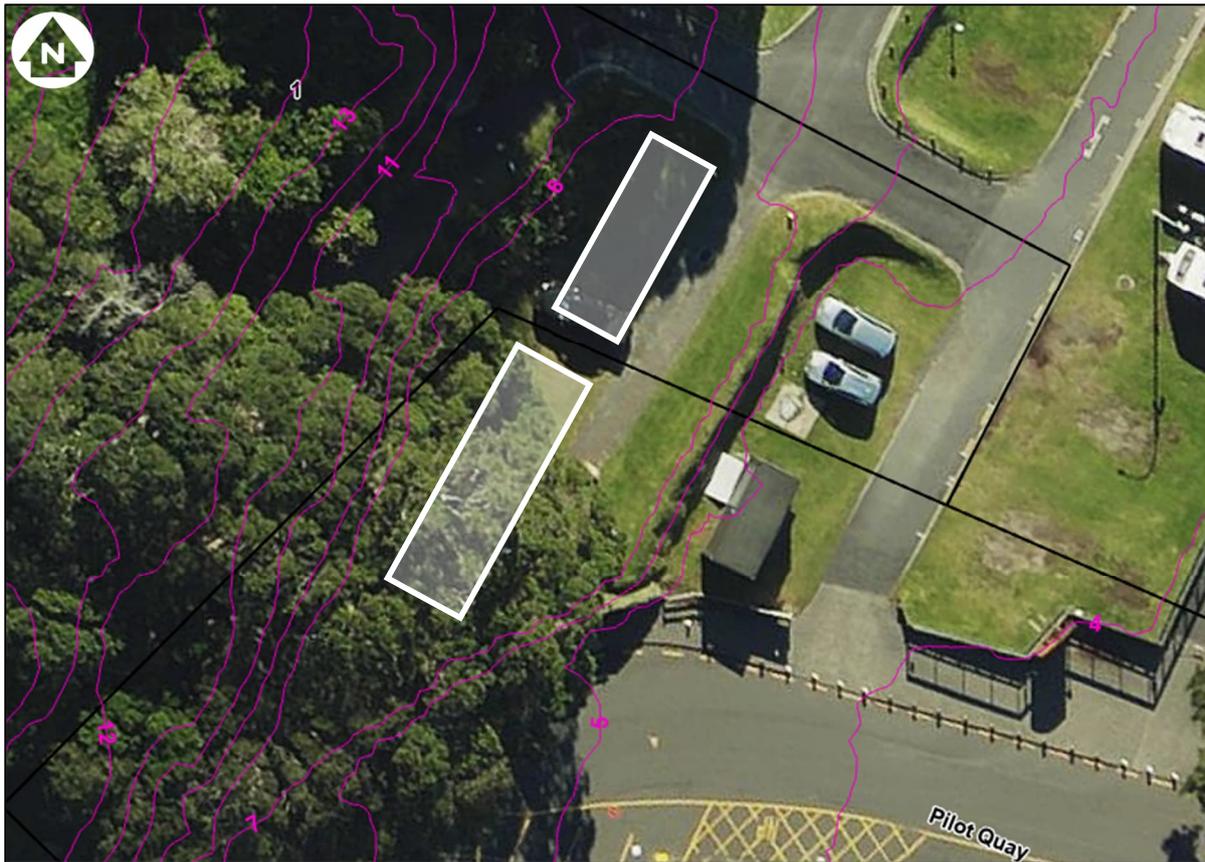
Figure 2 | Site plan showing the approximate location of the proposed buildings. The topography of the site is shown by 1.0 m contours (TCC Mapi).

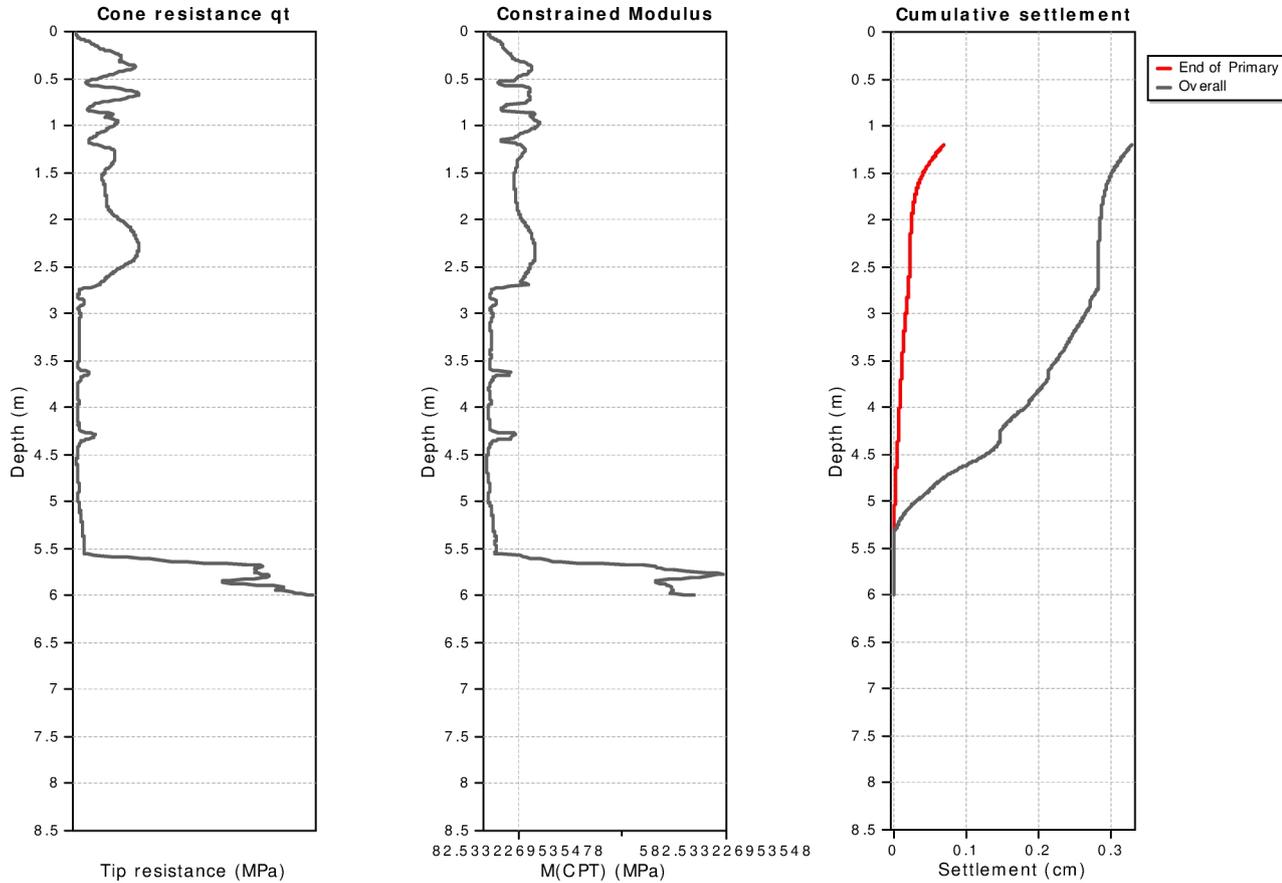
A load scenario of 100 kPa on a 0.45 m diameter foundation at 1.2 m depth, reflecting a piled foundation was used for the settlement analysis.

The analyses indicated that under a piled foundation the predicted primary settlements are less than 3 mm. The total predicted settlements expected to be less than 4 mm in CPT01a and approximately 29 mm in CPT02, predominately occurring below approximately 7.5 m bgl. We consider that the predicted long-term static settlements in the deep soil layers are over-predicted as the existing overburden pressure from the soil below a depth of approximately 5 m is more than 100 kPa. As the proposed building loads are relatively low compared to the overburden pressure, the natural soil at depth is therefore not expected to settle significantly under the proposed building loads. Additionally, the secondary settlements are not affected by the load applied and reflects the consolidation of the soils based on overburden pressures. Furthermore, the site will be cut, reducing the overall applied loads within the building platform.
