Mauao Base Track Remediation
Geotechnical Assessment

October 2018

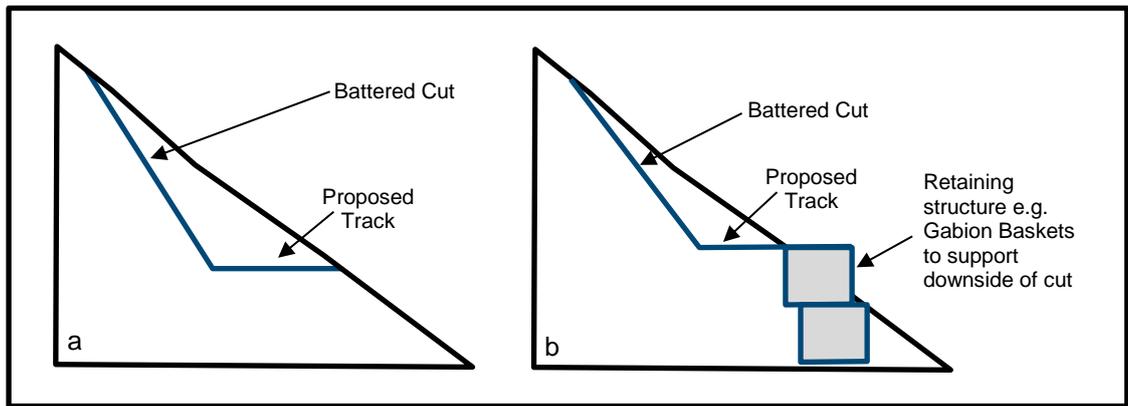
Figure 4: Track Formation recommendations.

[a) Cut track entirely constructed on cut ground. b) Cut track half on cut and half on fill, supported by a Gabion Basket retaining wall].

- Option 2 would be to construct the track on cut ground rather than filled ground. This could potentially require retaining on the downhill side of the track in places. The recommend cut styles are illustrated in Figure 4. The constraints of this option is that in order to achieve a safe batter angle upside of the track, and due to the proposed gradient of the track down to the revetment, large amounts of excavations would be required along this length of track. This would result in disturbing heritage sites and removing significant amounts of vegetation leaving large exposed cut faces and retaining structures.

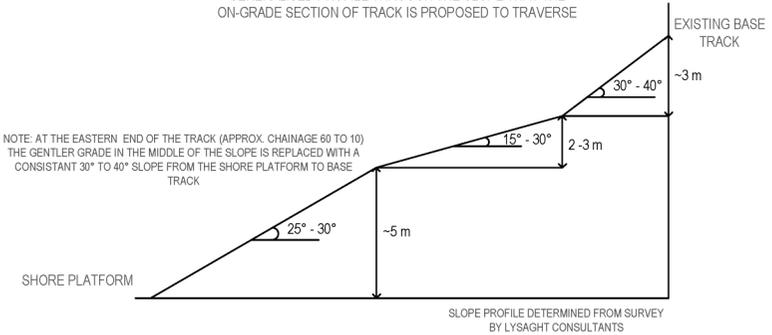
GENERALISED PROFILE THROUGH THE SLOPE THAT THE ON-GRADE SECTION OF TRACK IS PROPOSED TO TRAVERSE

SLOPE IS APPROXIMATELY 10 - 15 m HIGH. SEE GENERALISED SLOPE PROFILE IN SECTION BELOW

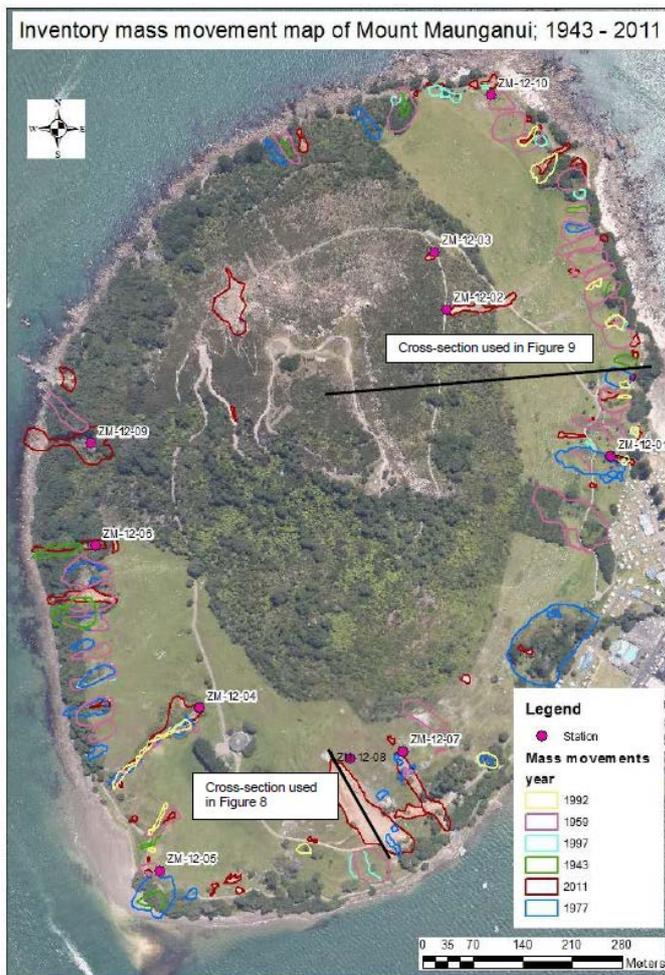
Figure 2: Spatial distribution of landslides on Mount Manganui.

Using the historical information collected from “Martin_Brideau_2014” Figure 2 the following events occurred in the location of our study area;

Using an average over this 74 year period approximately 0.2 events occurred per annum which correlates to a “moderate hazard” description for small landslides on natural slopes therefore;

Figure 4: Spatial distribution of the landslide on Mount Maunganui between 1943 and 2011. Stations represent landslides that were described in details during the 2012 field season.
