Boffa Miskell Limited  
Mauao Base Track Remediation  
Geotechnical Assessment

July 2018

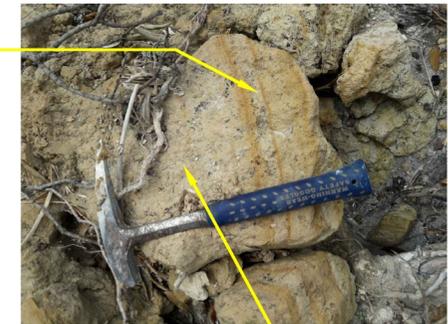
PUMICEOUS SILT ENCOUNTERED IN COLLUVIUM PILE

ORANGE BANDING LIKELY INDICATING THIN AIR FALL DEPOSITS

Pumiceous SILT, some fine sand, pale orange brown, banded orange. Silt to very stiff, moist, low plasticity
