**Archaeological Site
Condition Monitoring Report**

Mauao Historic Reserve, Tauranga

11 September 2020

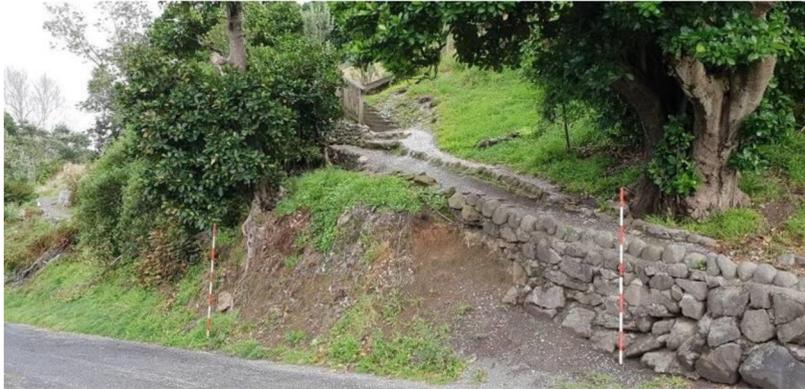
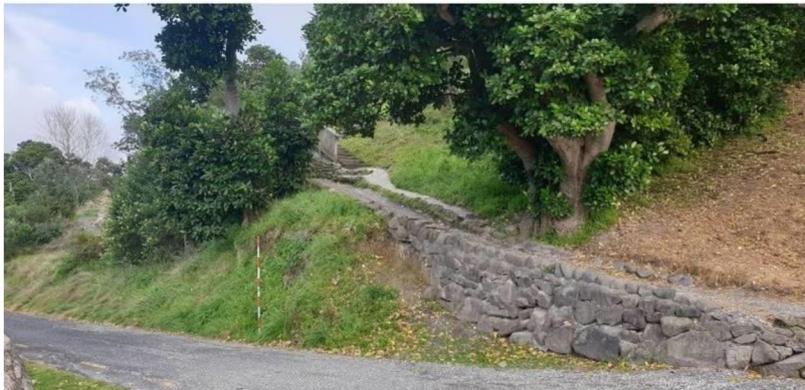
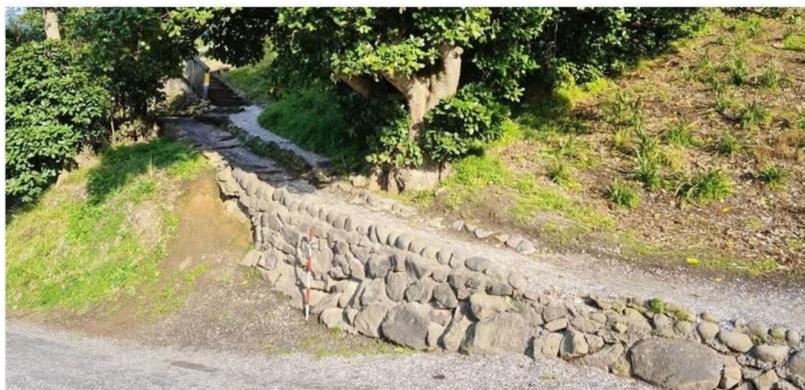
Monitoring point 1:

Notes: Grass cover decreased from 2019, but no new erosion visible. Grass cover should be monitored and re-sown if it does not naturally re-establish during spring. The area of terraces to the east of the monitoring point planted in winter 2019, becoming established. Bare ground where release spraying has occurred.

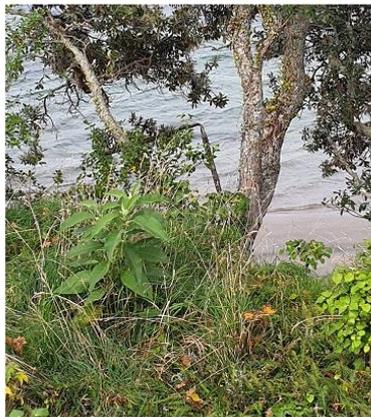
Top to Bottom:
30th April 2018
2nd July 2019
26th August 2020

Notes: Vegetation clearance has been completed to reduce pohutukawa and sycamore growing on the stonework face of the jetty. Possible interpretation could be developed at the jetty. It should be maintained in low vegetation/ferns/rank grass, with periodic weed eating. Terrace surface less visible than in 2018. The view shaft to the iron debris offshore should be maintained.

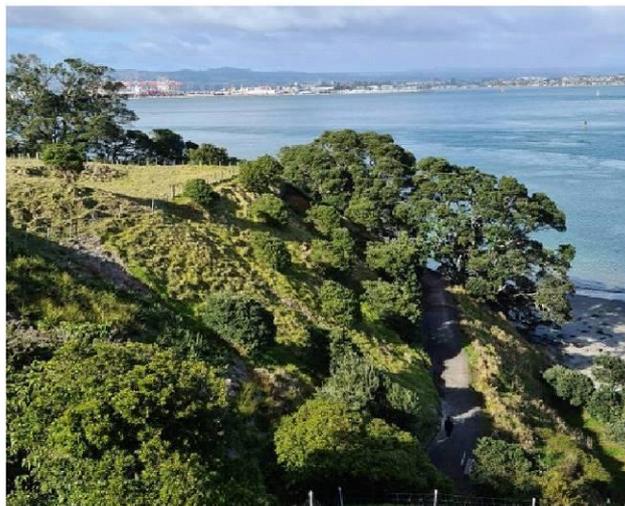
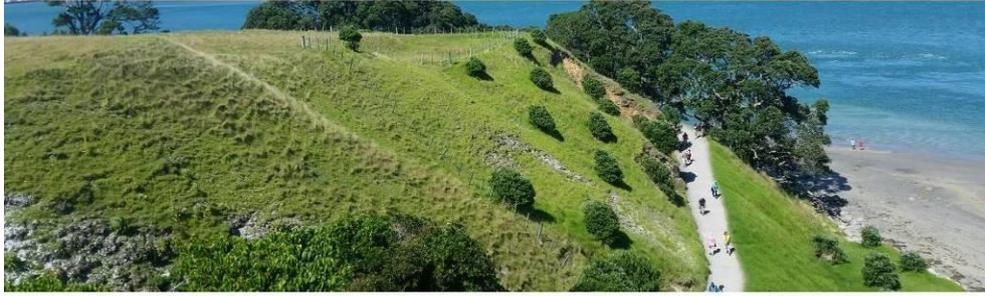
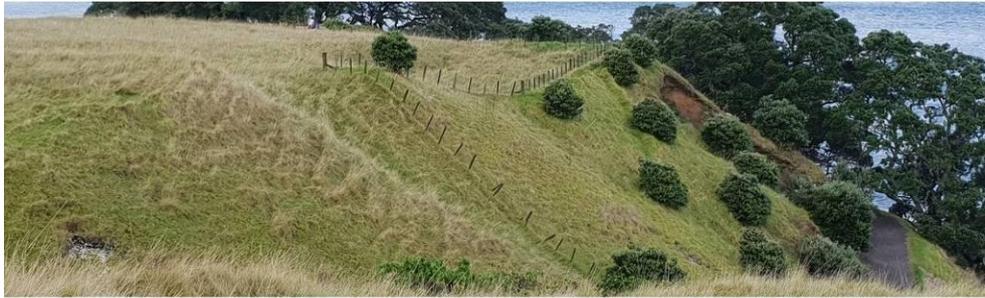
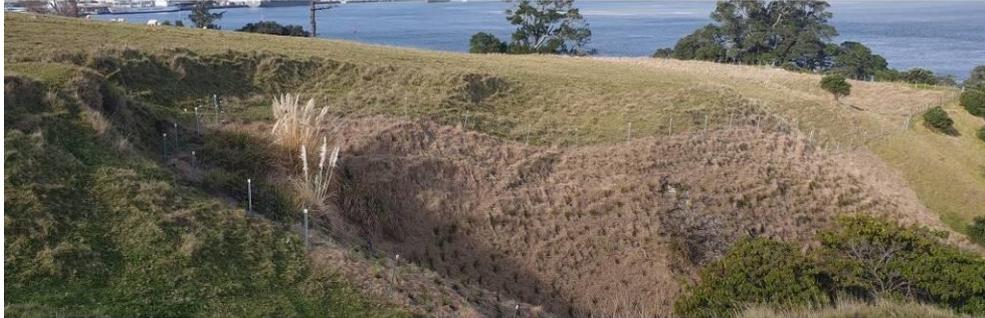
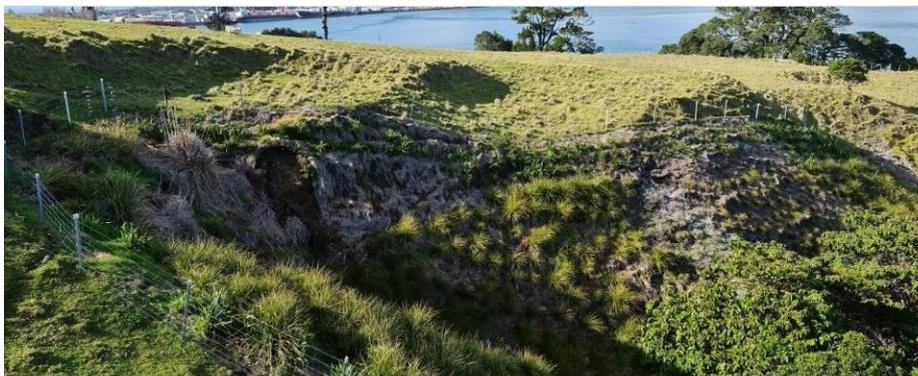
Monitoring Point 4:

Notes: In 2019 the fence alignment was adjusted to remove it from archaeological features, using new waratah standard and netting system. Slope below has been planted, and livestock have been excluded from steep areas, to stabilise midden and protect features uphill. There is more growth appearing on the slope since rabbit numbers were reduced. Midden is less visible. Two years on the plantings are becoming well established, midden is less visible and the fence system is well maintained. Bare ground where plants have been release sprayed.

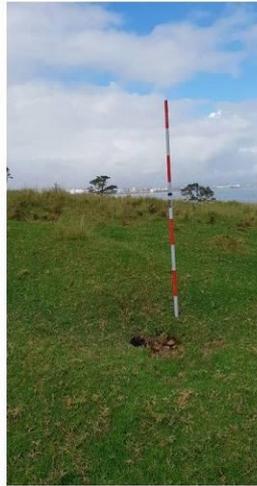
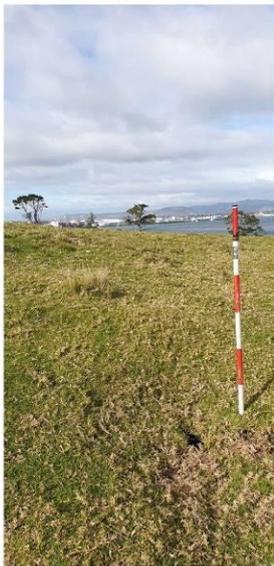
Monitoring point 5:

Notes: Old rabbit damage, visibility decreasing. Note danger that such features start to look like archaeological depressions over time. Area around burrow entrance has deflated over time.

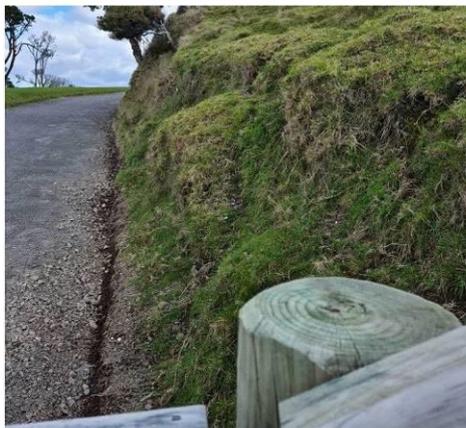
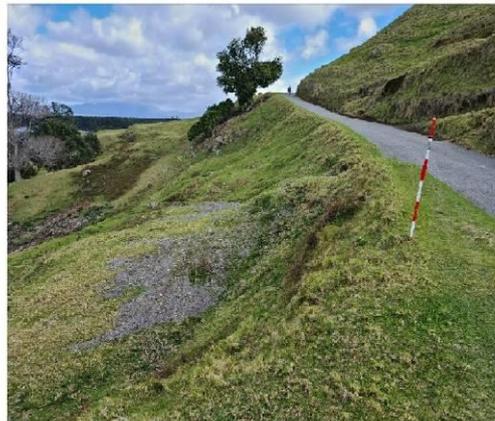
Notes: There is no recent evidence of tailings being dumped on archaeological features above the track, as was the issue in the past. However, the artificial build-up of material continues to ‘create’ features adjacent to the track. Remedial and maintenance issues relating to the 4WD track have been on-going, and there is still a significant issue with metal being distributed onto terraces below the track. The distance between culverts, their function and the treatment of tailings needs further management attention. Consideration should be given to removal of artificial build-up with archaeological supervision.

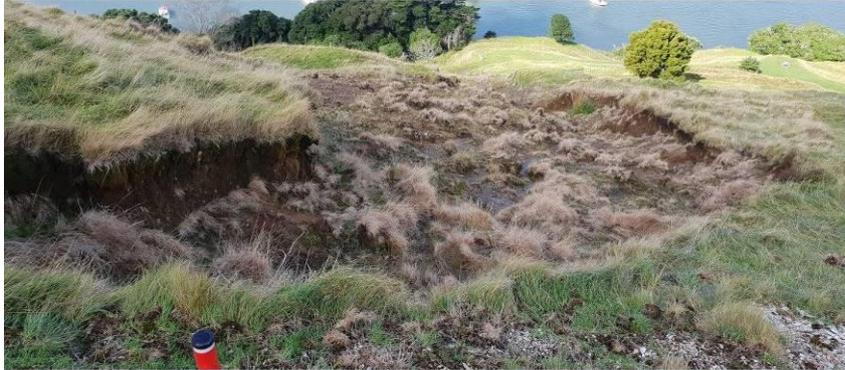
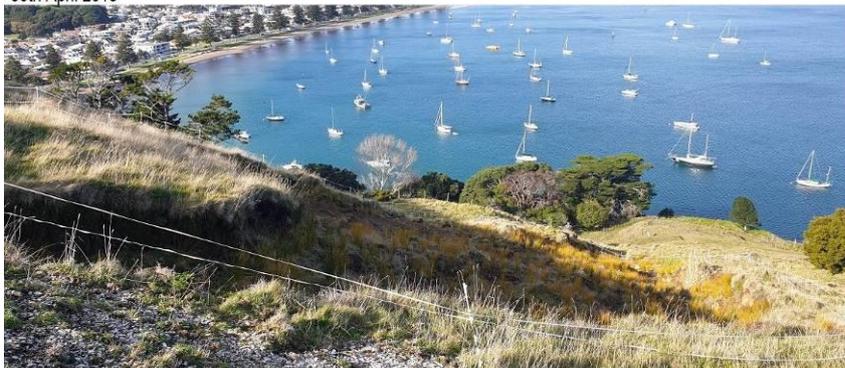
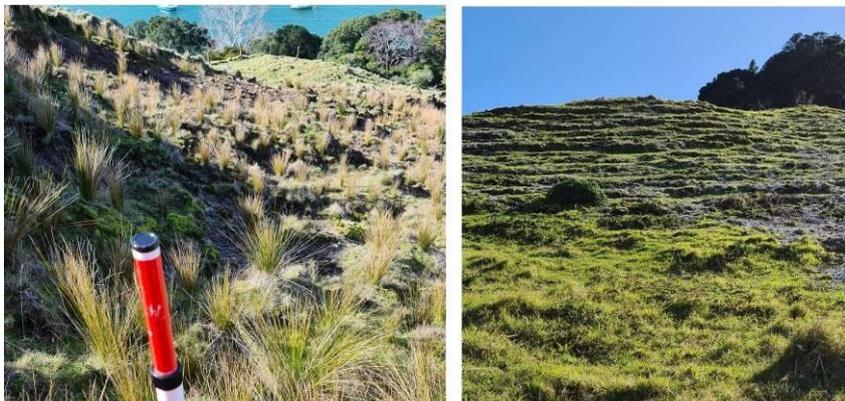
Notes: 2018 planting of slip scar becoming well established. There is still a lot of visible shell midden at the top of the slip scar and some evidence of recent new exposure, and there was active water flow through the slip at the time of the inspection. The shell mound immediately above the slip scar is very exposed and appears increasingly unstable. There is some possibility that this area could slip, and consideration should be given to archaeological investigation before this occurs. As an interim measure the stock exclusion trial should be moved to this shell mound.

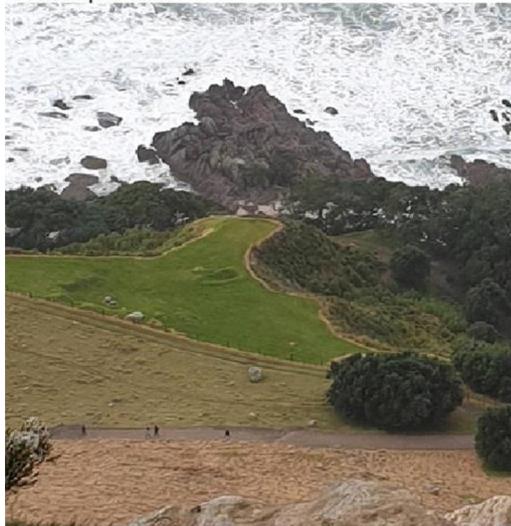
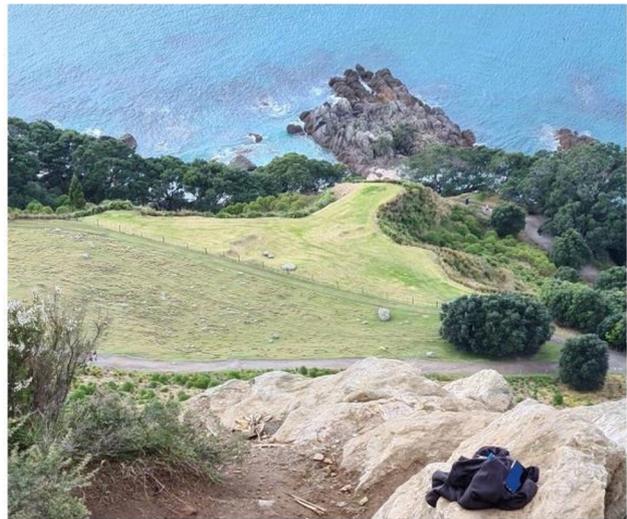
Notes: Management of vegetation and site visibility has significantly improved following cessation of grazing.

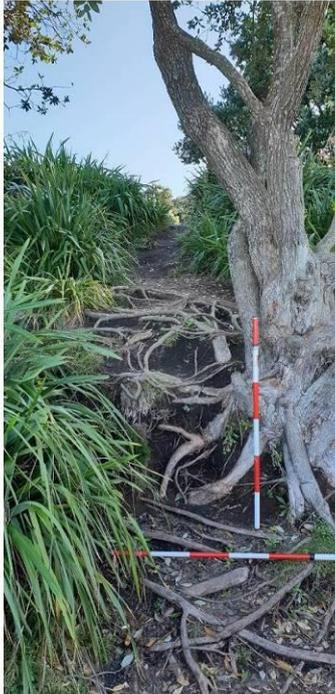
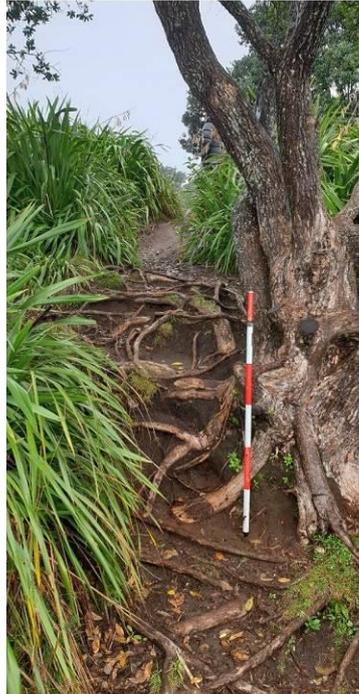
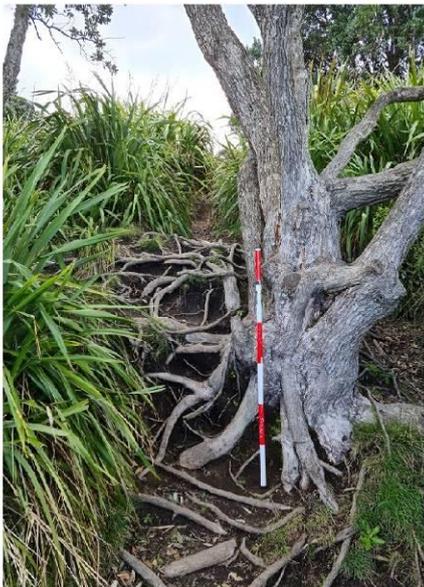
Notes: Desire line is continuing to cause wear to intact archaeological deposit, and soil loss is readily apparent. Action to block access to prevent further wear was recommended in 2018, and needs to be implemented. Continue monitoring.

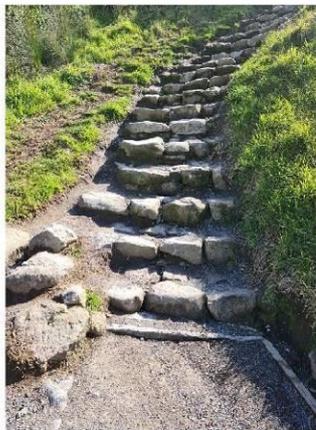
Notes: Stone work stable at present, but erosion from desire line more visible than in 2019, basically back to 2018 level, if not worse. Continue to monitor.
