## Memorandum

To	s 7(2)(f)(ii)
Copy	s 7(2)(a) - Privacy
From	s 7(2)(a) - Privacy
Office	Tauranga
Date	1 March 2023
File/Ref	2-9B559.00
Subject	TCC Slip Inspections for Council Reserves

This letter relates to our recent site inspections of landslips affecting Council Reserves in Tauranga City. The geotechnical inspections are to inform TCC of any immediate risk to people or property and to provide recommendations for further work to remediate the sites. As part of our assessments, the following sites have been inspected.

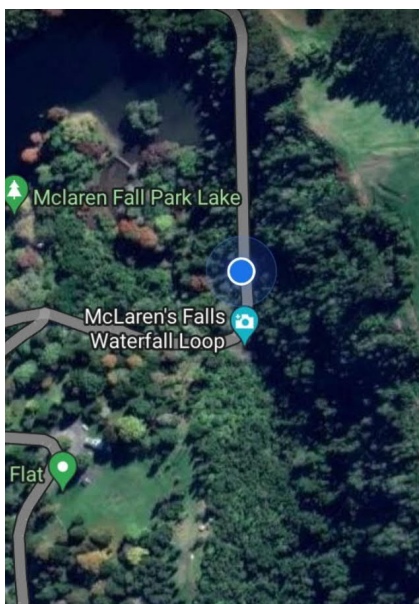
Figure 1: Site Location

The road slump site within the park is located on the access road which leads to McLarens Falls Waterfall Loop track within the park. The straight section of road is bound on the east by a steep escarpment and to the west by swampy ground and small river below the road level. The road at this location is 4.3m wide with the slumping affecting 1.3m from the edge of seal to the widest part of the slump.

The site is characterised by an arcuate tension crack (13m long) in the road pavement and seal, from which the tension crack then leads to a straight section (9m long) along the edge of seal. There has been slumping and lateral movement towards the stream. Site measurements indicate the tension cracking is approximately 50mm wide with a vertical drop of 80 to 100mm at the maximum location. There is also approximately 50mm of settlement in a localised area of the road on the opposite side of the road. The downslope side of the road drops in elevation by approximately 1.7 to 1.8m over a horizontal distance of approximately 5m (i.e., 1V:3H).

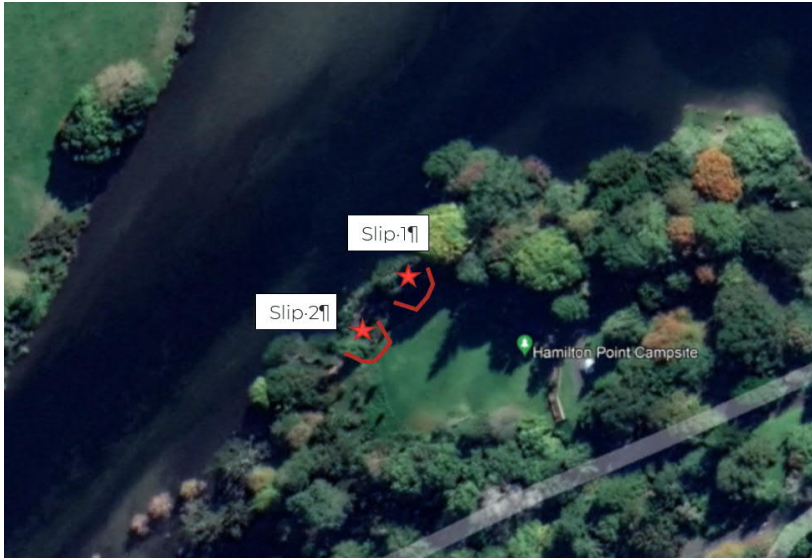
Figure 1: Location of slips at Hamilton Point.

The subject site comprises two slips that have occurred at the western end of the Hamilton point campground at the edge of Lake McLaren. The site locations are indicated on Figure 1 below.
