Project Number: 2-9B497.00

Tauranga City Council – Mauao Base Track

High Level Qualitative Slope Stability Risk Assessment
16 November 2022

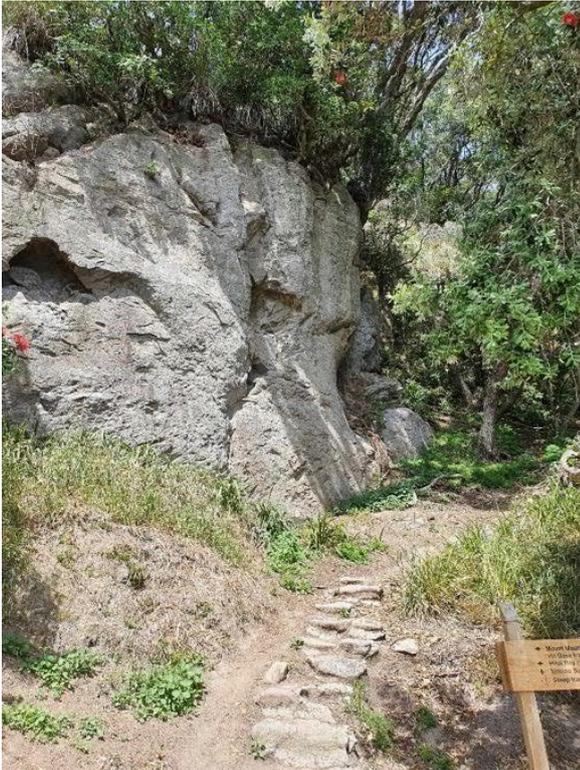
Figure 4: Minden rhyolite flow outcrop with subvertical joint. The Minden rhyolite bluffs are associated with rockfall where there are common cooling joints that can intersect creating release planes.

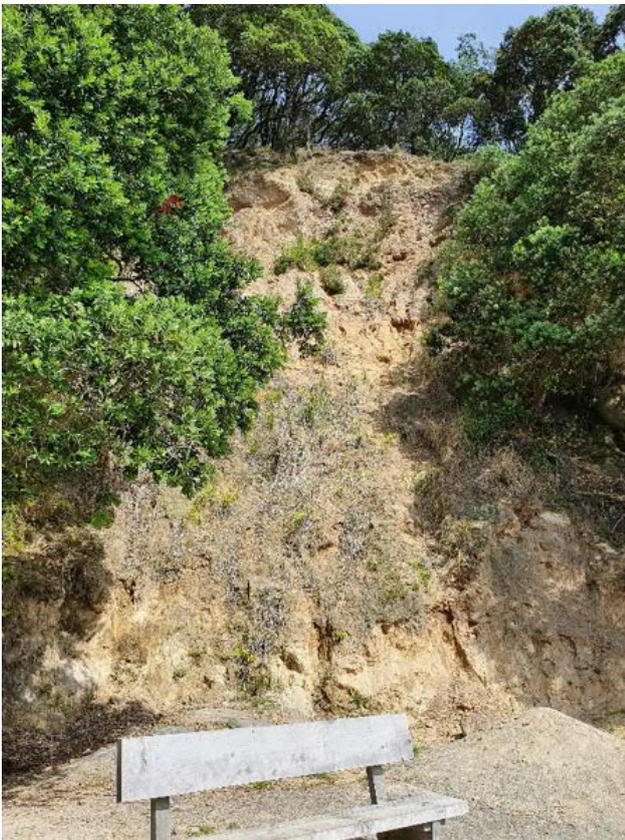
Figure 5: Landslide scar(overslip) in colluvium deposits located above base track on the western side.

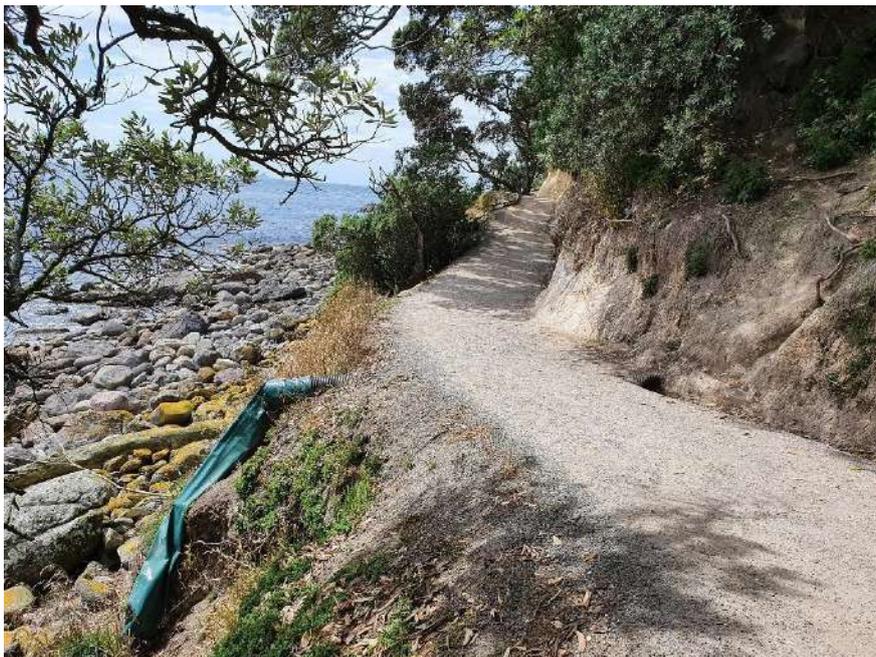
Site 27. Photograph 61

20	Small timber pole retaining wall installed. Overslip possible and underslip unlikely with medium consequence to track.	Low
21	Non engineered stone wall above and below track. Wall in fair condition, bulging slightly outward. Overslip and underslip likely with medium consequence.	Medium
22	Past underslip noted in track. Underslip and overslip likely with medium consequence.	Medium
23	Underslip and overslip likely with medium consequence.	Medium
24	Underslip and overslip likely with medium consequence.	Medium
25	Underslip and overslip likely to possible under somewhat adverse conditions with medium to major consequences leading to track being closed for months to a year. Track exposed to coastal erosion, some portions of track overhanging.	Medium to high
26		Medium to high
27		Medium to high

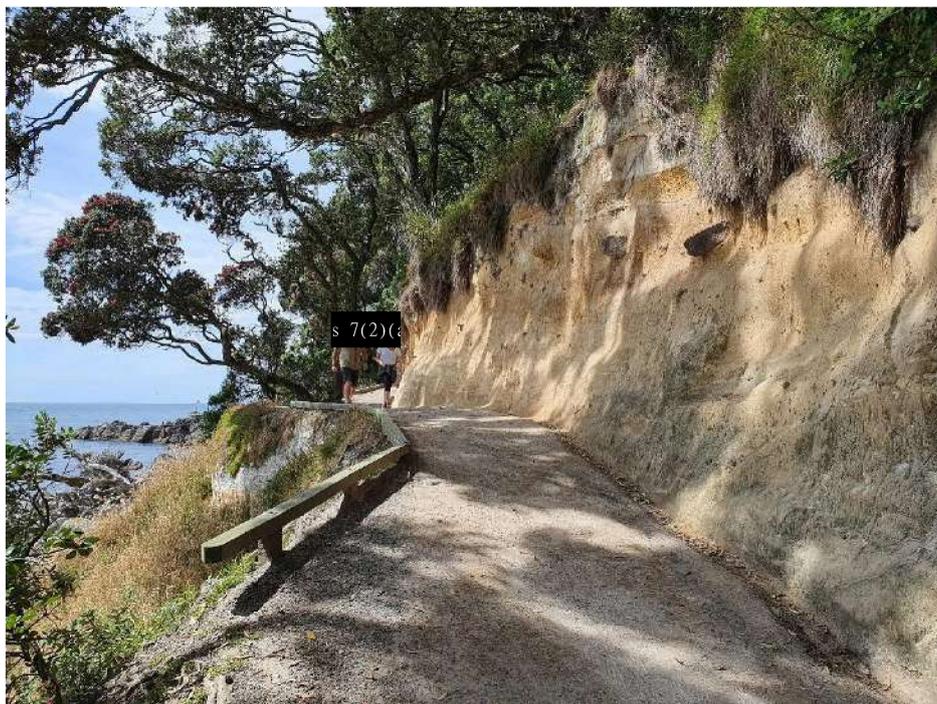
Site 29. Photograph 63

28	Stone retaining wall in good condition supporting track. Underslip and overslip possible with medium consequence.	Low
29	Underslip and overslip possible with medium to major consequence. Weakly welded ignimbrite noted above and below track.	Medium
30		Medium
31		Medium
32	Underslip possible and overslip likely. Consequence assessed as medium. A debris flow occurred in 2011 due to sustained heavy rainfall.	Medium
33	Underslip possible and overslip likely. Consequence minor to medium.	Low to medium
34	Underslip unlikely and overslip possible. Coastal erosion possible. Medium consequence as overslip could be cleared.	Low
35		Low
36		Low
37		Low
38		Low
39		Low
40		Low
41	Underslip and overslip likely under somewhat adverse conditions with a medium to major consequence to track. Mass movements have occurred along north to north eastern portion of base track in 1943, 1959 and 1977.	Medium to high
42		Medium to high

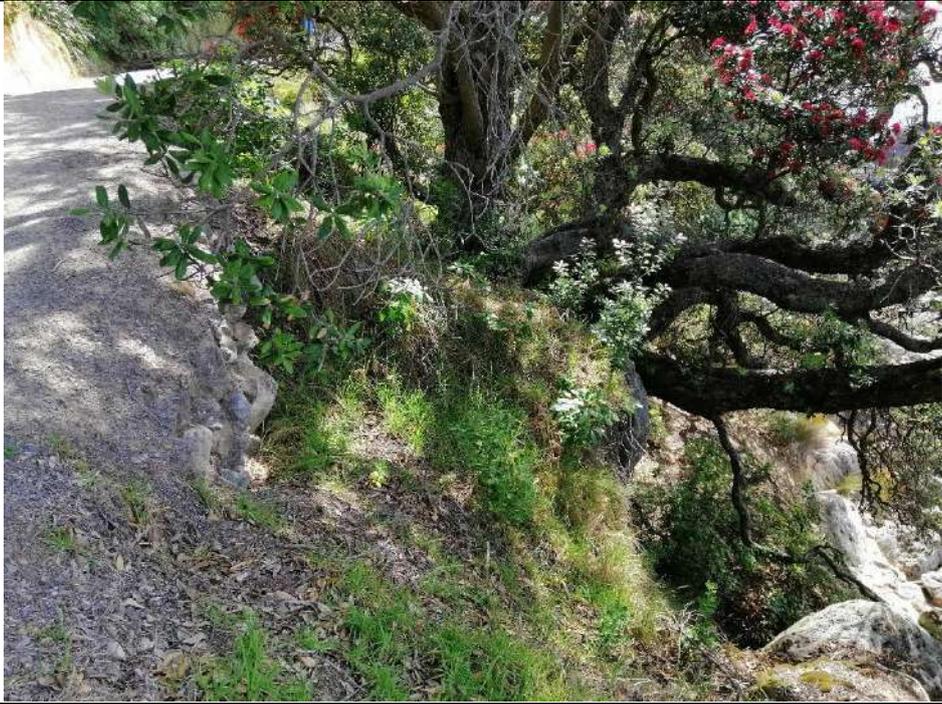
Site 43. Photograph 91

43	Underslip and overslip likely with estimated 5 to 20% annual probability of occurrence. Expected to medium to major to repair.	Medium to high
44		Medium to high
45	Underslip possible and overslip likely under adverse conditions. Consequence to track rated as medium.	Low to medium
46		Medium
47		Medium
48	Underslips and overslips possible under moderate to very adverse conditions. Consequence to track rated as medium. Landslides noted above the site in 1943, 1959 and 1977.	Low
49		Low
50	Underslips and overslips possible with slips closure for up to a month.	Low
51	Underslips and overslips likely under somewhat adverse conditions. Consequence to track rated as	Medium to high
52		Medium to high
