13 April 2023

BC330131 Request for Further Information #3 - Category 1 Geo-Professional Review

30 September 2022

Awaiti Project Geotechnical Investigation and Desktop Summary Report

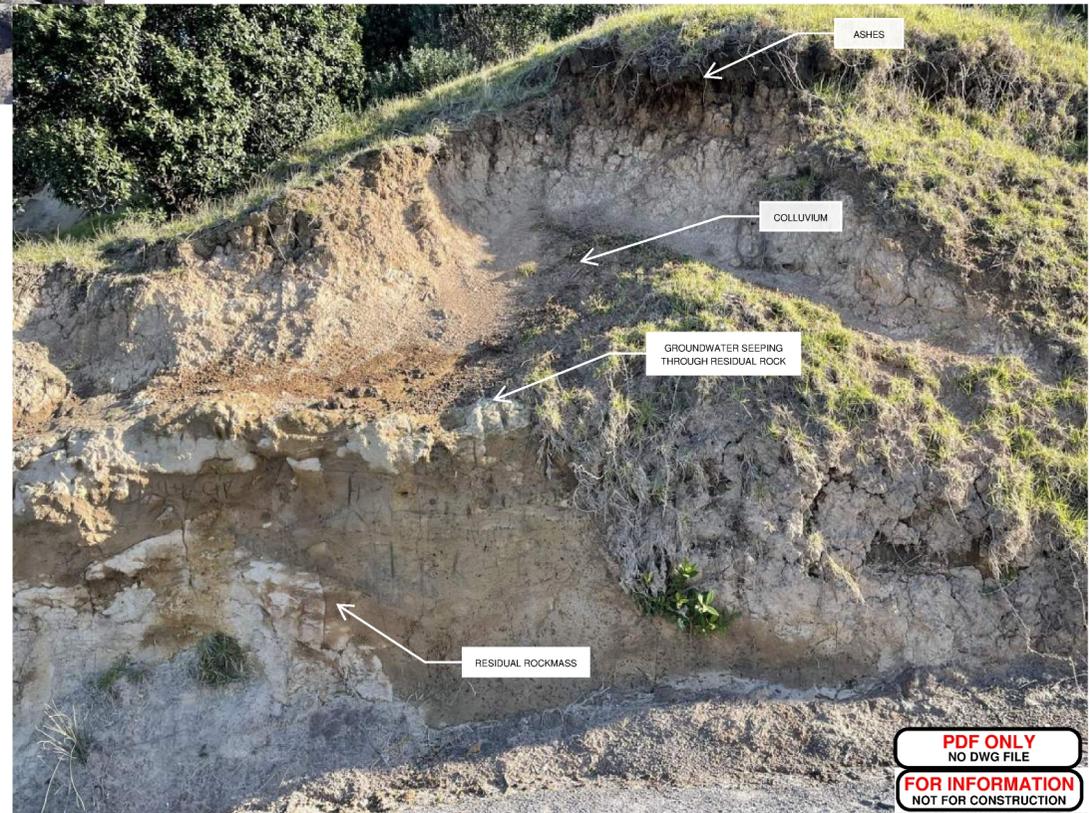
B DETAIL
GE-K002 N.T.S

1. IMAGE A: VIEW FROM BEACH TOWARDS PROPOSED VIEWING PLATFORM. ROCK FACE IS APPROXIMATELY 5m HIGH. ROCK OUTCROP IS VERY STEEPLY INCLINED. VERTICAL. ROCK APPEARS TO BE IN-SITU. NO SIGNS OF INSTABILITY OF THE ROCK FACE. GROUNDWATER SEEPING THROUGH THE BOTTOM OF THE SLOPE.
2. IMAGE B: VIEW TOWARDS SLOPE FROM PATH. ABOVE PROPOSED VIEWING PLATFORM. EXPOSED CUT APPROXIMATELY 3m HIGH. SOILS APPEAR TO BE COLLUVIUM AND ASHES OVERLYING RESIDUAL ROCK MASS. HEAD SCARP WITH MINOR DOWNTHROWN FEATURES TRACK SOUTH TOWARDS TREE. WATER SEEPING THROUGH RESIDUAL ROCK. NO IMMEDIATE RISK OF SLOPE FAILURE AFFECTING VIEWING PLATFORM.

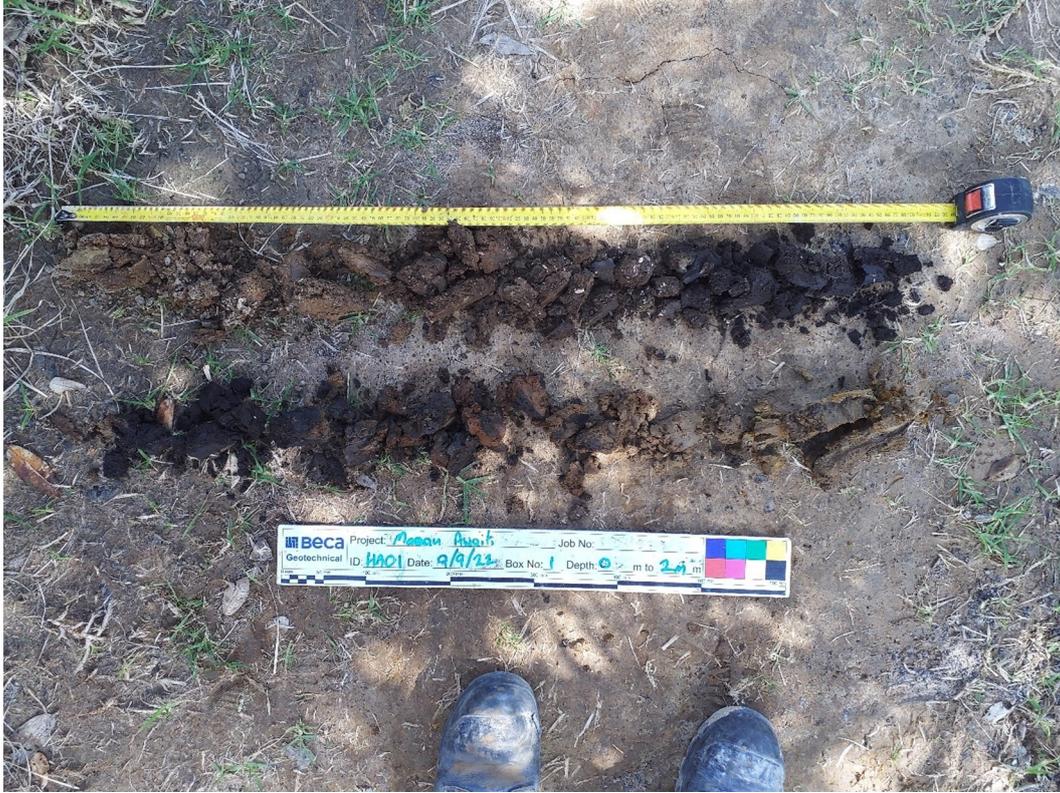
Box 1 - 0.00m to 2.00m

Project: Mauao Awaiti	Project number: 4280807	
Site location: Northern point of Mauao Base Track	Client Name: TCC	
Location: Western end of proposed platform.	Coordinate system: BOP2000	Vertical datum: NZVD 2016
	Northing: 815038.6	Ground level (mRL): 7.00
	Easting: 374177.5	Location method: Map

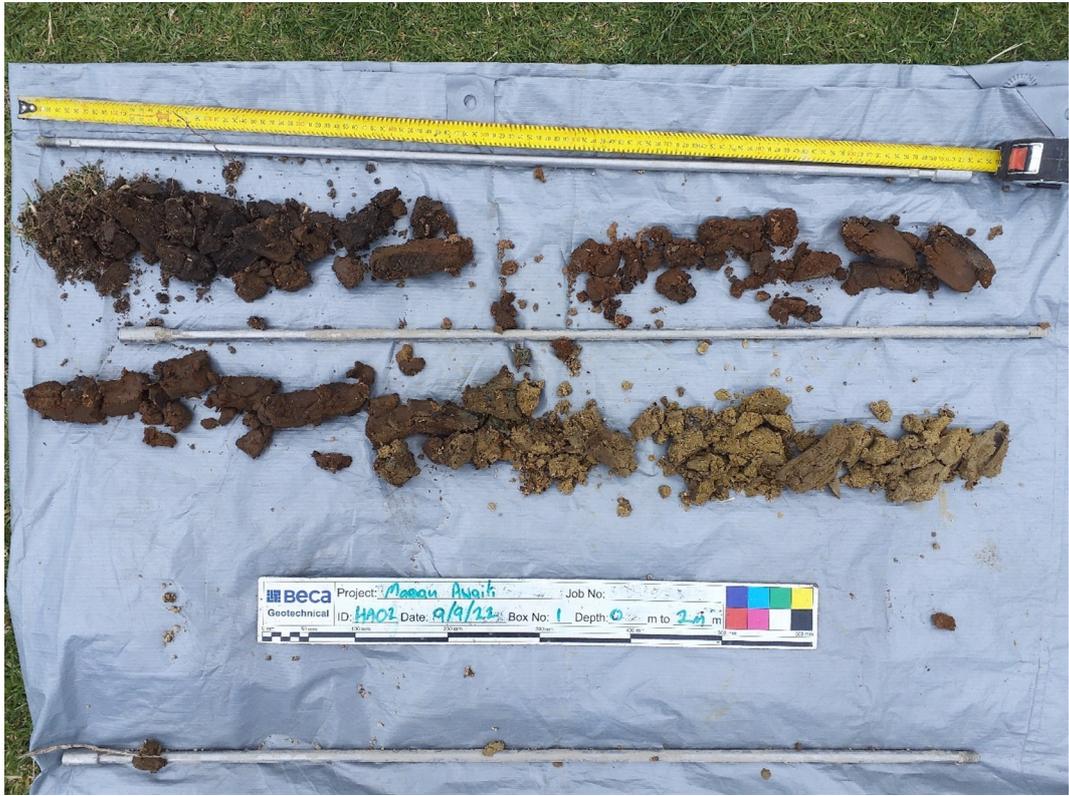
Box 1 - 0.00m to 2.00m

Project: Mauao Awaiti	Project number: 4280807	
Site location: Northern point of Mauao Base Track	Client Name: TCC	
Location: Centre of proposed platform	Coordinate system: BOP2000	Vertical datum: NZVD 2016
	Northing: 815036.2	Ground level (mRL): 7.00
	Easting: 374188.0	Location method: Map

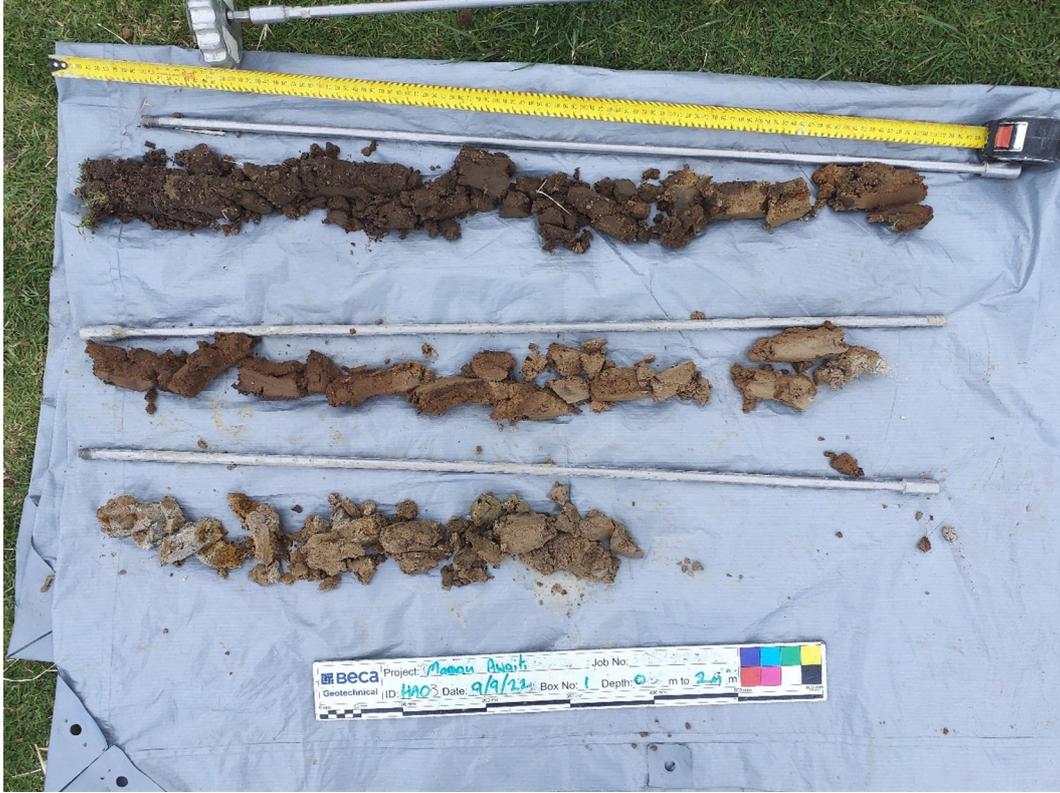
Box 1 - 0.00m to 2.50m

Project: Mauao Awaiti	Project number: 4280807	
Site location: Northern point of Mauao Base Track	Client Name: TCC	
Location: Eastern end of proposed platform	Coordinate system: BOP2000	Vertical datum: NZVD 2016
	Northing: 815029.4	Ground level (mRL): 7.00
	Easting: 374193.1	Location method: Map

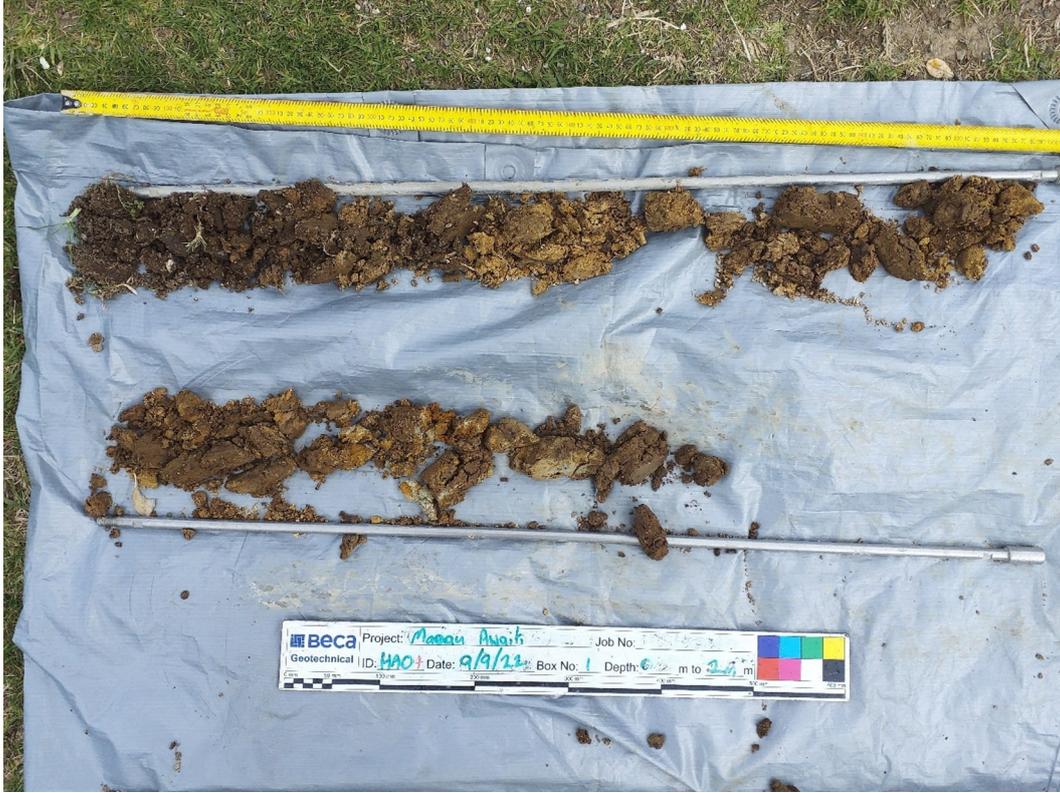
Box 1 - 0.00m to 1.50m

Project: Mauao Awaiti	Project number: 4280807	
Site location: Northern point of Mauao Base Track	Client Name: TCC	
Location: Between existing stair rail and seat	Coordinate system: BOP2000	Vertical datum: NZVD 2016
	Northing: 815032.7	Ground level (mRL): 8.00
	Easting: 374185.3	Location method: Map
