ARCHAEOLOGICAL SITE CONDITION MONITORING
REPORT - MAUAO HISTORIC RESERVE, TAURANGA

InSitu Heritage Ltd

29 October 2021

Tauranga City Council
Private Bag 12022
TAURANGA

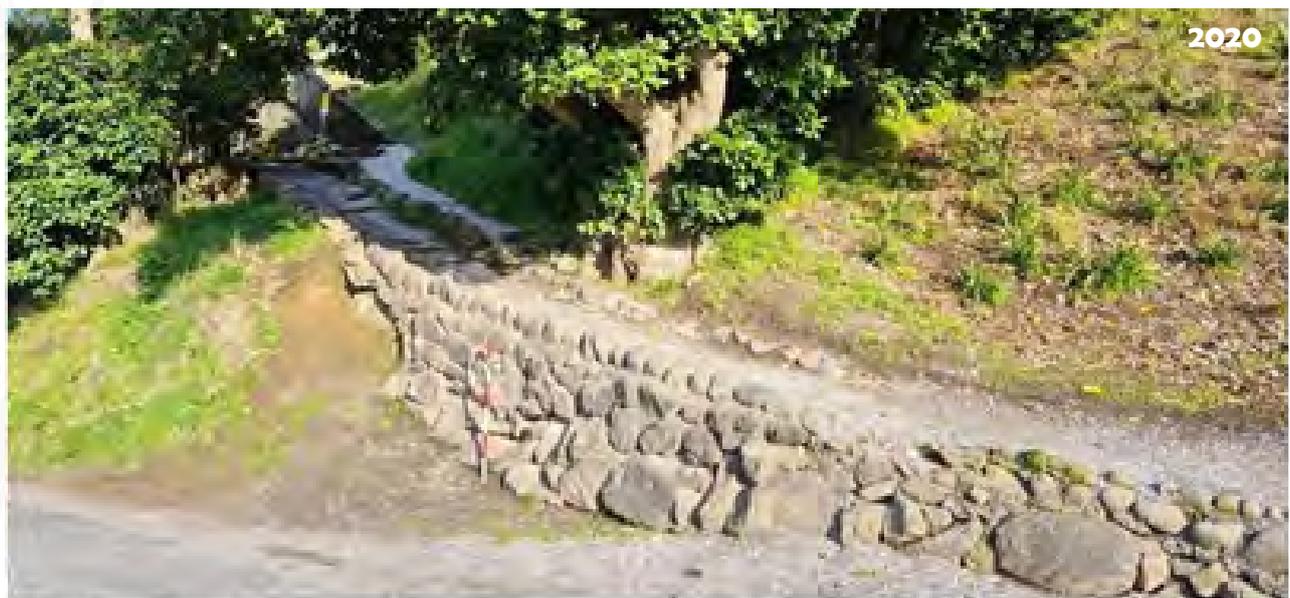
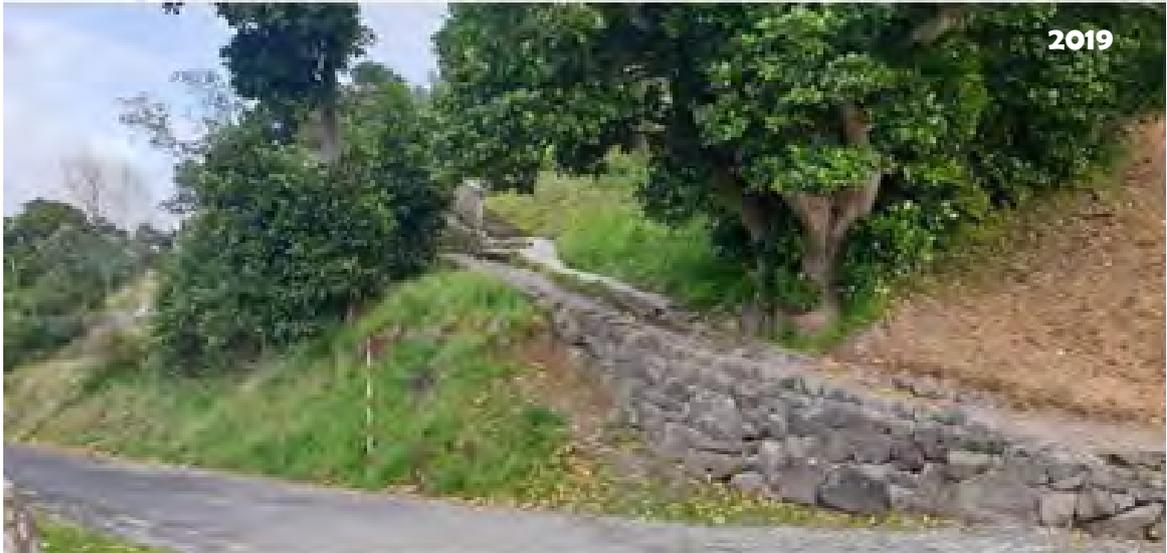
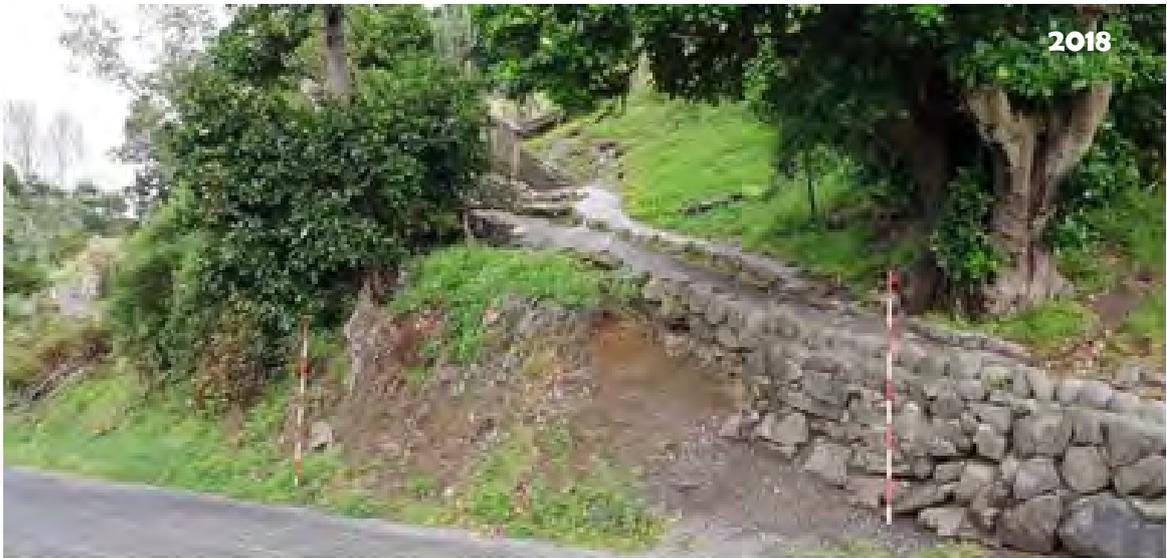
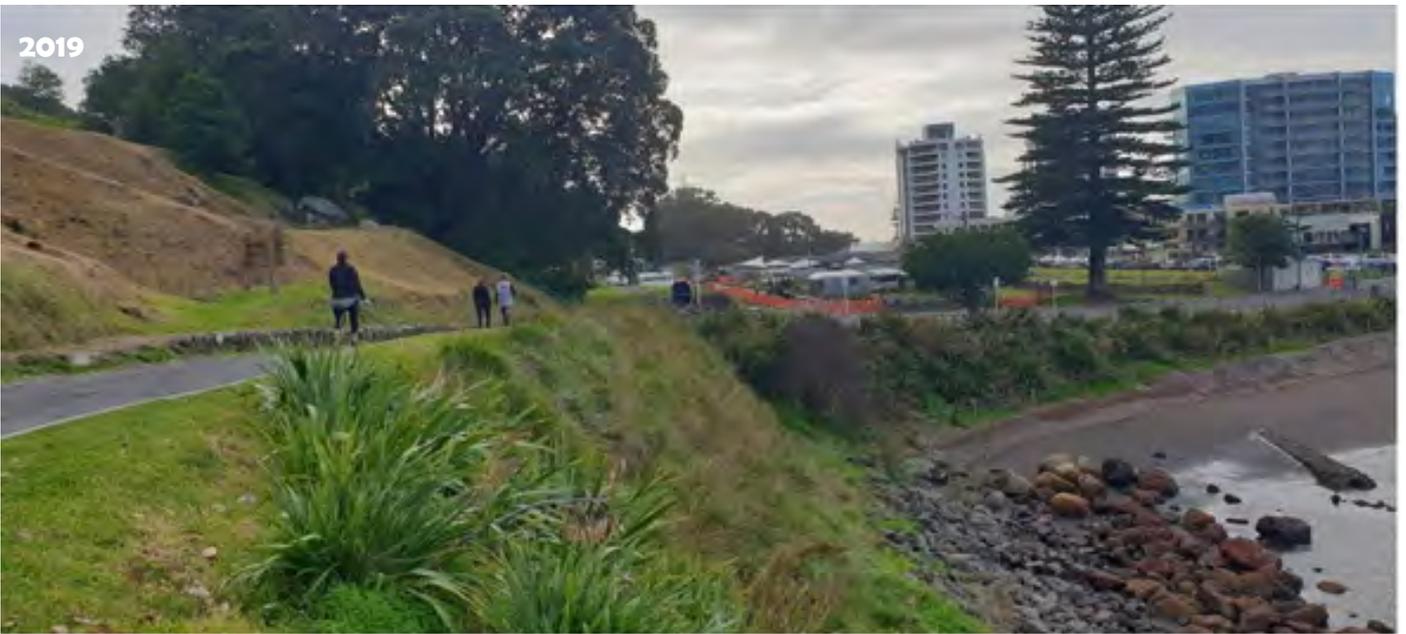
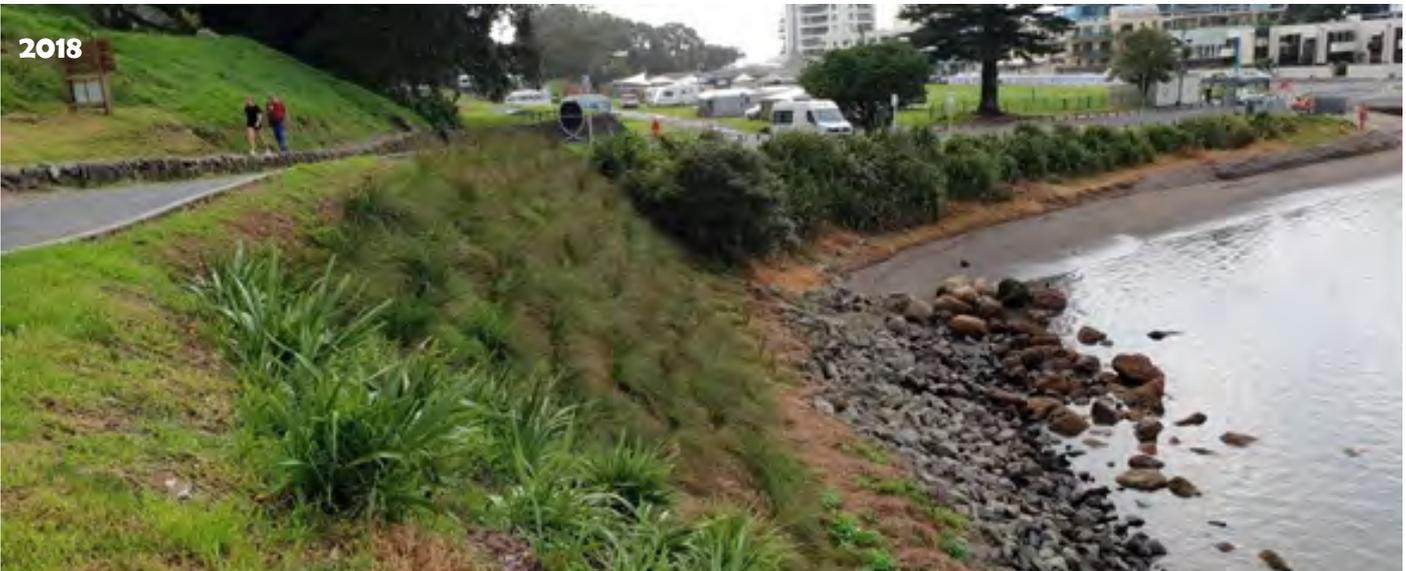
Stone Jetty surrounds - stone walls

Notes: Erosion is unchanged from 2020, grass cover advancing, but this could be primarily due to seasonal variability. Plants on terraces now well established, but some minor infill planting is required. Introduction of soil and planting along the track margin would assist to restrict visitor access to the formed track.

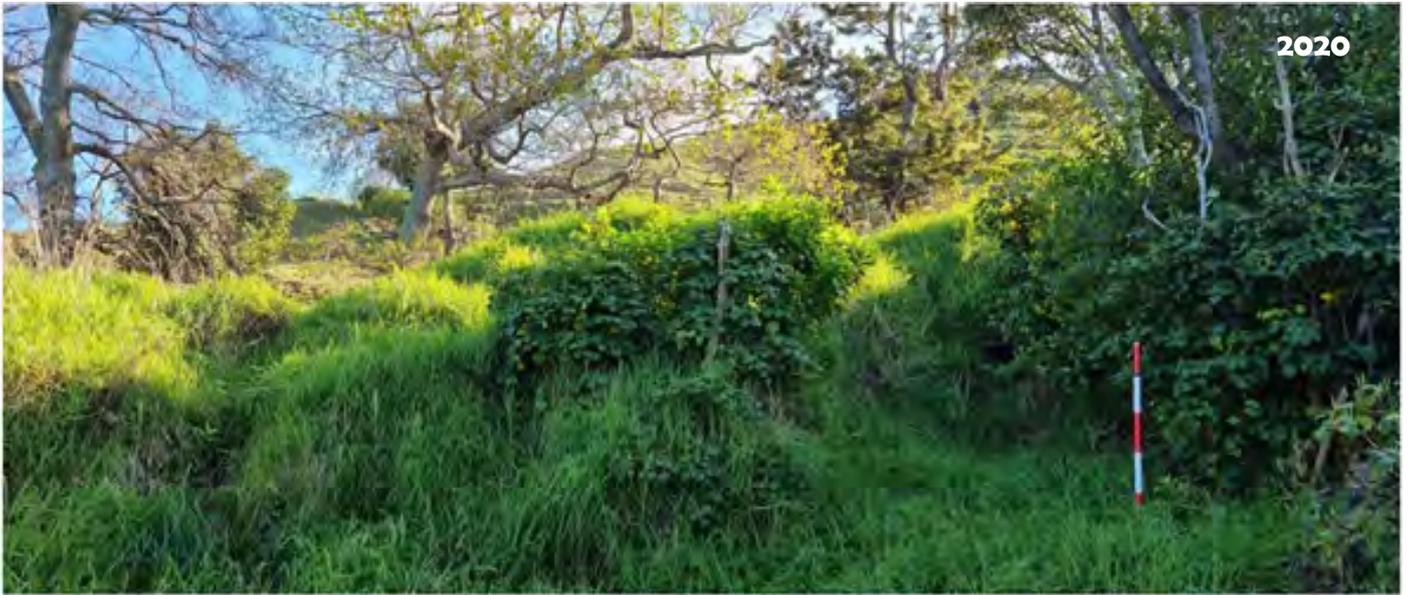
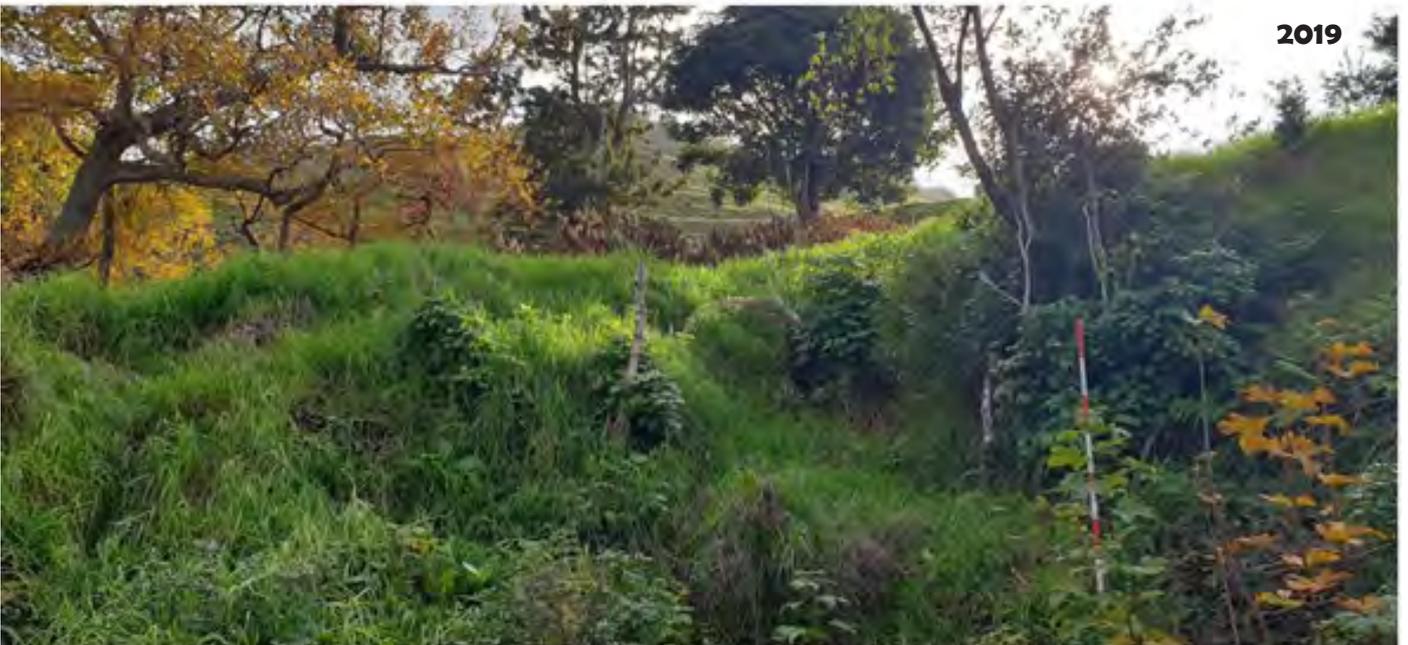
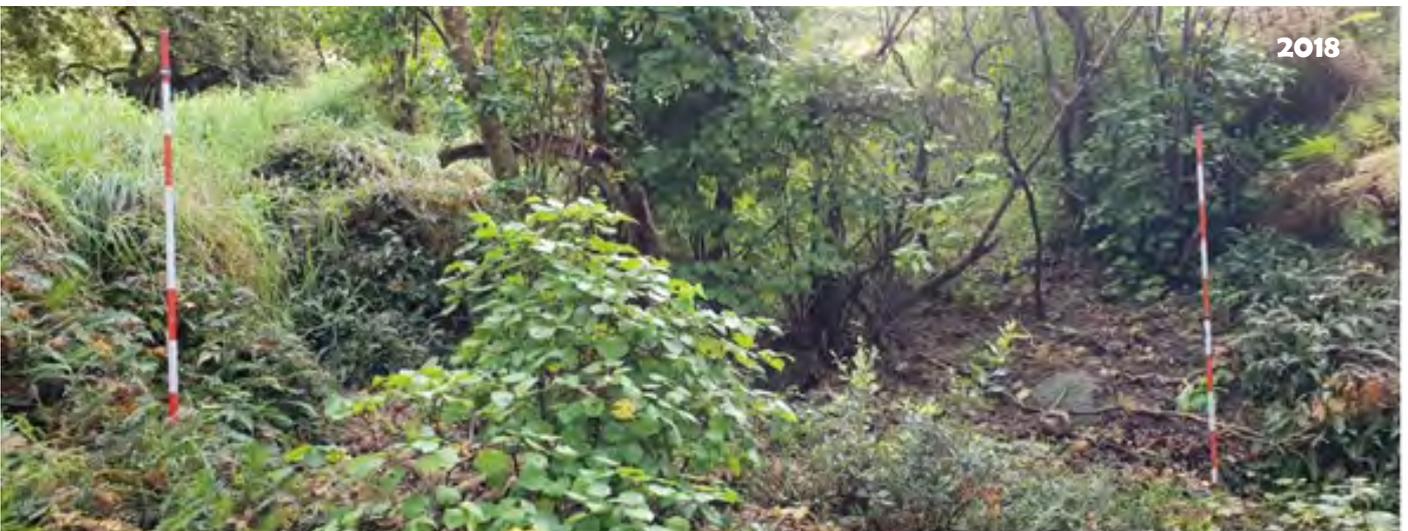
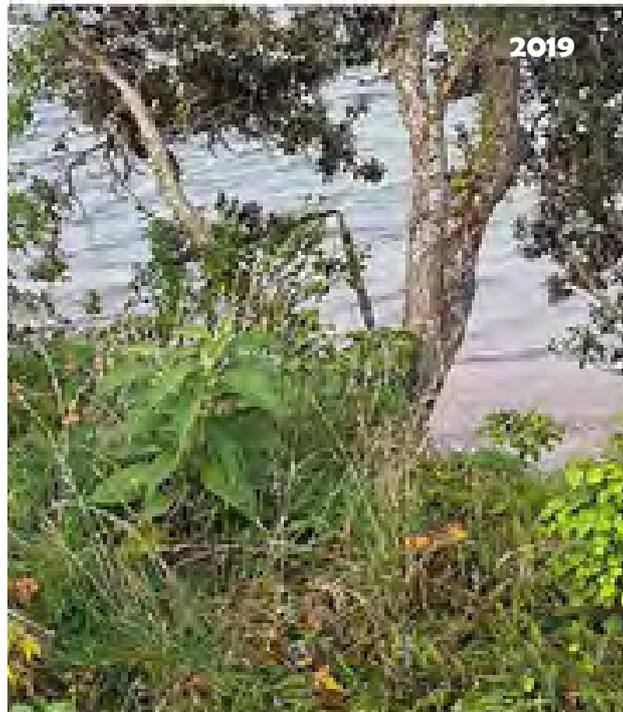
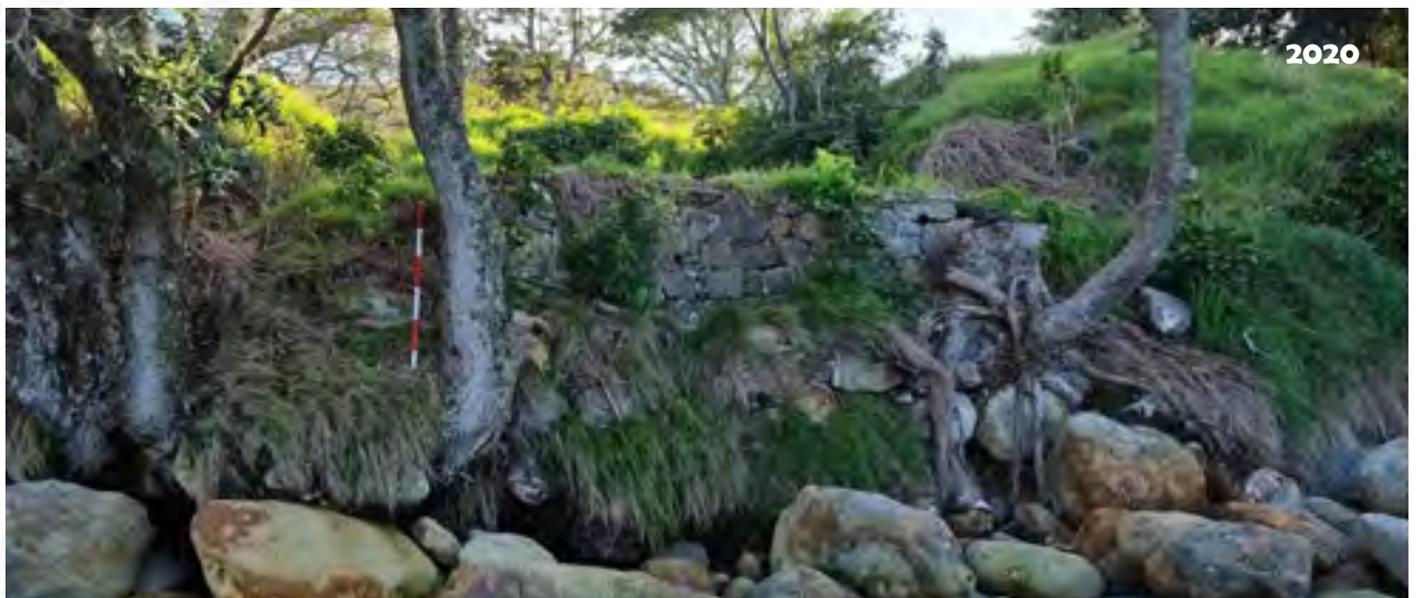
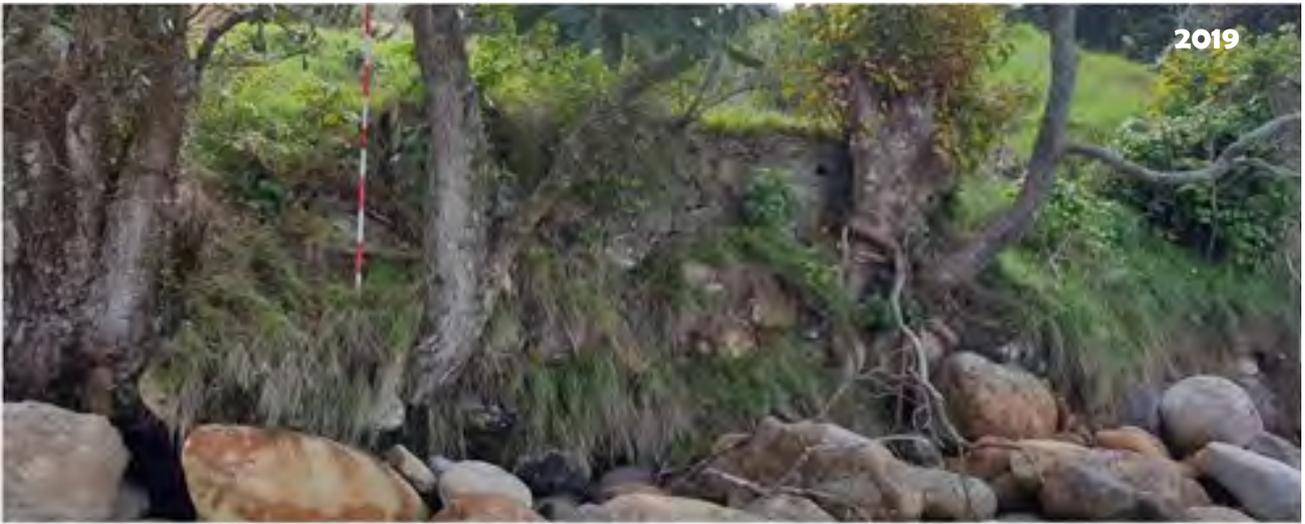
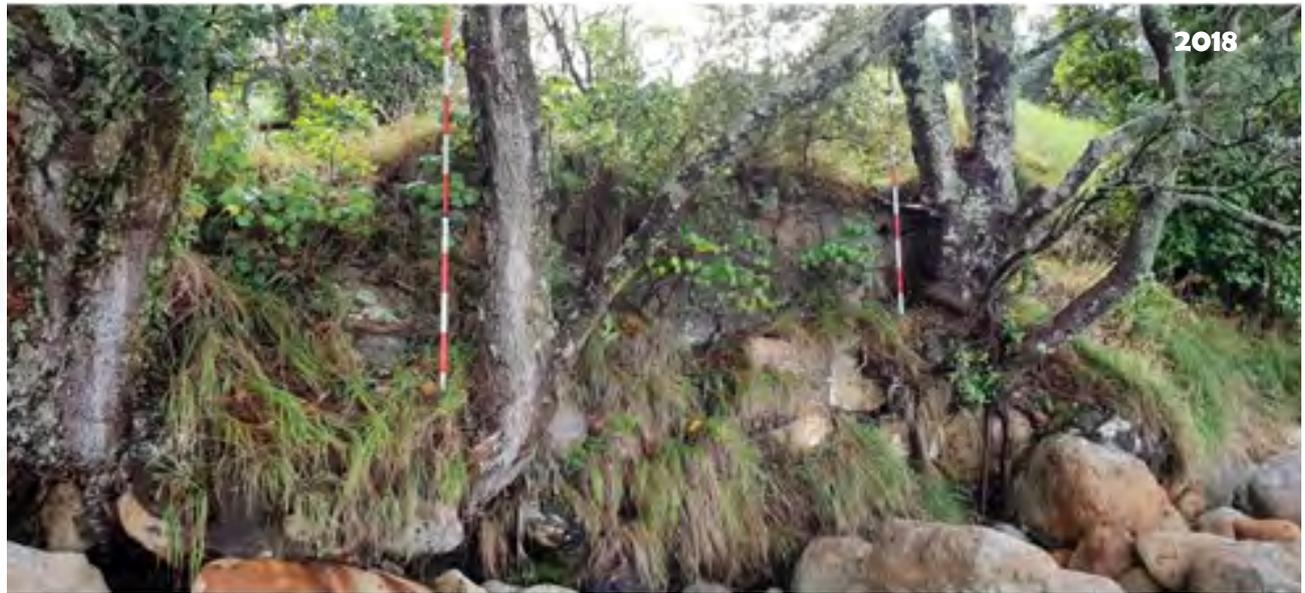
Iron jetty and surrounds

Notes: Vegetation clearance to reduce pōhutukawa and sycamore growing on the stonework face of the jetty that was done in 2020 needs to be maintained. There is on-going invasion by sycamore and other tree species. Interpretation should be developed at the jetty as part of the current project and the site should continue to be maintained in low vegetation/ferns/rank grass, with periodic weed

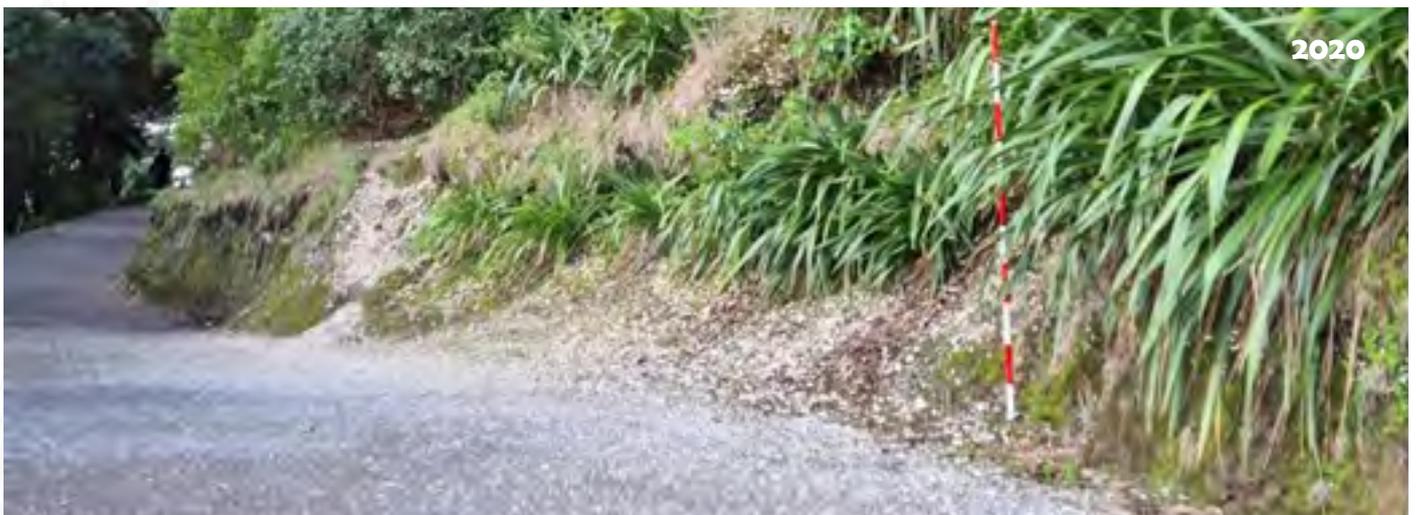
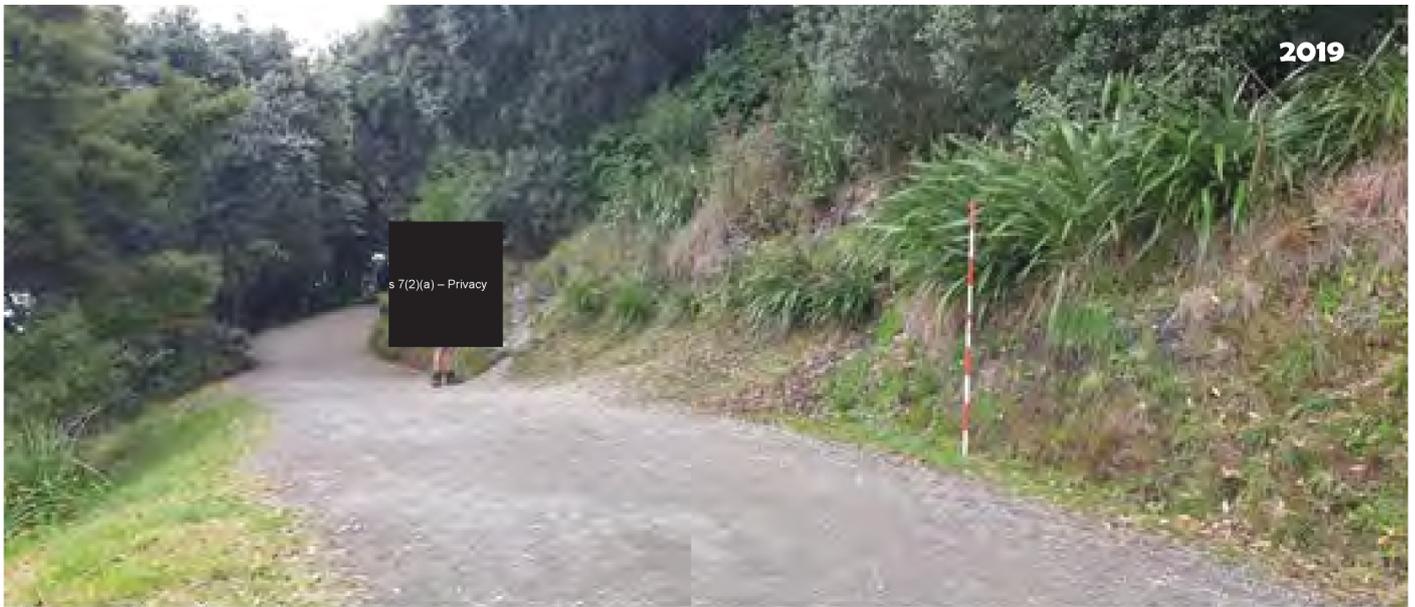
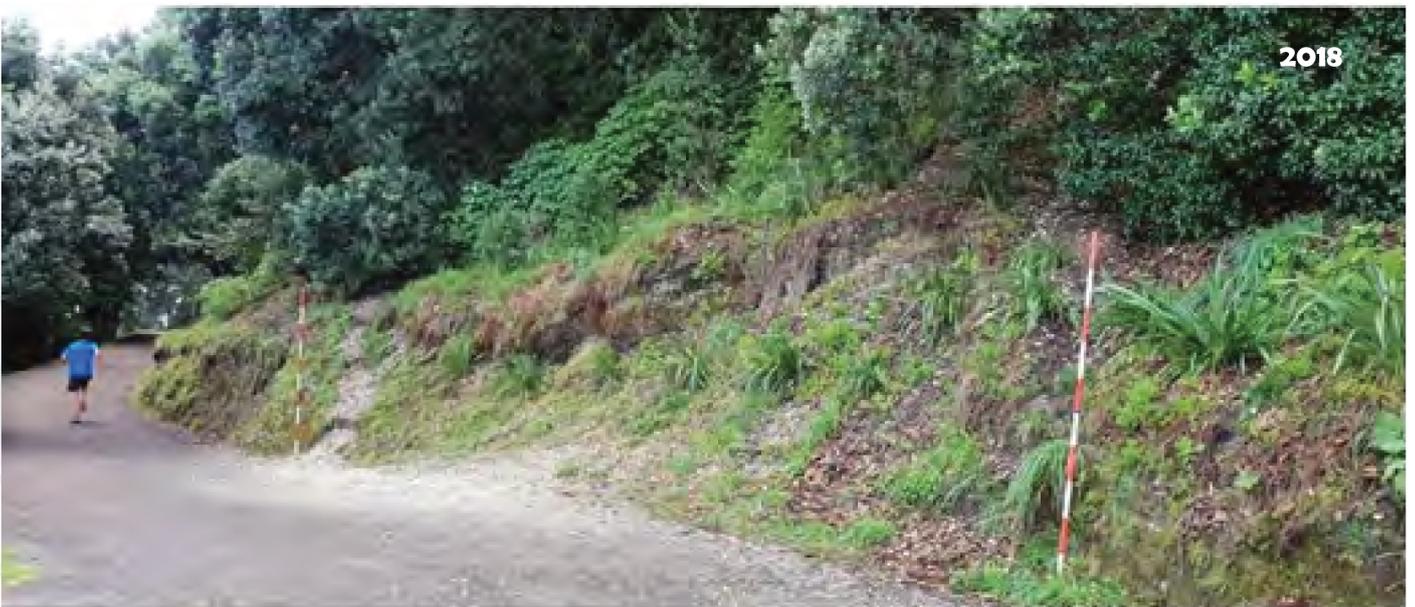
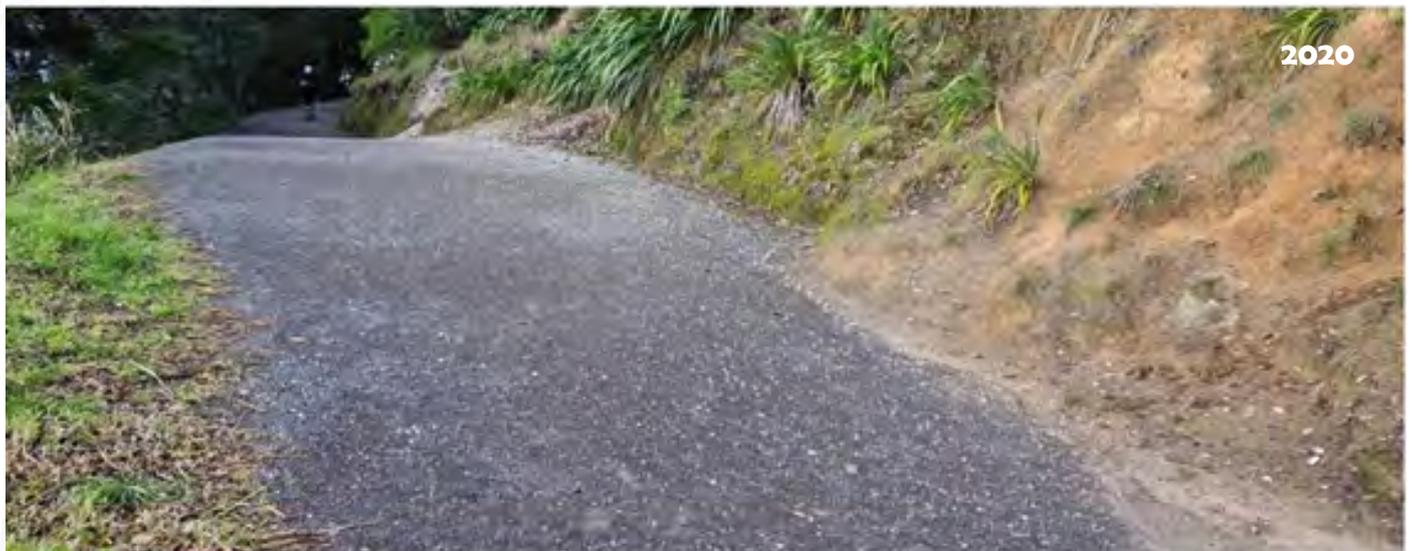
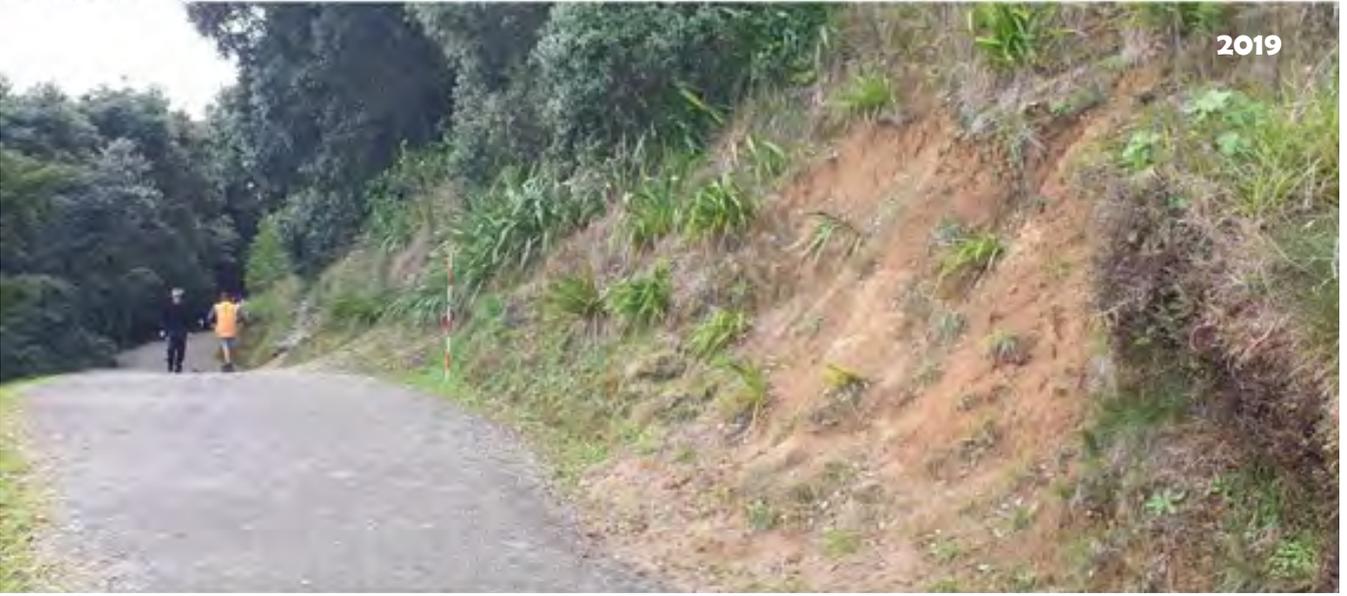
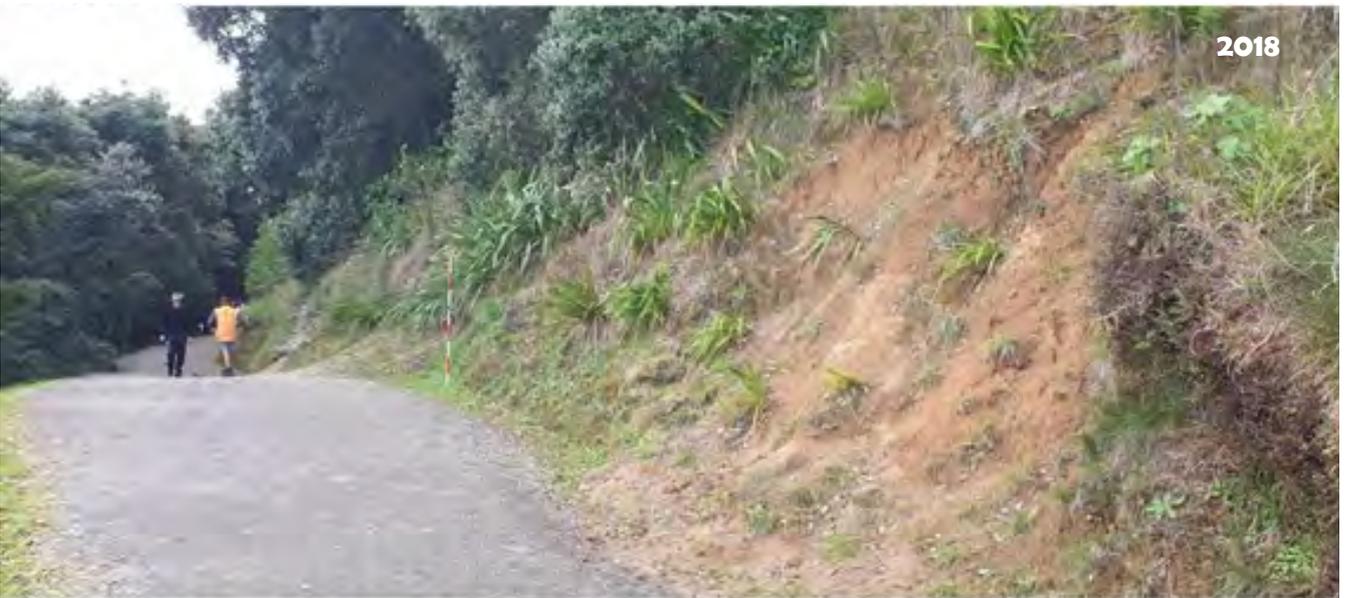
Base track midden erosion

Notes: There has been no significant advance or improvement in vegetation cover over the monitoring period and the eroded face is still highly visible. Shell is still accumulating at the base of the slope. Introduction of fill material may be required to get plant cover better established.

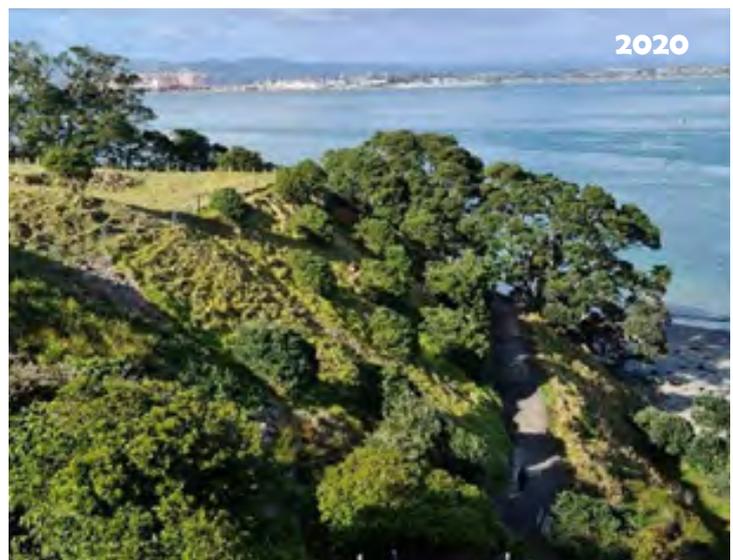
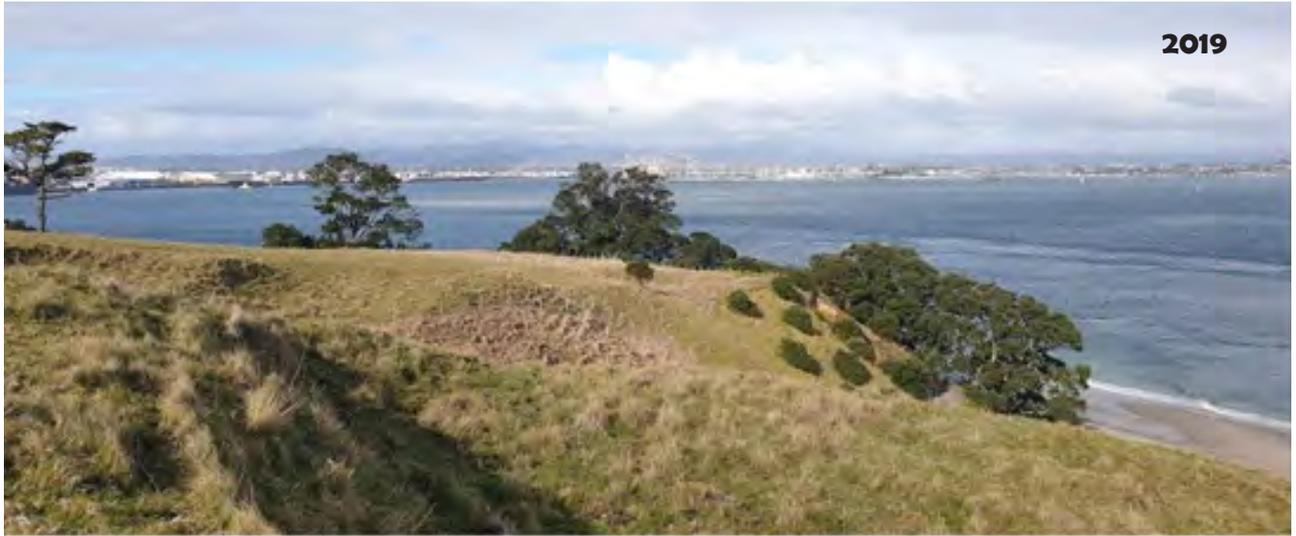
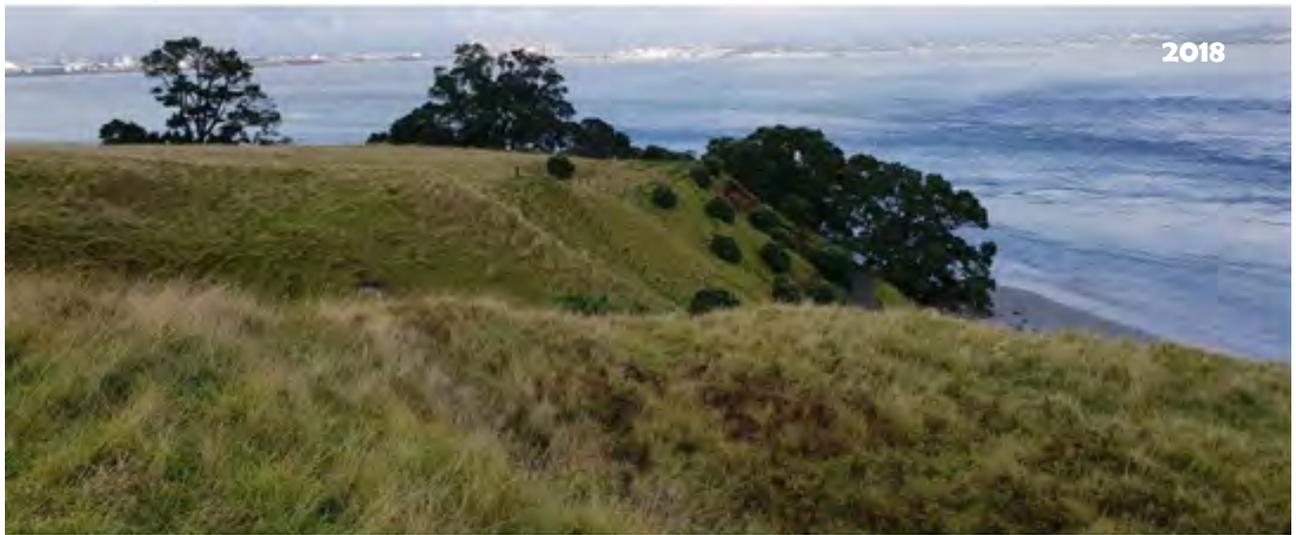
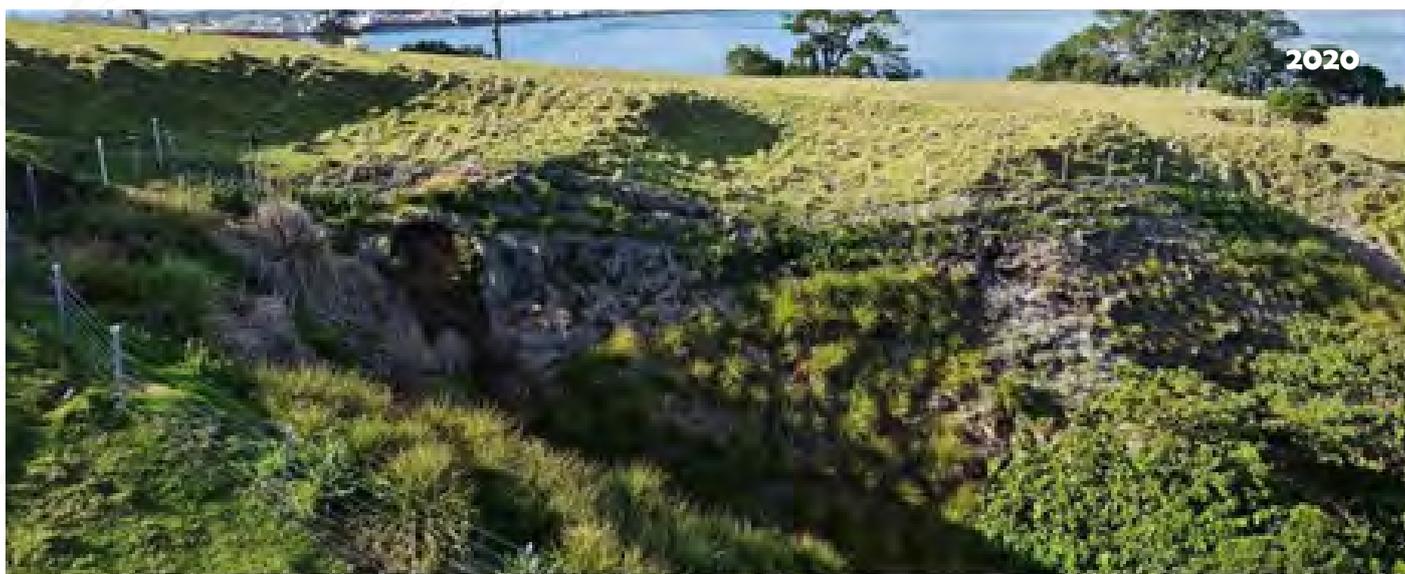
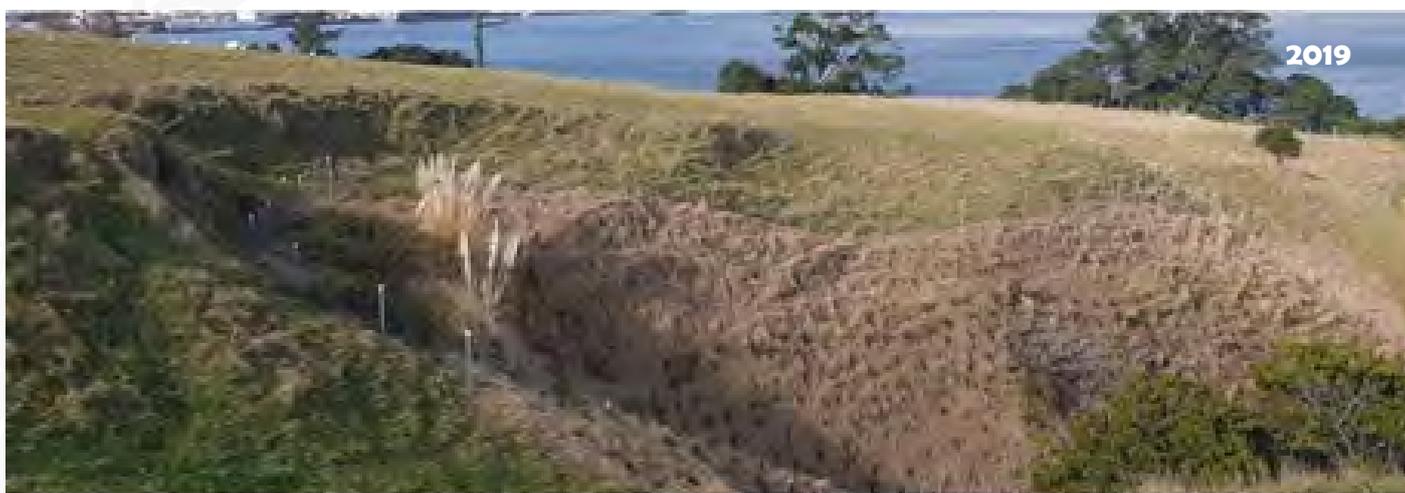
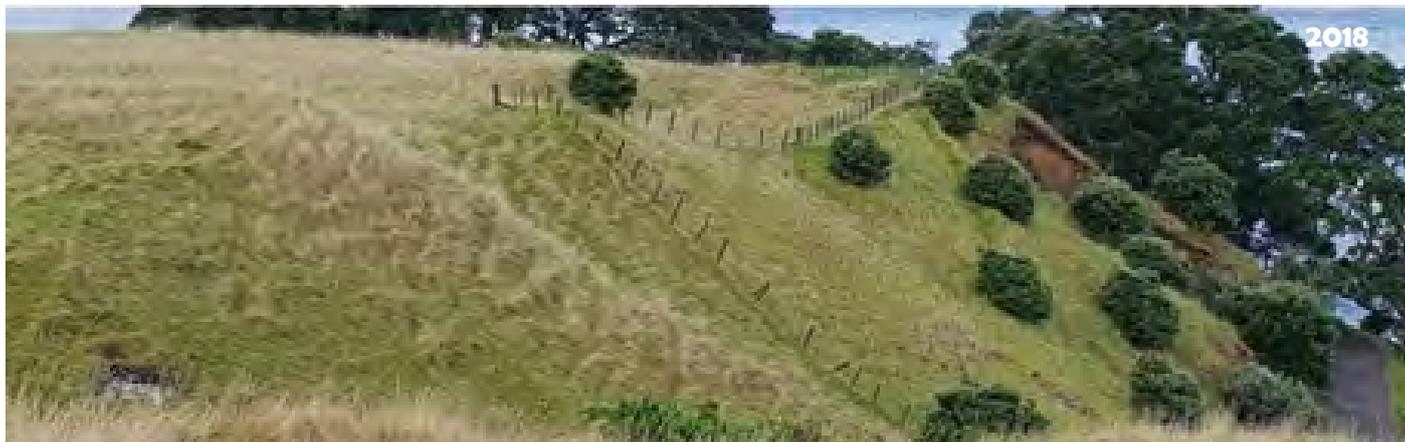
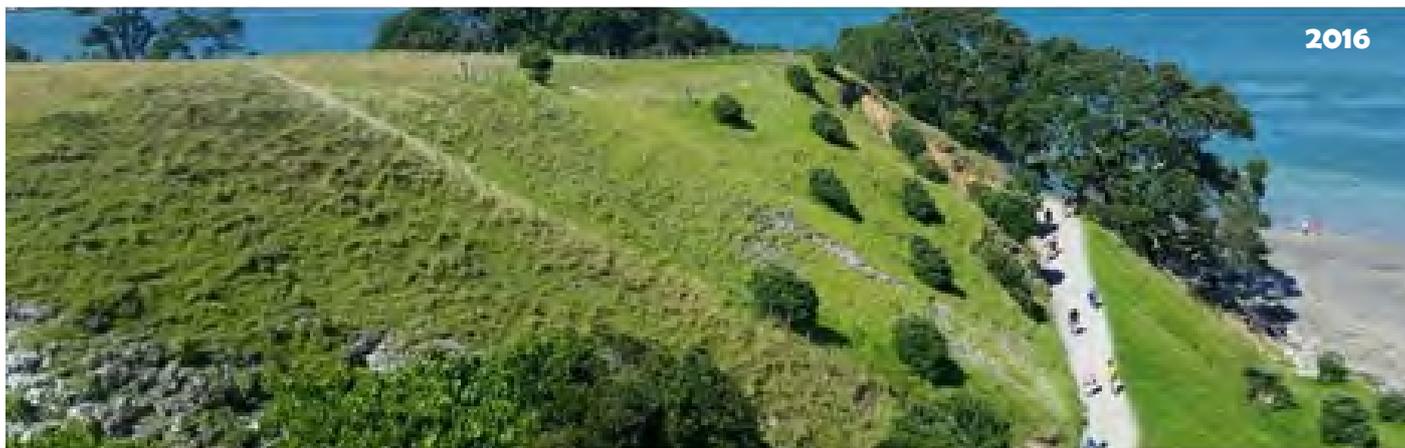
Fence placement, rabbit browse and slope stability

Notes: Vegetation cover on eroding archaeological features is now well established. There is no significant evidence of rabbit browse in the areas where grazing has ceased. There has been considerable improvement in vegetation cover and slope stability over the monitoring period.

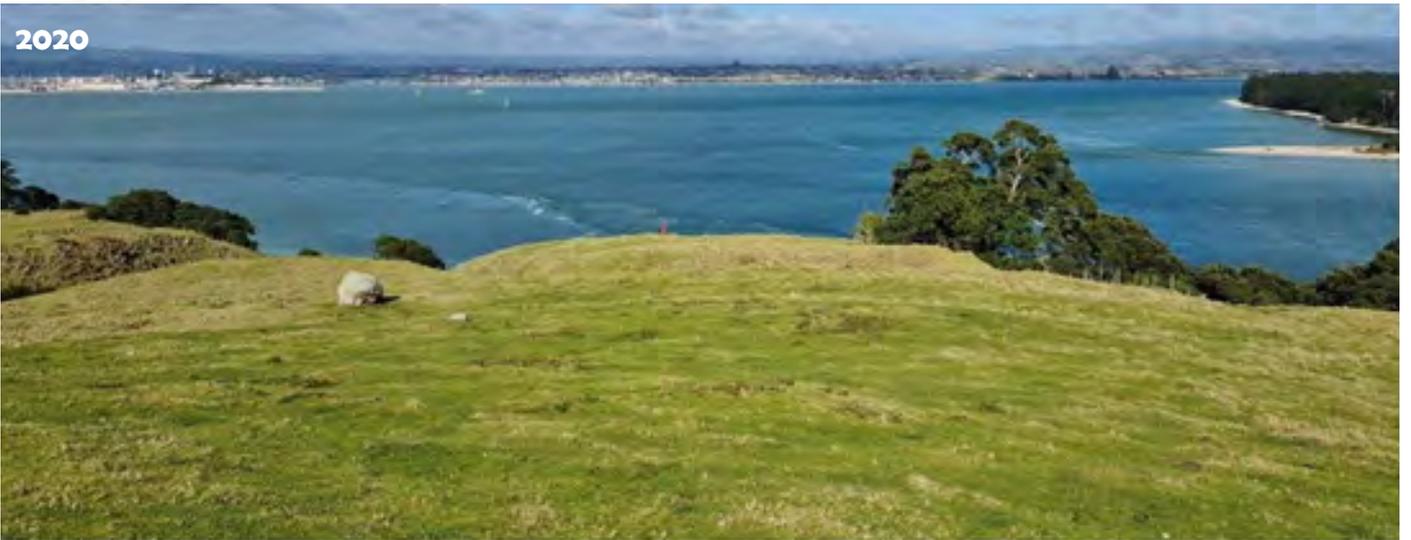
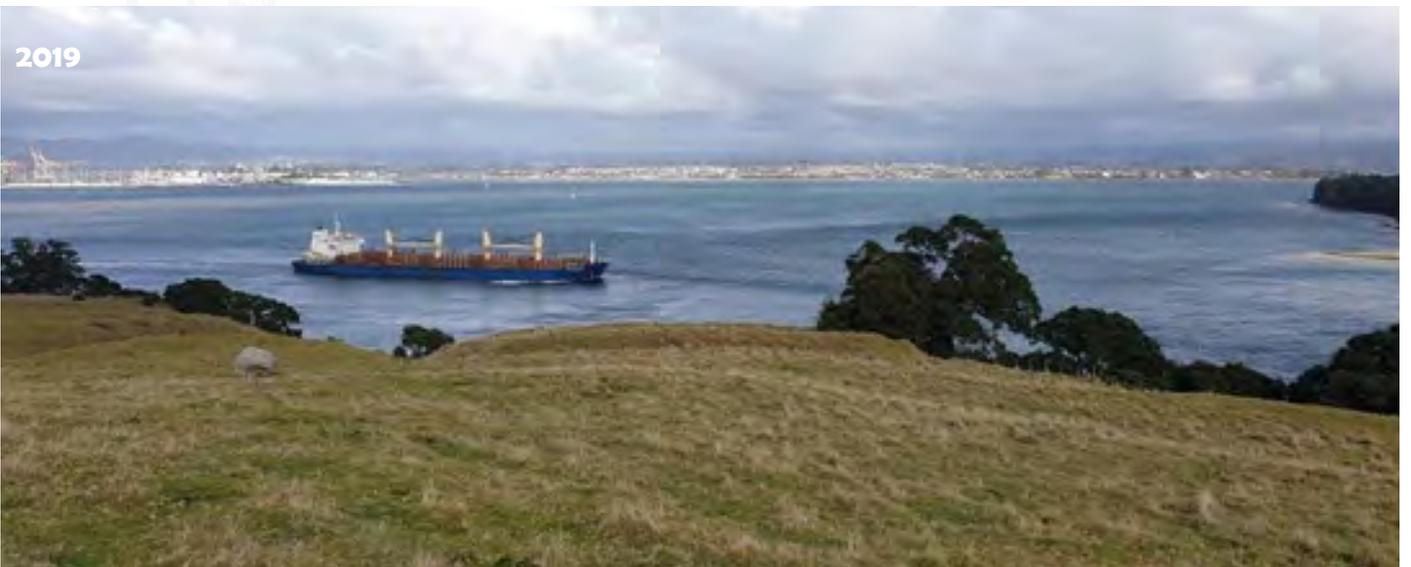
Pa U14/173 condition/grass cover

Notes: General views across pa to demonstrate grass cover. Site is stable with good ground cover being maintained. Very little evidence of recent rabbit browse but rabbits are present in low numbers and should be closely monitored.

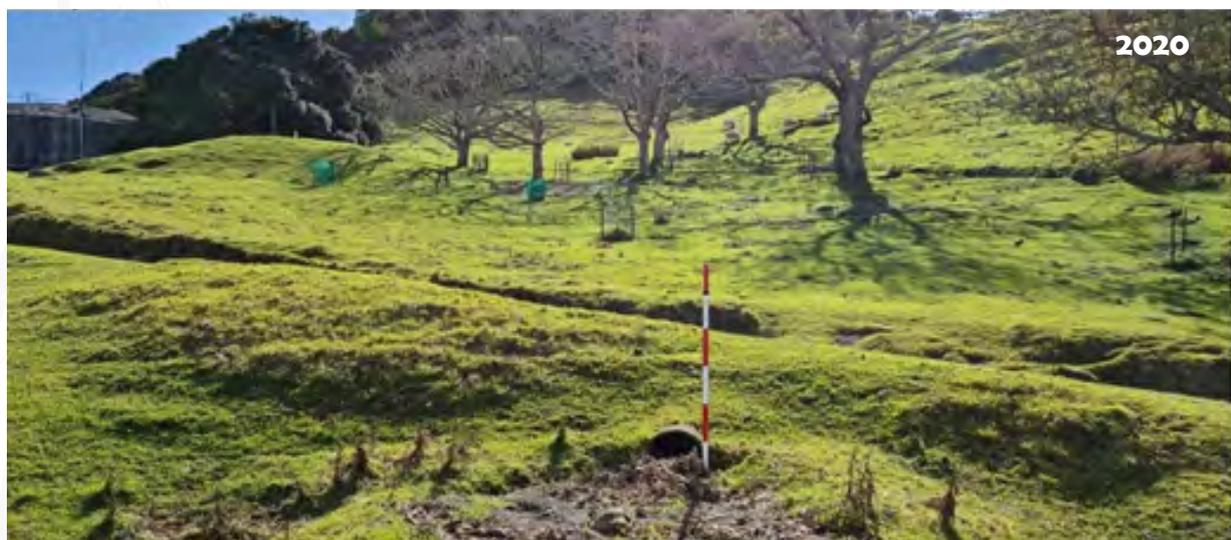
4WD track maintenance issues - tailings management

Notes: There is no recent evidence of tailings being dumped on archaeological features above the track, as was the issue in the past. However, the artificial build-up of material continues to 'create' features adjacent to the track. There is still a significant issue with metal being distributed onto terraces below the track. The distance between culverts, their function and the treatment of tailings needs further management attention. Consideration should be given to removal of artificial build-up with archaeological supervision.
