ARCHAEOLOGICAL SITE CONDITION MONITORING
REPORT - MAUAO HISTORIC RESERVE, TAURANGA

InSitu Heritage Ltd

29 October 2021

Tauranga City Council
Private Bag 12022
TAURANGA

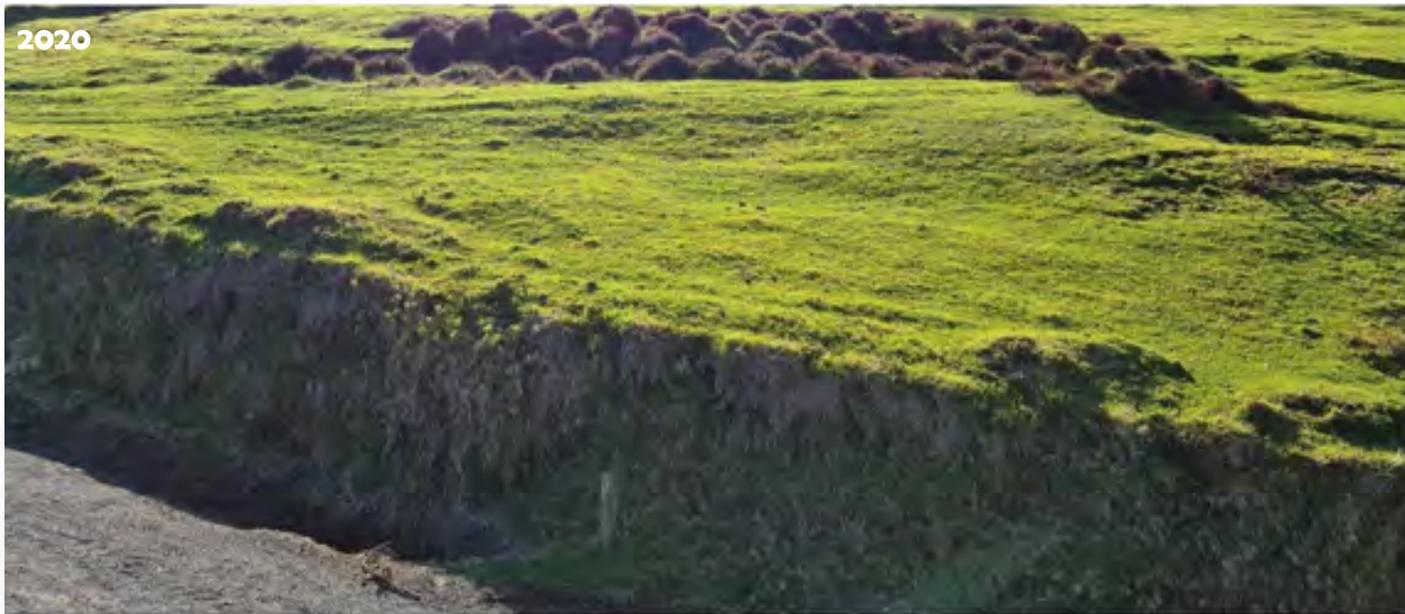
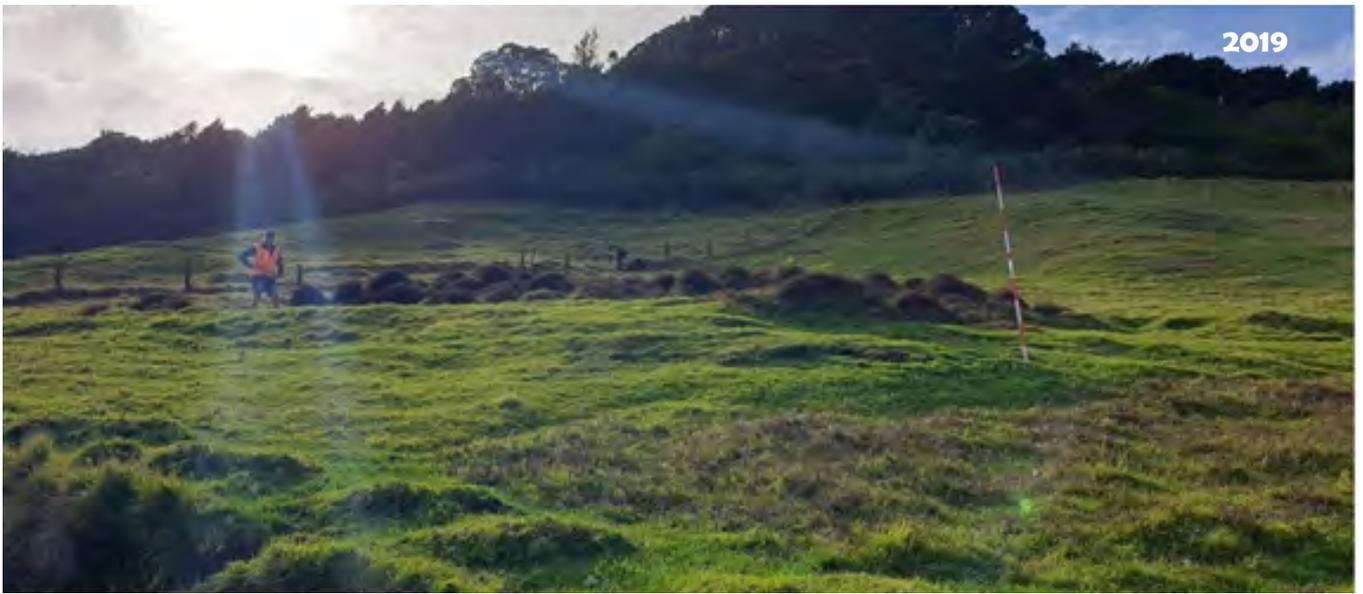
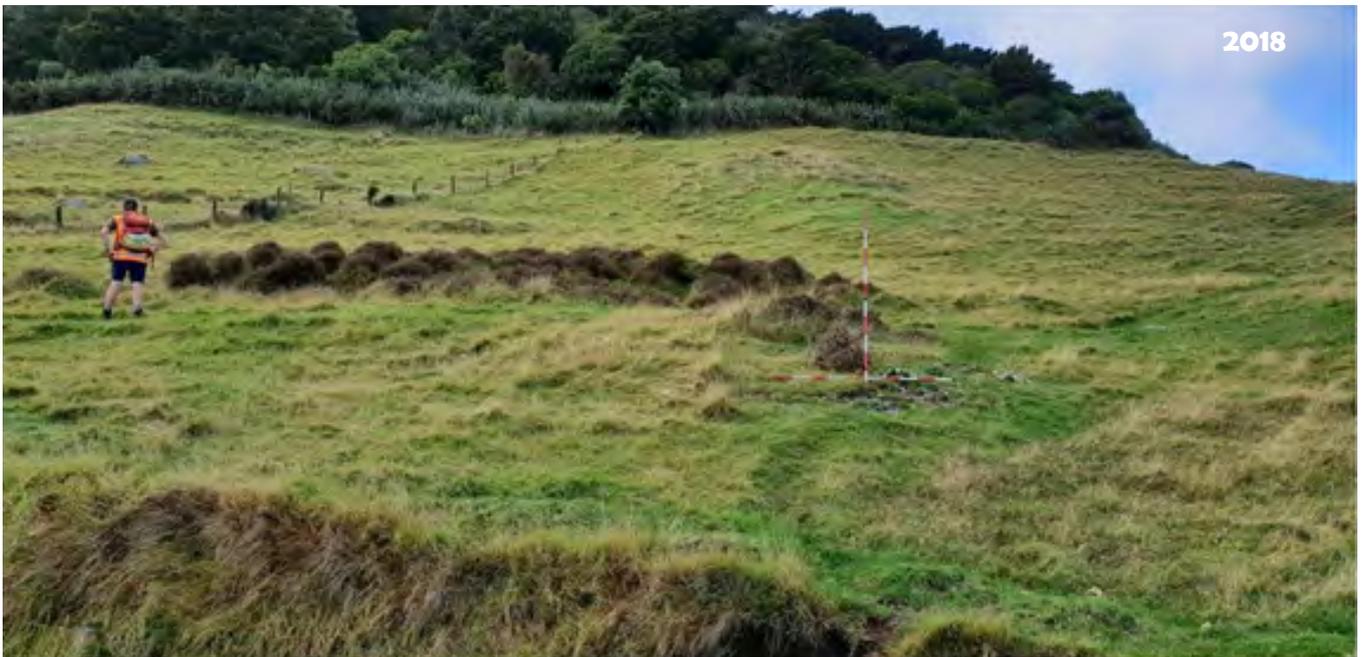
Monitoring Site 8

Midden and vegetation management - pōhuehue growth

Notes: Grass sward is kikuyu; stock have had access to the mound since December 2019. Stock numbers in Spring 2021 are higher than the previous year and this has impacted on the grass cover on the southern side of the mound. Stock numbers should be closely monitored and reduced if necessary to

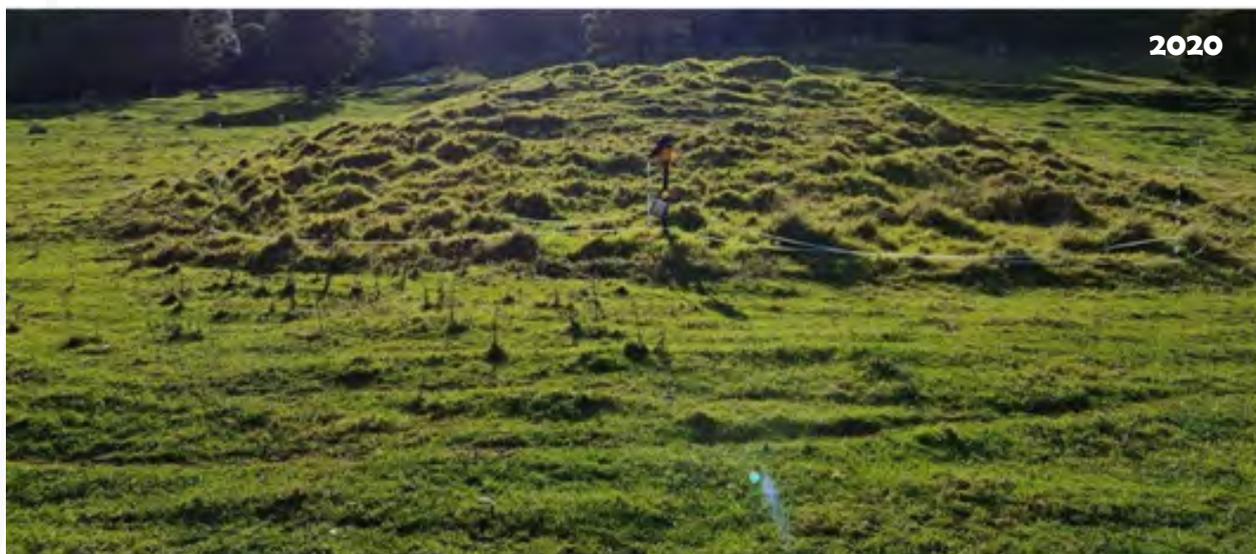
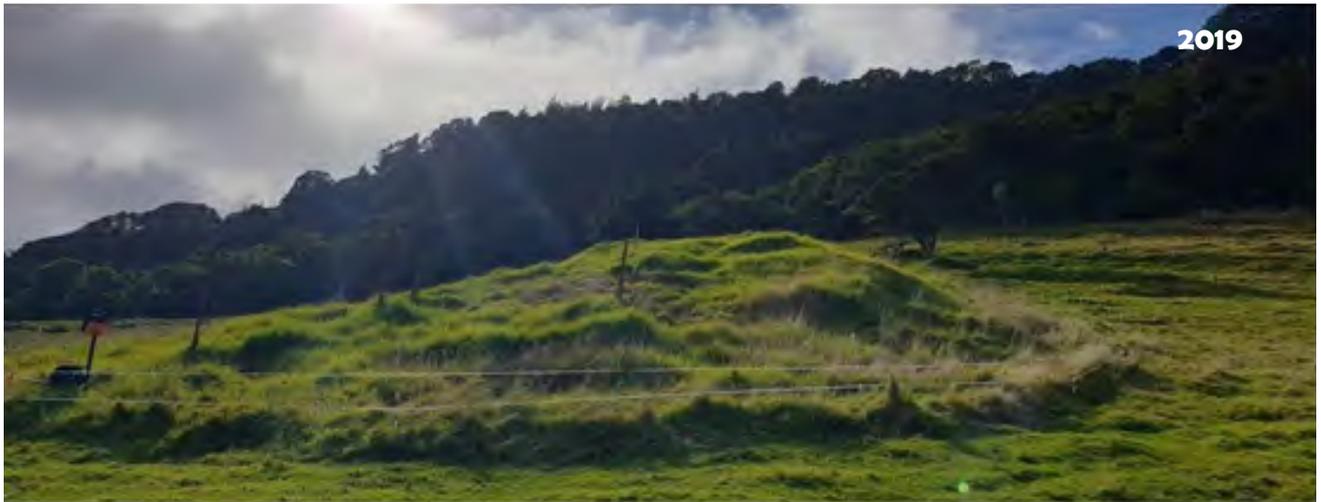
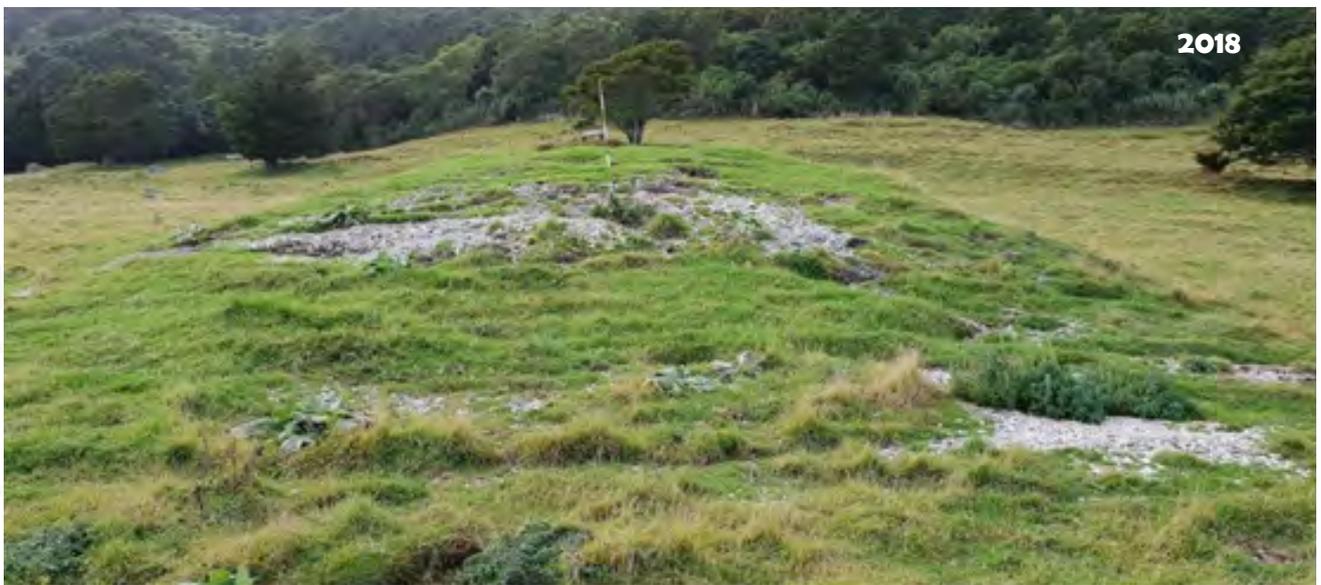
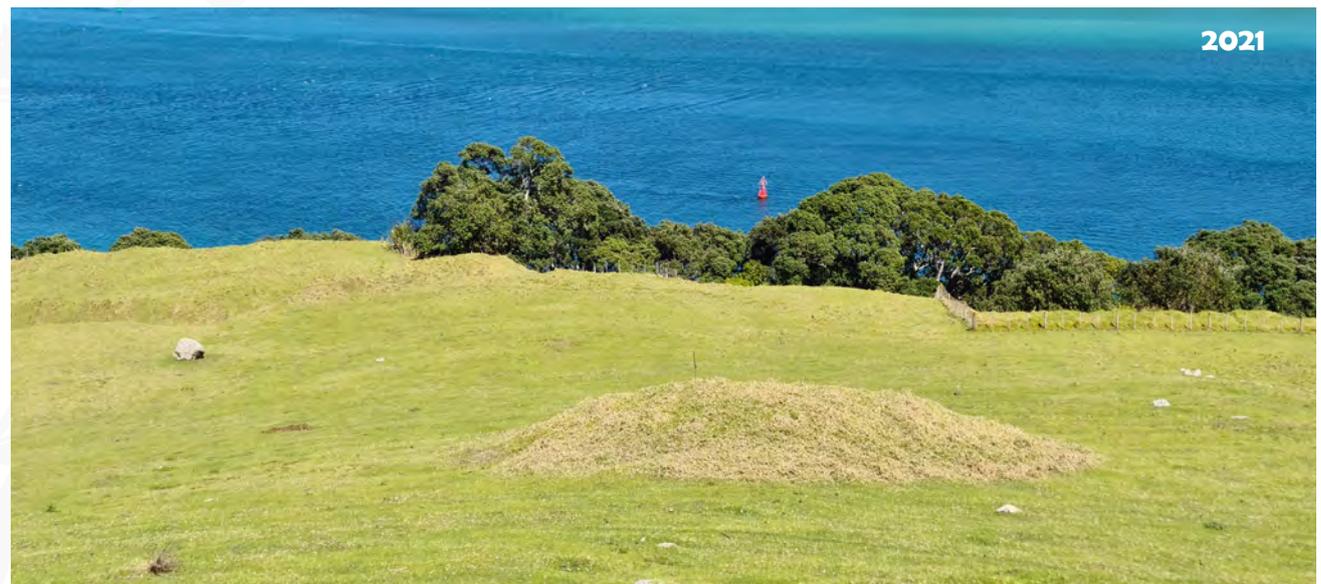
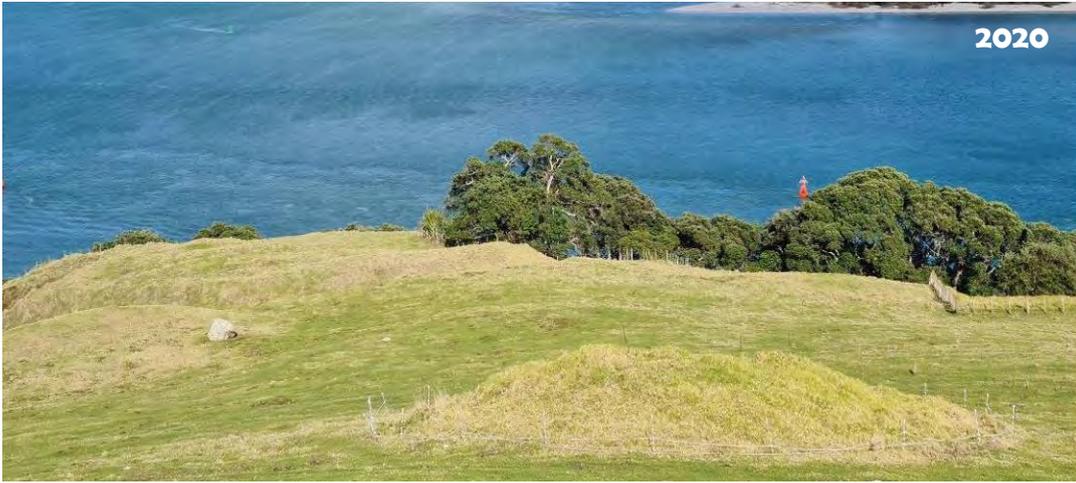
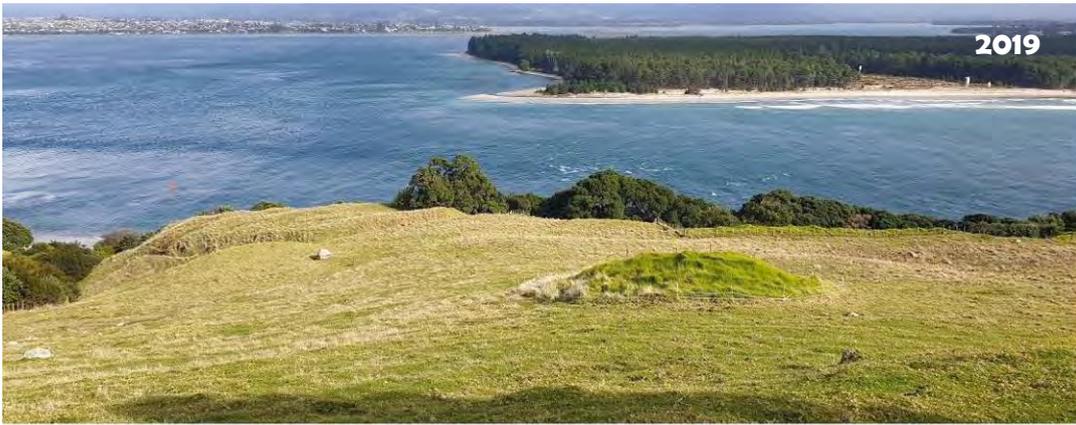
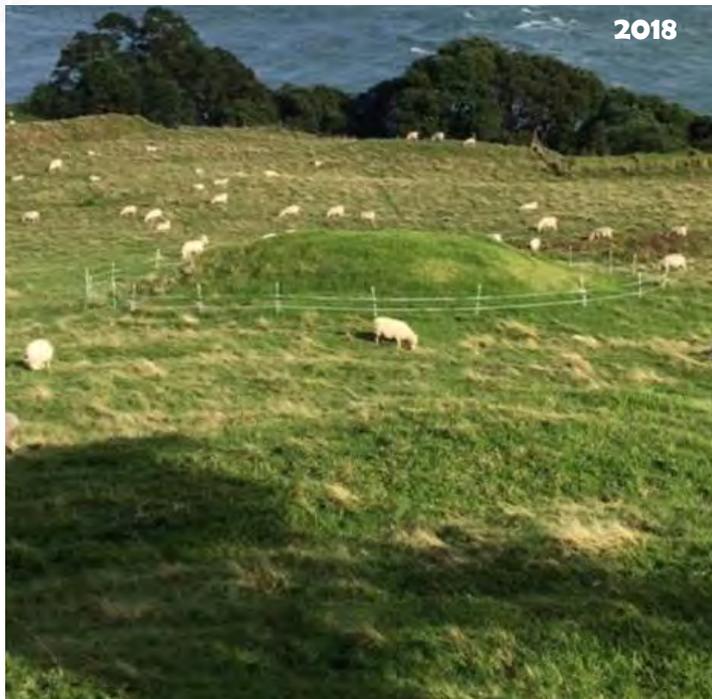
Monitoring Site 9

Erosion on shell mound - stock and vegetation management

Notes: Grass sward is kikuyu; stock have had access to the mound since December 2019. Stock numbers in Spring 2021 are higher than the previous year and this has impacted on the grass cover on the southern side of the mound. Stock numbers should be closely monitored and reduced if necessary to maintain sward height.

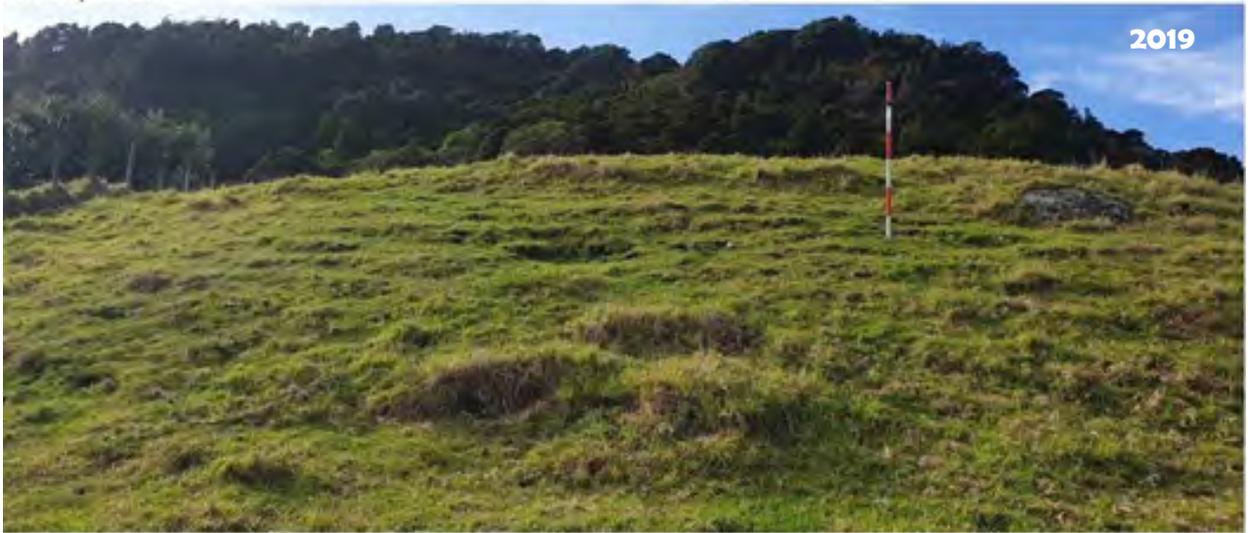
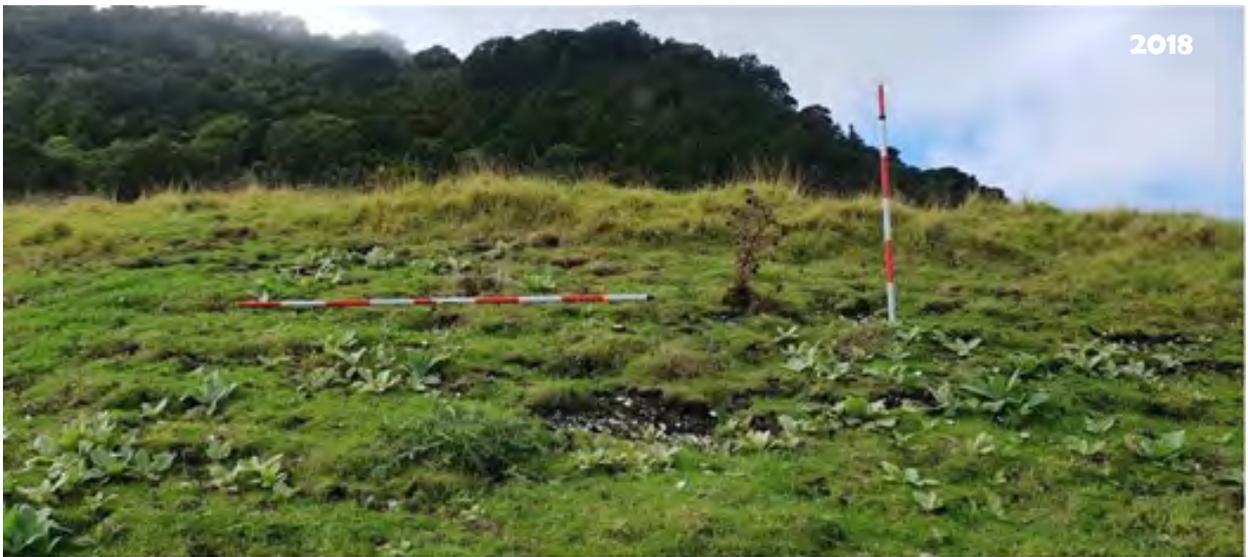
Monitoring Site 10

Rabbit damage (active)

Notes: Vegetation cover has significantly improved as greater rabbit control measures are in place, but this should be closely monitored. No recent rabbit browse at this location, but rabbits were seen in the area during the monitoring visit.

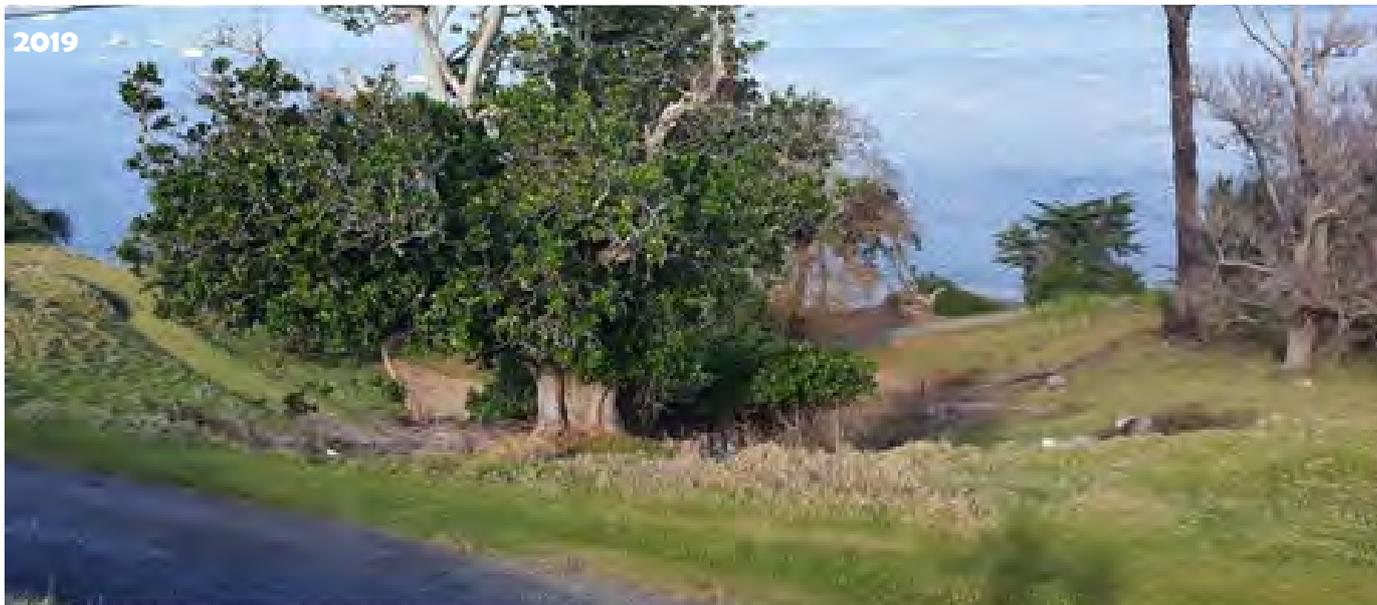
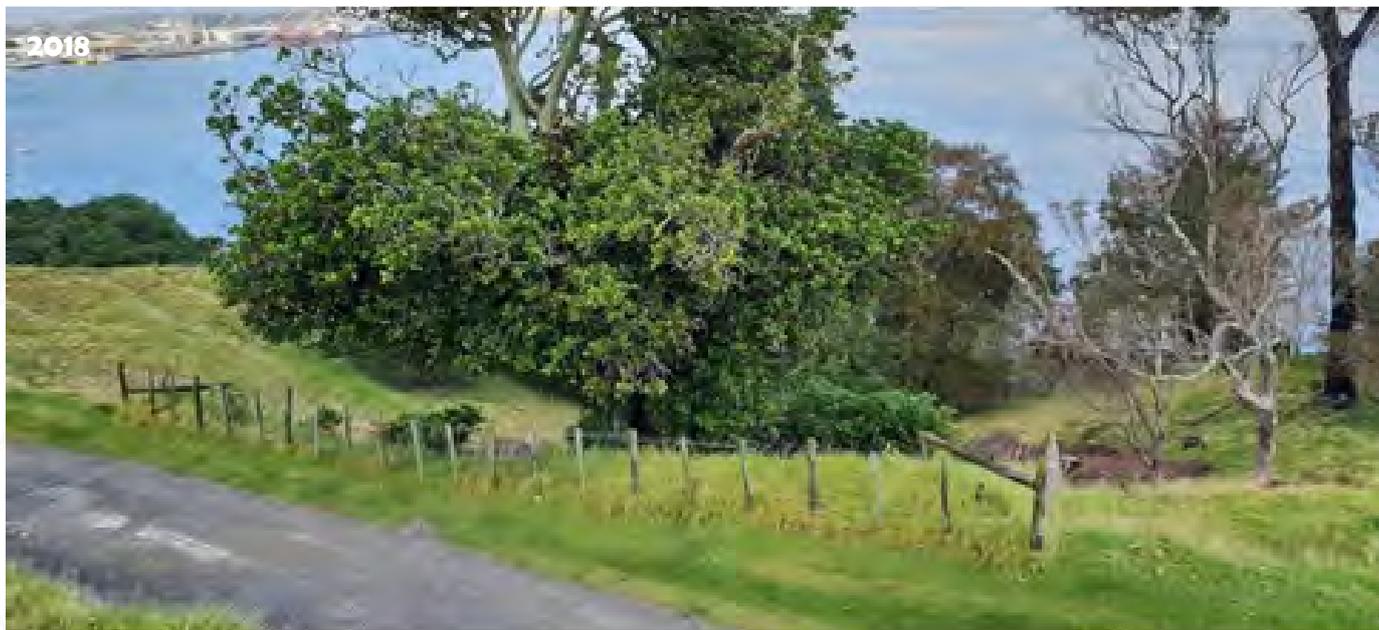
Monitoring Site 12

Fence around middens on southern slope

Notes: Fence around middens that was installed in 2003 was removed in 2018. Some browse of young karaka initially, but grove now well established and no new erosion of midden in evidence. Continue to monitor condition.

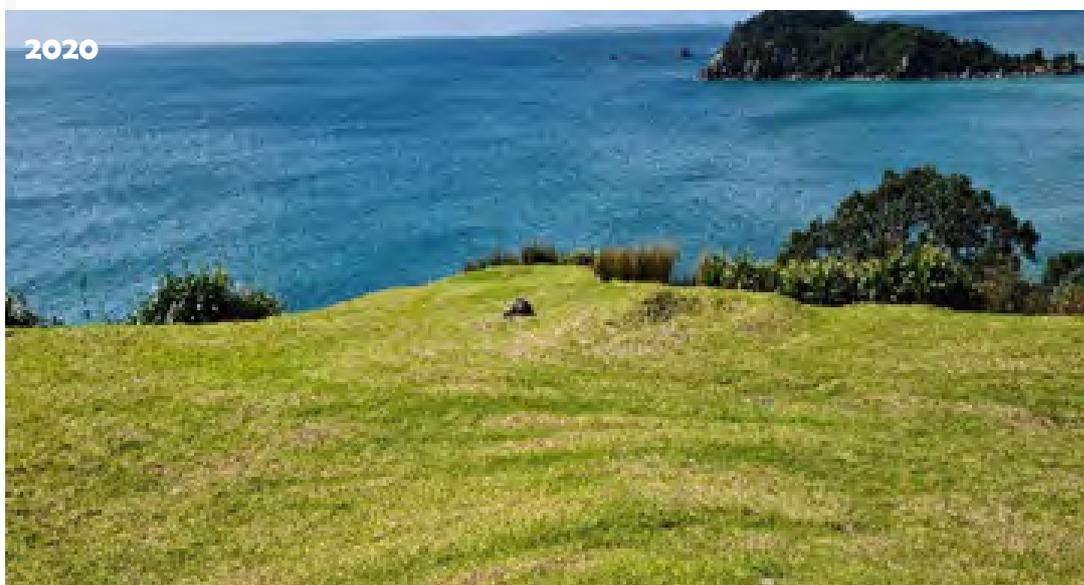
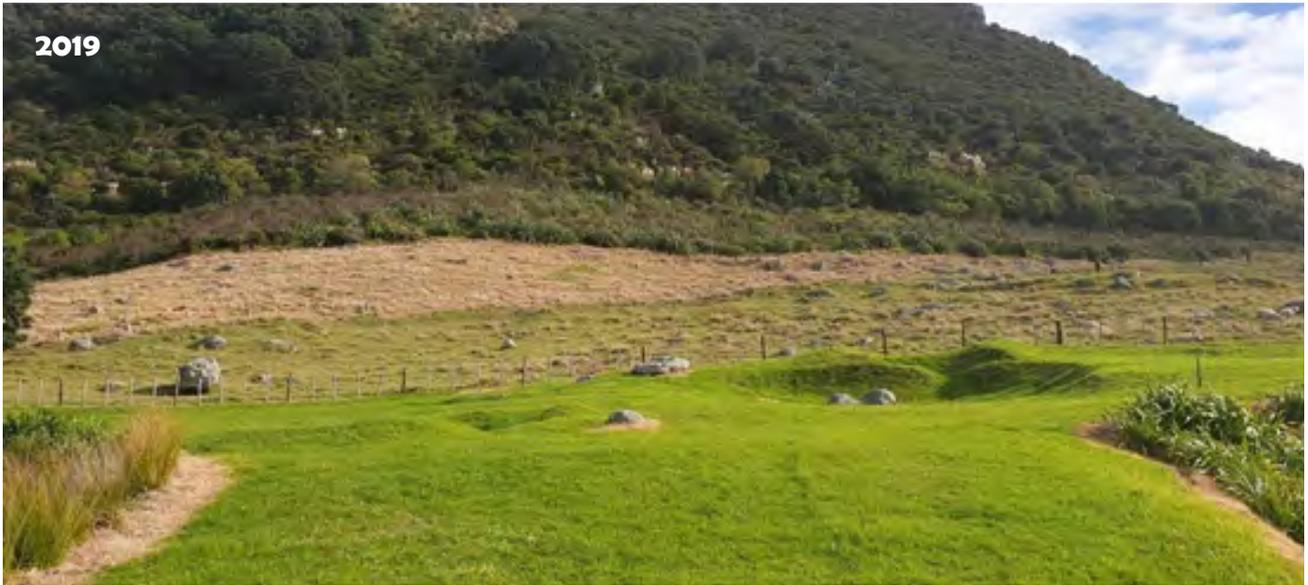
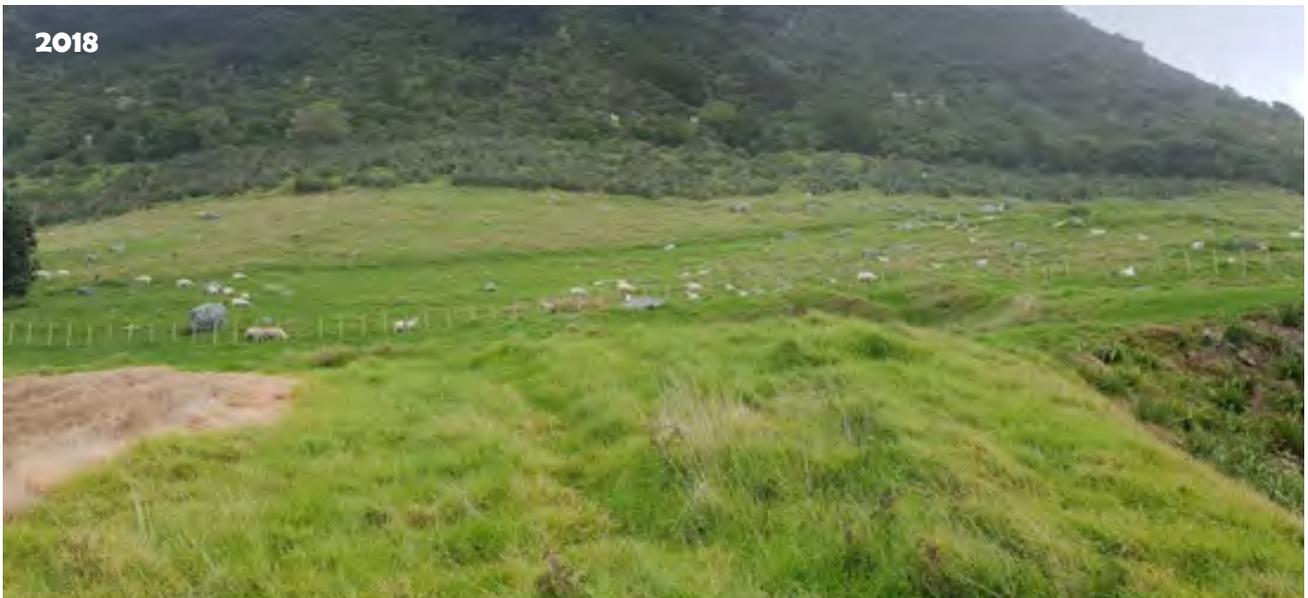
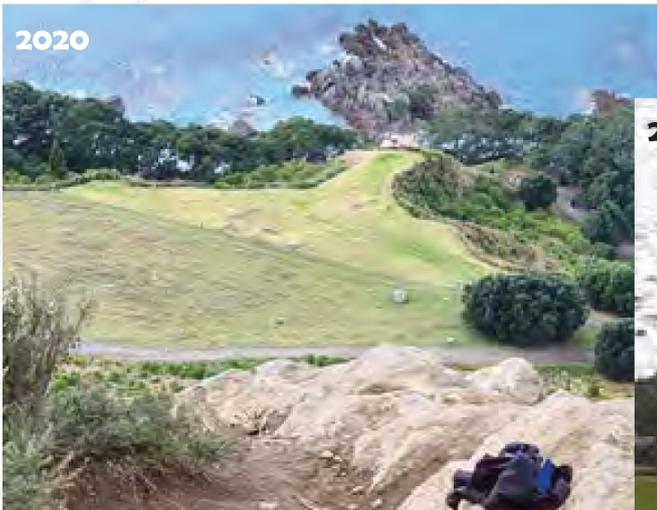
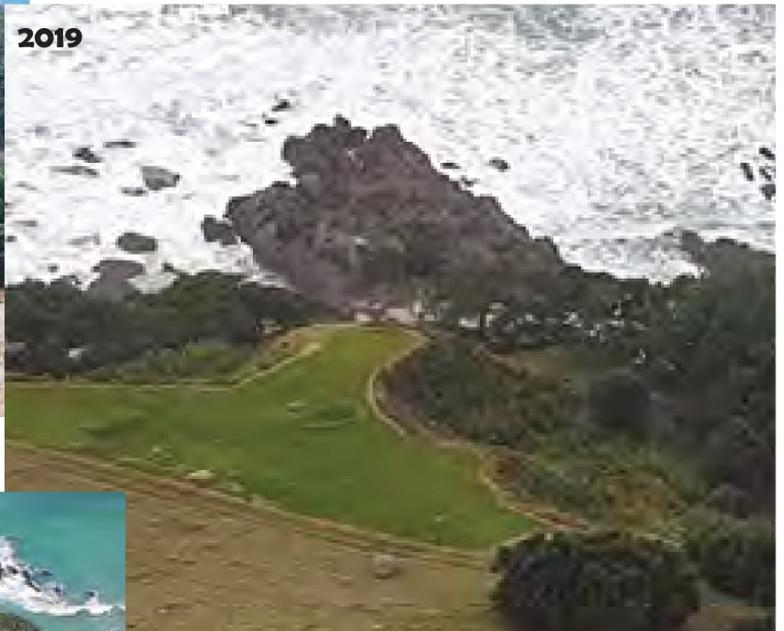
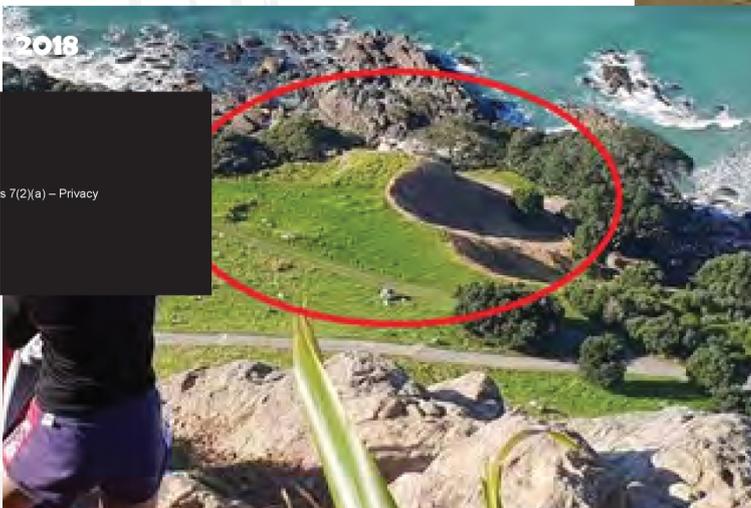
Monitoring Site 13

Area of military camp, helicopter pad, pits and terraces retired from grazing in 2018

Notes: Management of vegetation and site visibility has significantly improved following cessation of grazing. Features stable.

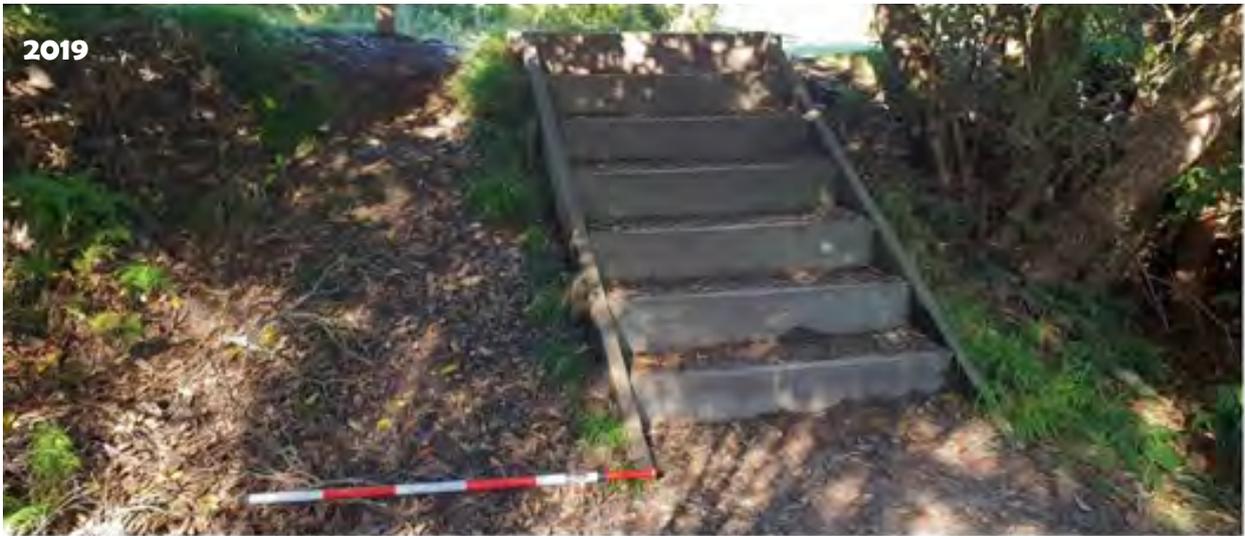
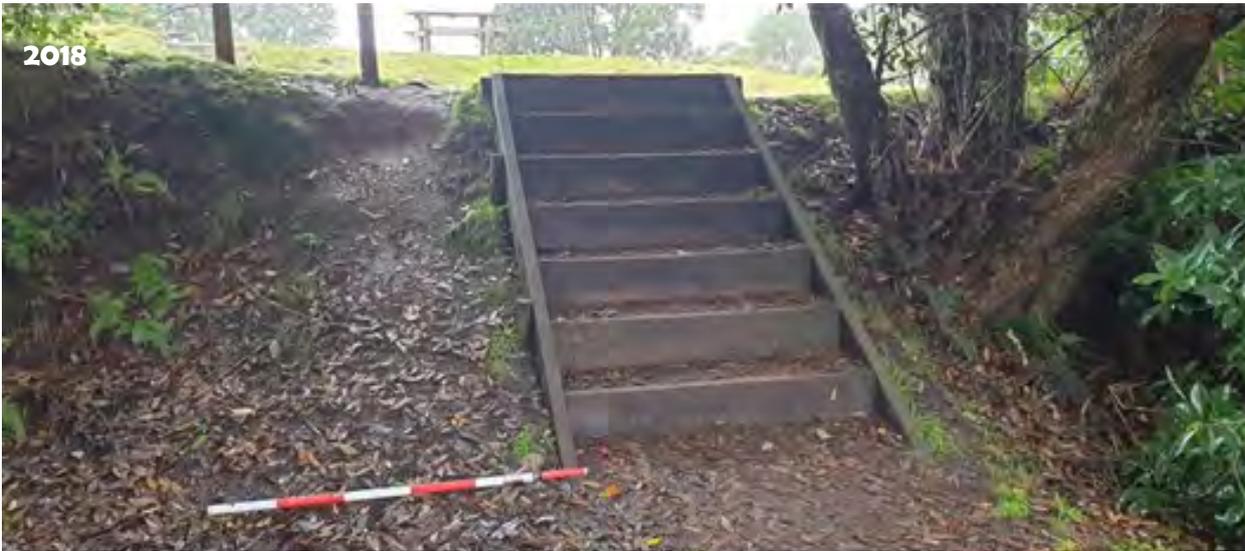
Monitoring Site 15

Repair to bank on summit and steps intallation

Notes: Width of steps has been increased to cover desire line. Continue to monitor use.

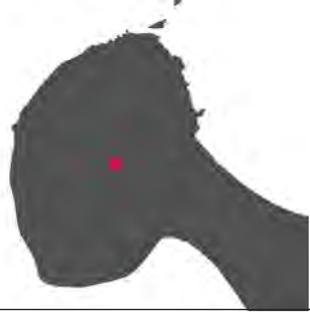
Monitoring Site 17

Desire line track on summit

Notes: Desire line is continuing to cause wear to intact archaeological deposit, and soil loss is readily apparent. Action to block access to prevent further wear was recommended in 2018 and needs to be implemented. Continue monitoring. Additional fill material may be required around the tree.

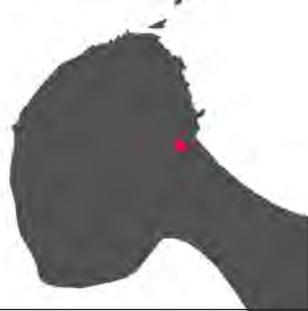
Monitoring Site 18

Stone steps condition and erosion
