TCC RESILIENCE PROJECT

PREPARED FOR TAURANGA CITY COUNCIL

7/7/2020

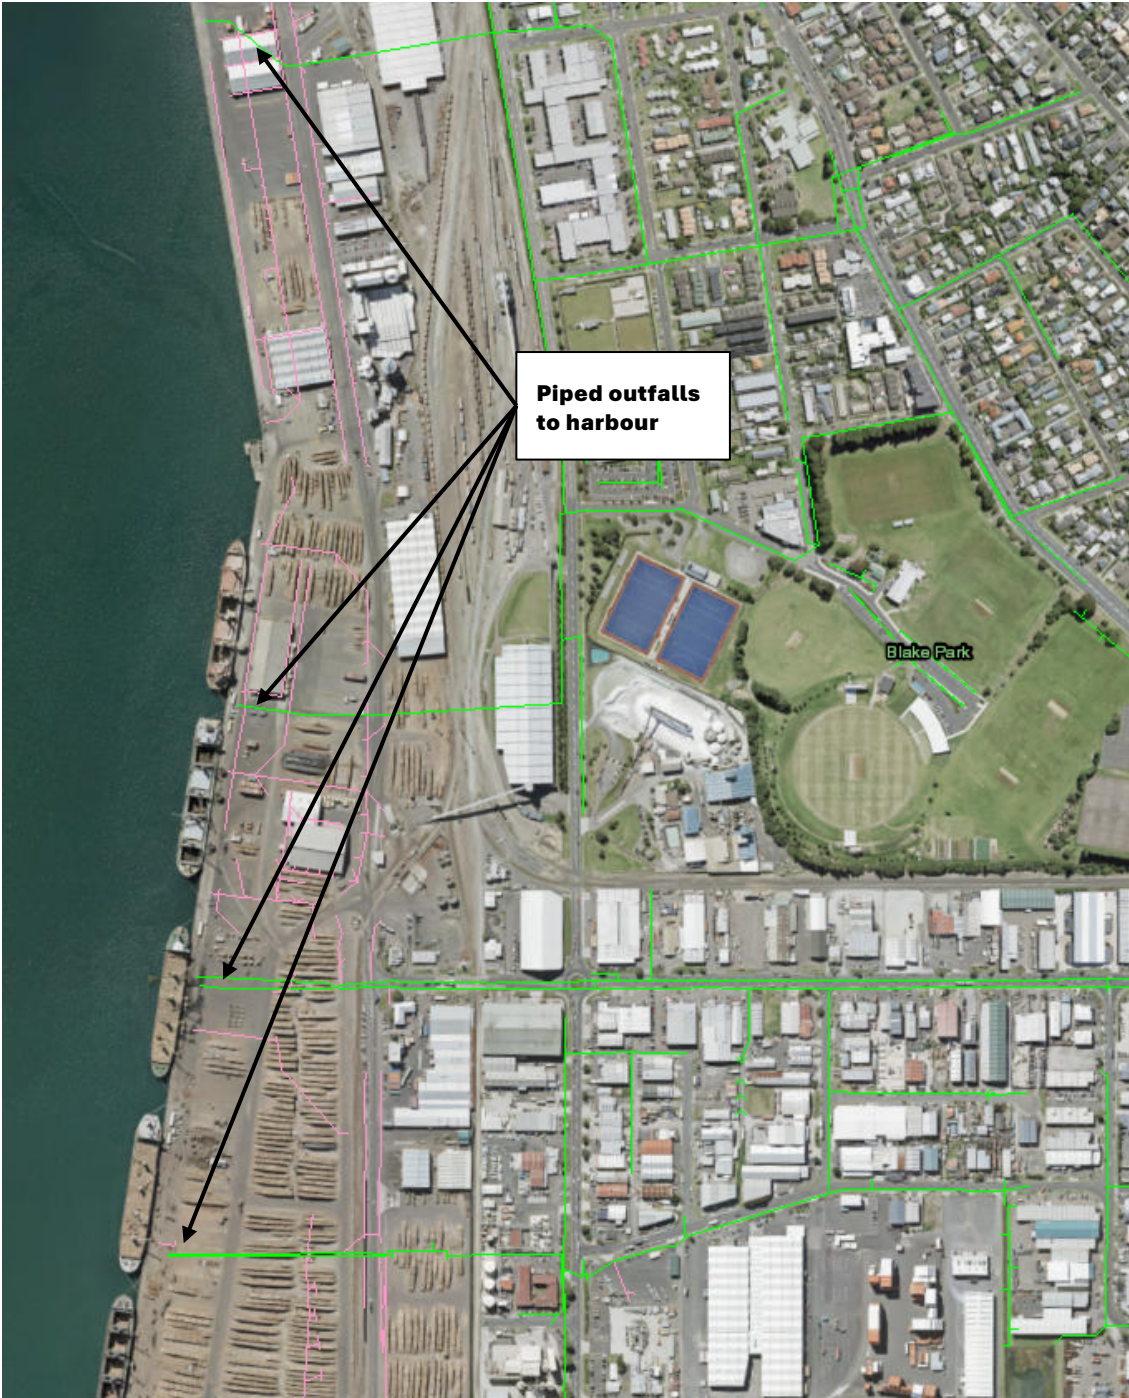
Figure 3: Piped stormwater outfalls to harbour

Stormwater in the area is mostly managed by gravity drainage to the coast or harbour. The densely populated Mount Maunganui residential, commercial and industrial areas discharge to the coast or harbour through piped outfalls (Figure 3). To the east in Papamoa Beach, where developments are low lying, stormwater is managed through long stormwater ponds (Figure 4) that discharge to the sea and harbour through a combination of piped outfalls and channels.

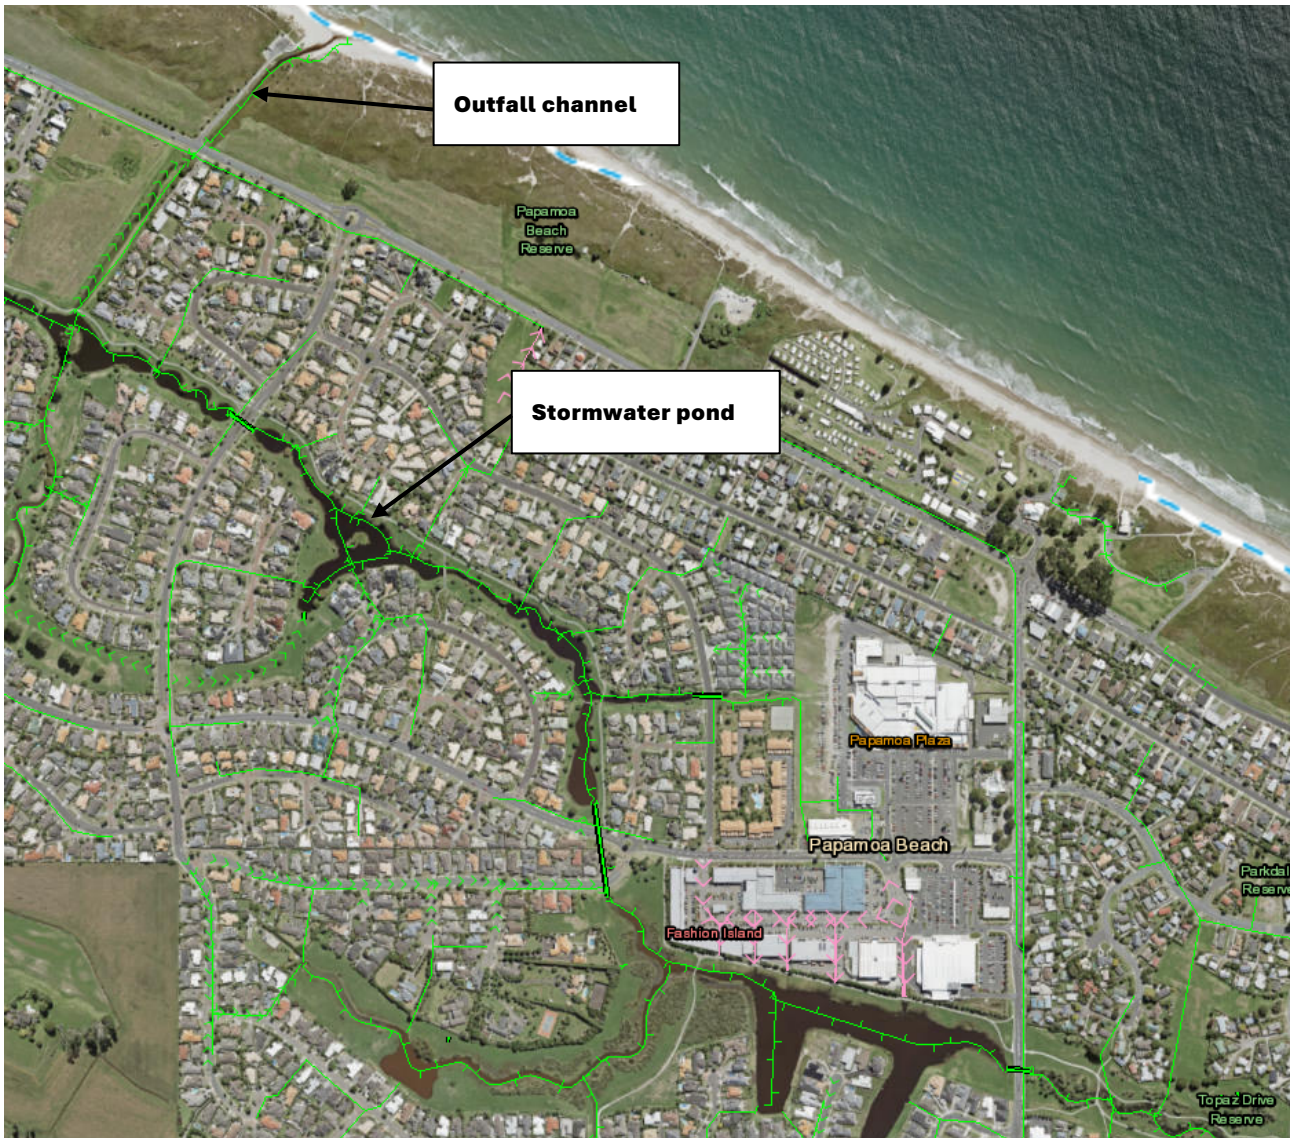
Figure 4: Stormwater ponds in Papamoa

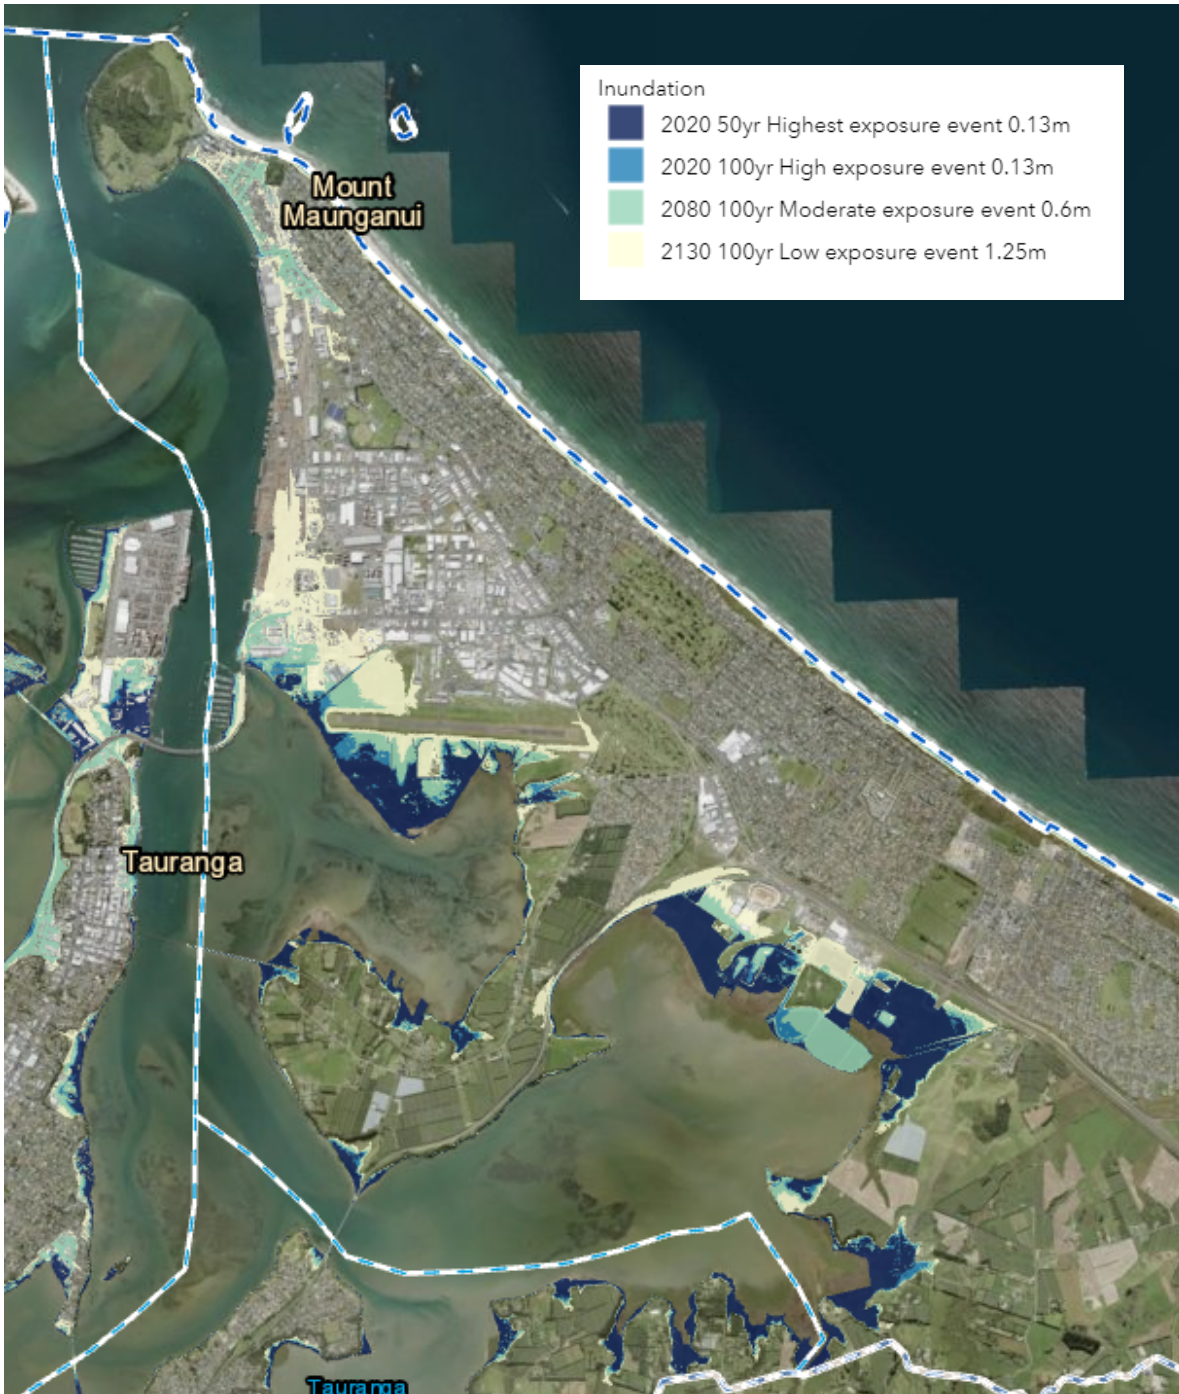
Figure 5: Inundation hazard

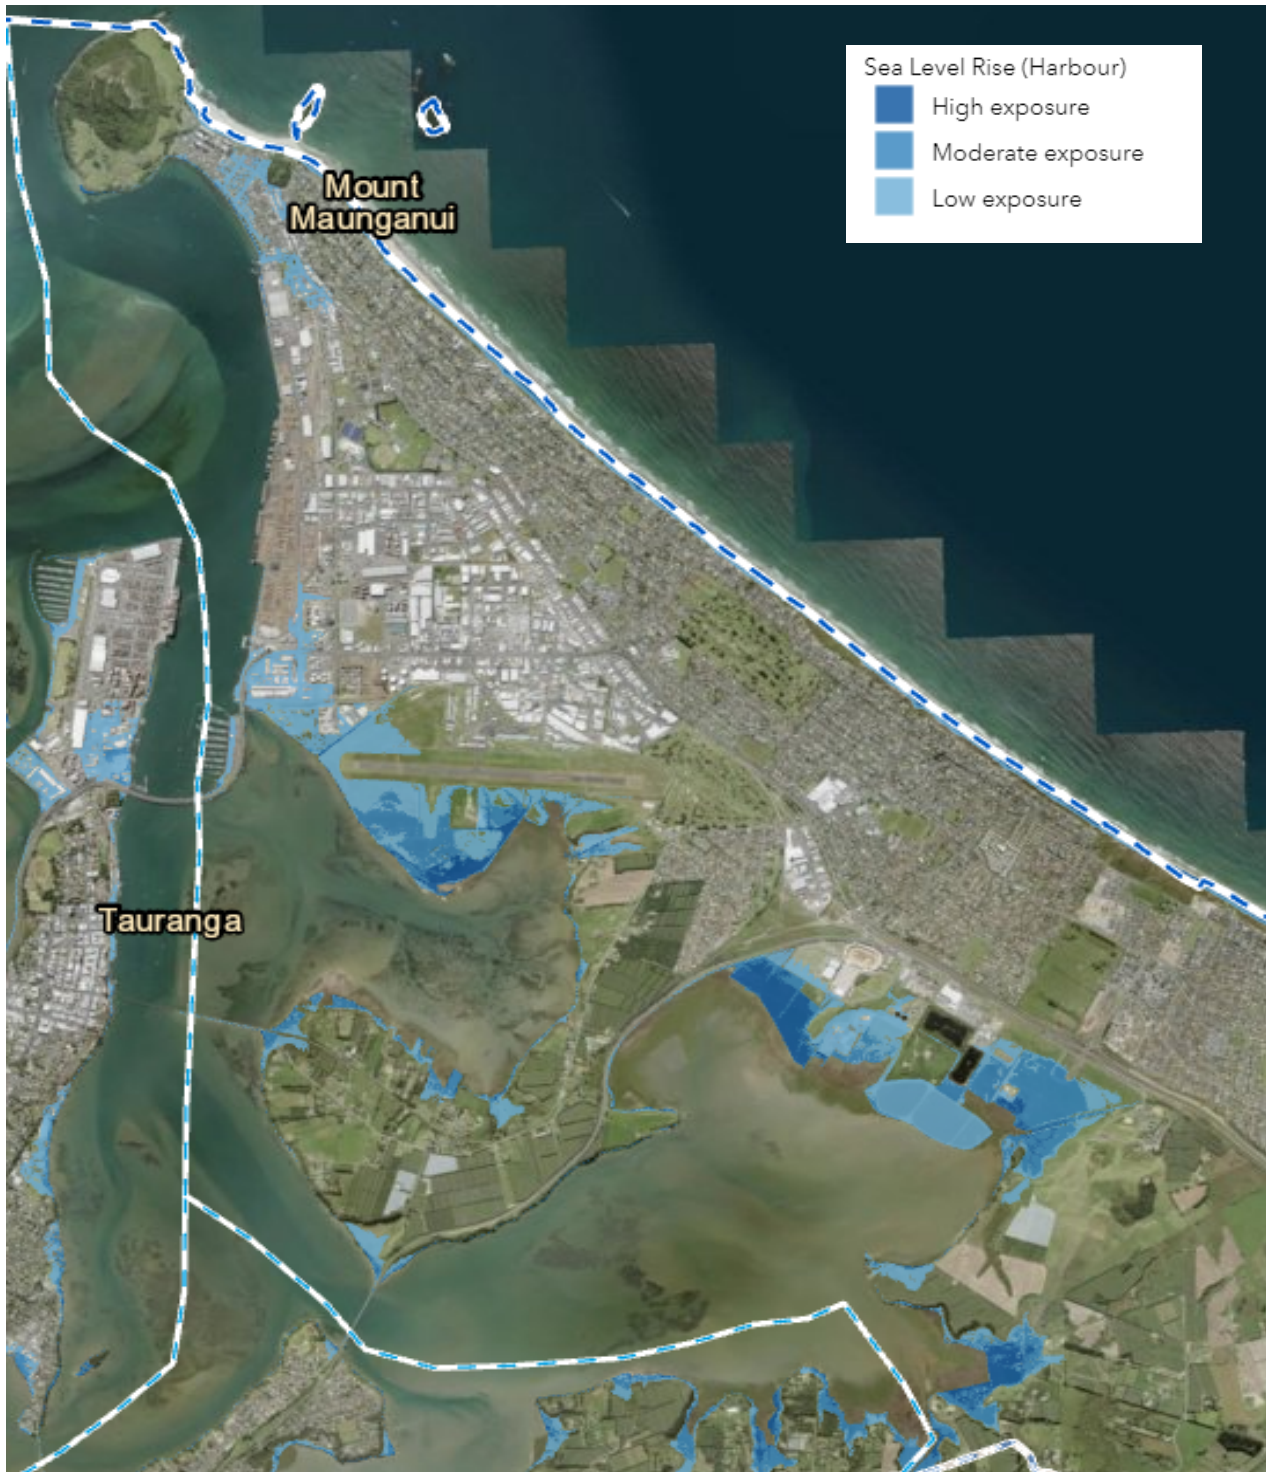
Figure 6: Sea Level rise hazard

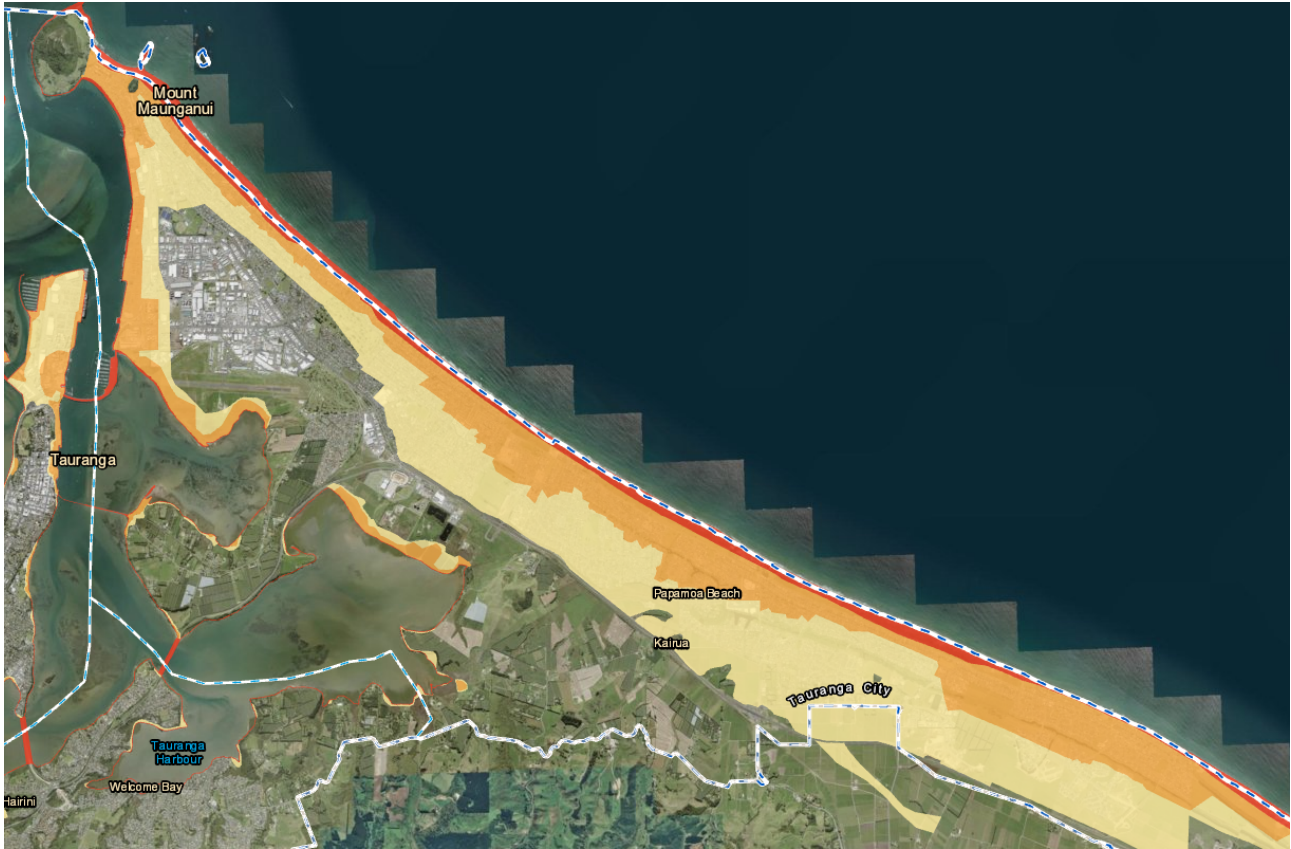
Figure 9: Tsunami Hazard Zones

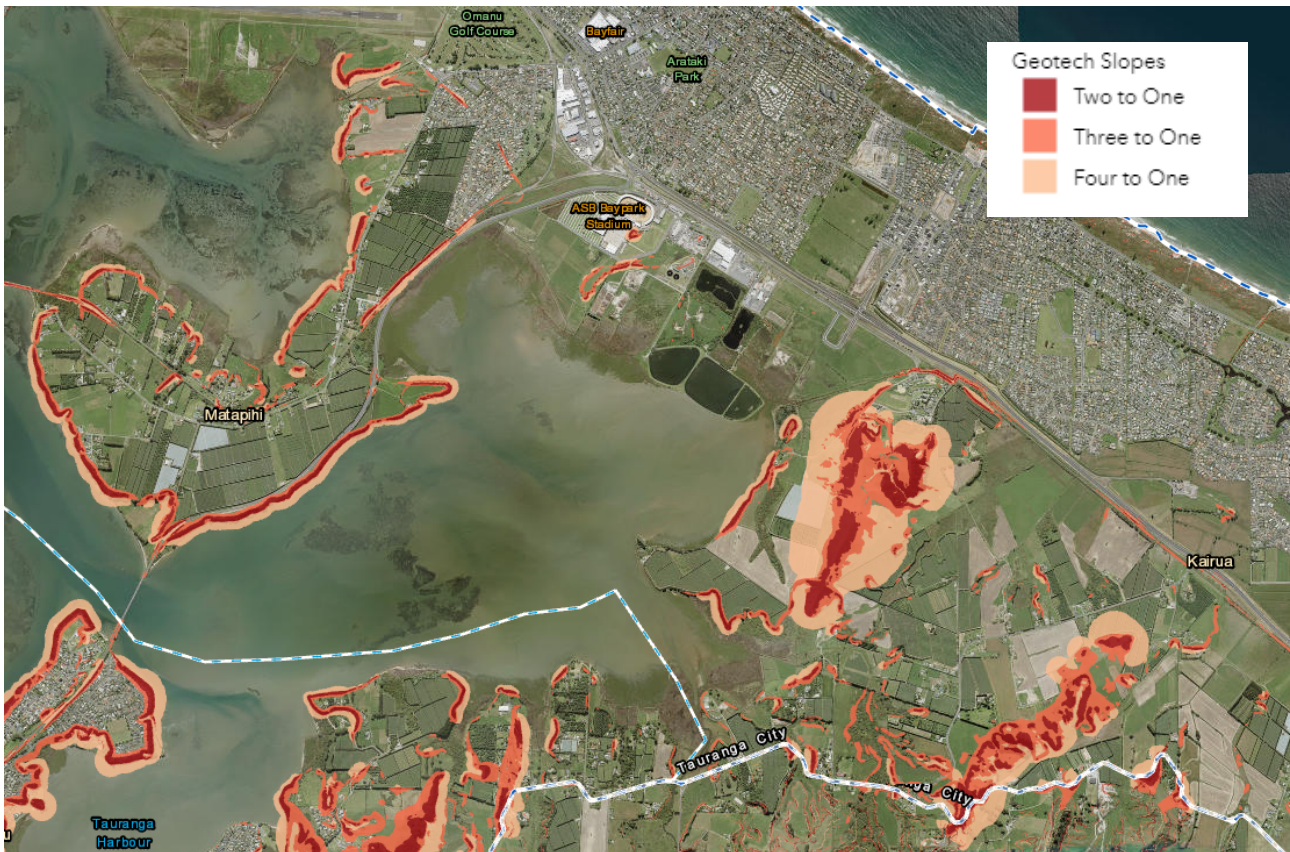
The geotech slopes hazards in the area are associated with steep slopes. Since the coastal area is mostly flat, the geotech slopes hazards are concentrated at the steep harbour embankments at Matapihi and the steep slopes at the Mangatawa reservoir complex. Assets founded in ground with geotech slopes hazard can become damaged when ground movement occurs.

Figure 10: Geotech Slopes Hazard

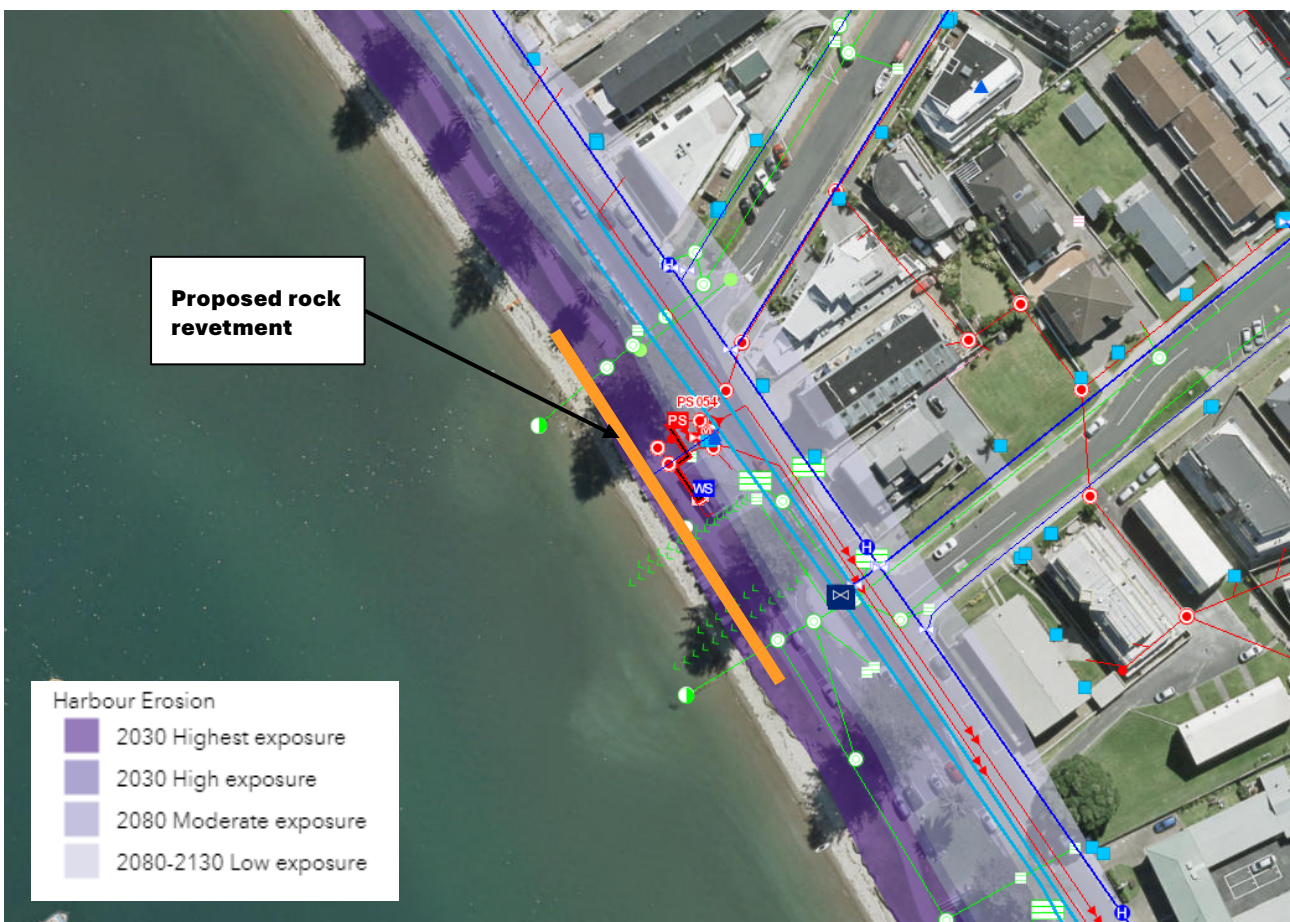
Figure 12: PS054 and proposed rock revetment location

Harbour erosion is shown to affect the beach along The Mall Road in Mount Maunganui. This poses a risk to a number of assets along The Mall Road over the next 50 years, but is expected to affect wastewater pump station PS054 and the stormwater outfalls in the short-term. In addition to the harbour erosion, the pump station is also exposed to sea level rise, tsunami, inundation, and liquefaction. However, addressing the harbour erosion risk is considered the most urgent. Harbour erosion exposure of PS054 is shown in Figure 12.

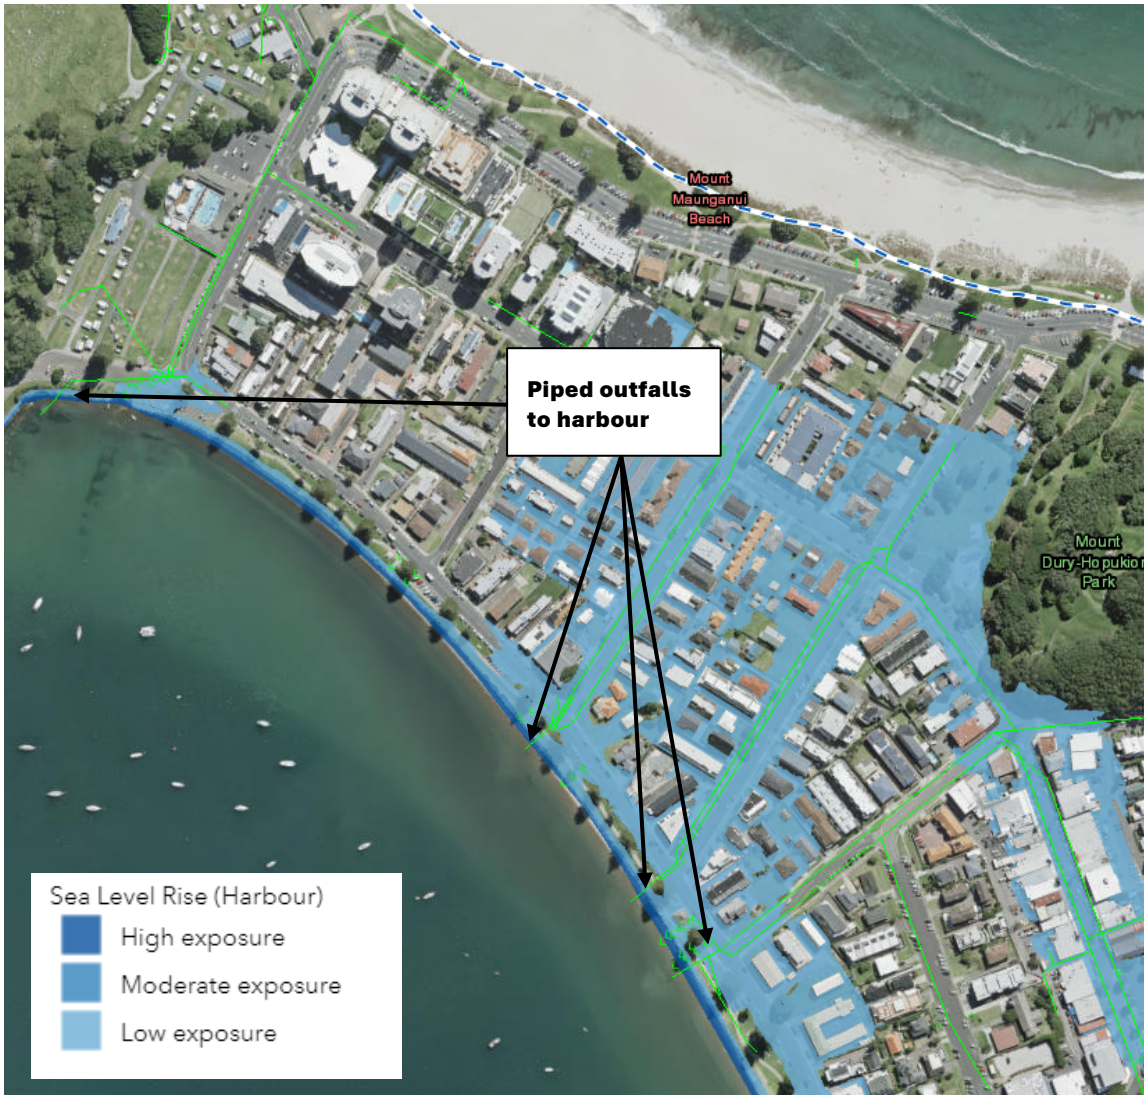
Figure 13: Stormwater outfalls in Mount Maunganui area

Even though it is good practice to have backflow prevention valves on the outfalls and they may already be installed on these outfalls, it may also be that they are not functioning correctly. It is therefore recommended to install non-return valves on outfall pipelines to prevent ingress of seawater at high tide. The outfall

performance should also be monitored to inform ongoing maintenance. It is proposed to inspect and install new valves on multiple outfalls at the same time. These outfalls are listed in Project IDs 531, 532, 533, 535, 538, 539 and 541.
