ENGEN371-19C Engineering Work Placement 2

Project Management Technical Report

Tauranga City Council

8.1 Mauao Slip Remediation

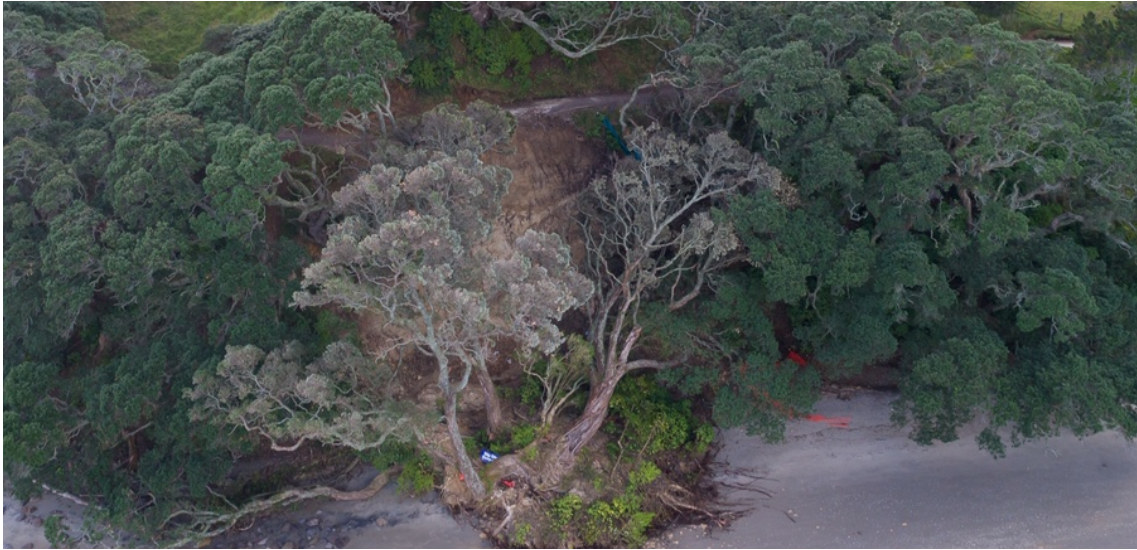
Figure 8:1: Mauao Slip, Prior to Physical Works (Tauranga City Council)

The first steps in the Mauao Slip Remediation, at least from when the student started at the Tauranga City Council, was the planning of how to address the issue. There were many issues with fixing the track, and they were all quite sensitive. There is an archaeological site close to the slip's upper slope, meaning that any plans for heavy excavation there could have been denied by Heritage New Zealand. There are also a few pohutukawa trees at, and even on the slip, which could cause further issue if not removed due to possible voids in their roots, but which the iwi that managed Mauao wished to keep due to their significance.

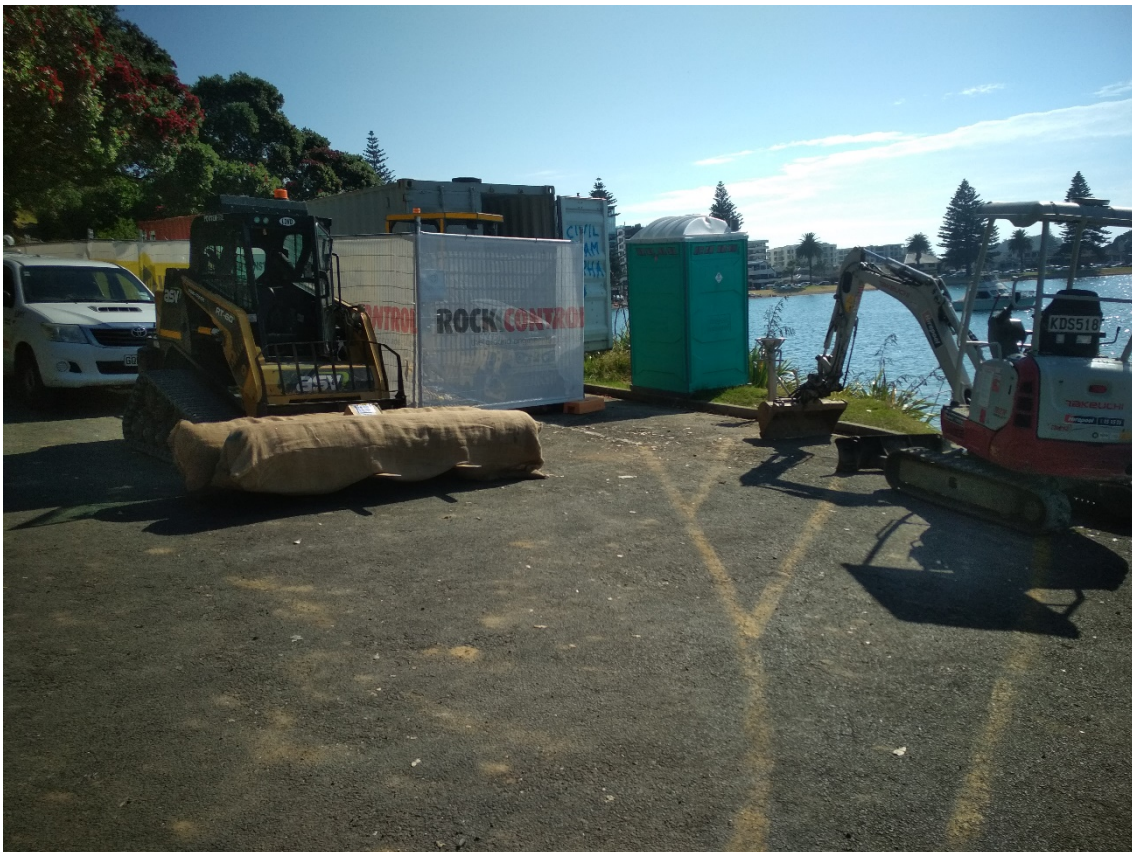
Figure 8:8: Container Set-up

For the methodology, firstly there was the establishment/mobilisation/dis-establishment by way of hiab and transporter. As can be seen by Fig. 8:8. the containment consisted of two containers to be located at the existing parking area seaward side in order to provide housing of materials and tools for the projects duration. A geo-cloth or similar was to bund socks around the outer of the containers.

For the plant, like those seen in Fig. 8:8. there was to be a 5 tonne excavator, 3 tonne skid steer, pedestrian roller 1.5 tonne, 5 tonne exc/drilling rig. The plant was to carry out the works, while also being able to move to and from the worksite through the track. A small ATV/Quad and Pump plant was also needed for grouting and hydroseeding native growth material.

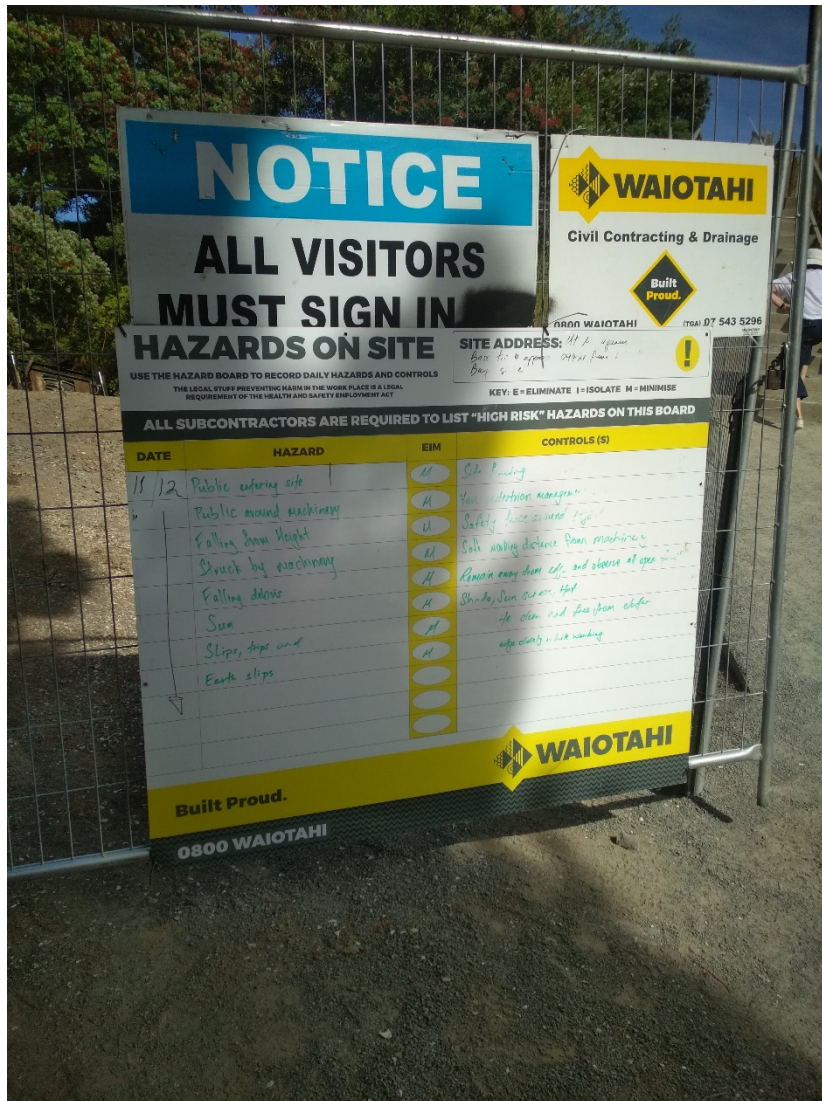
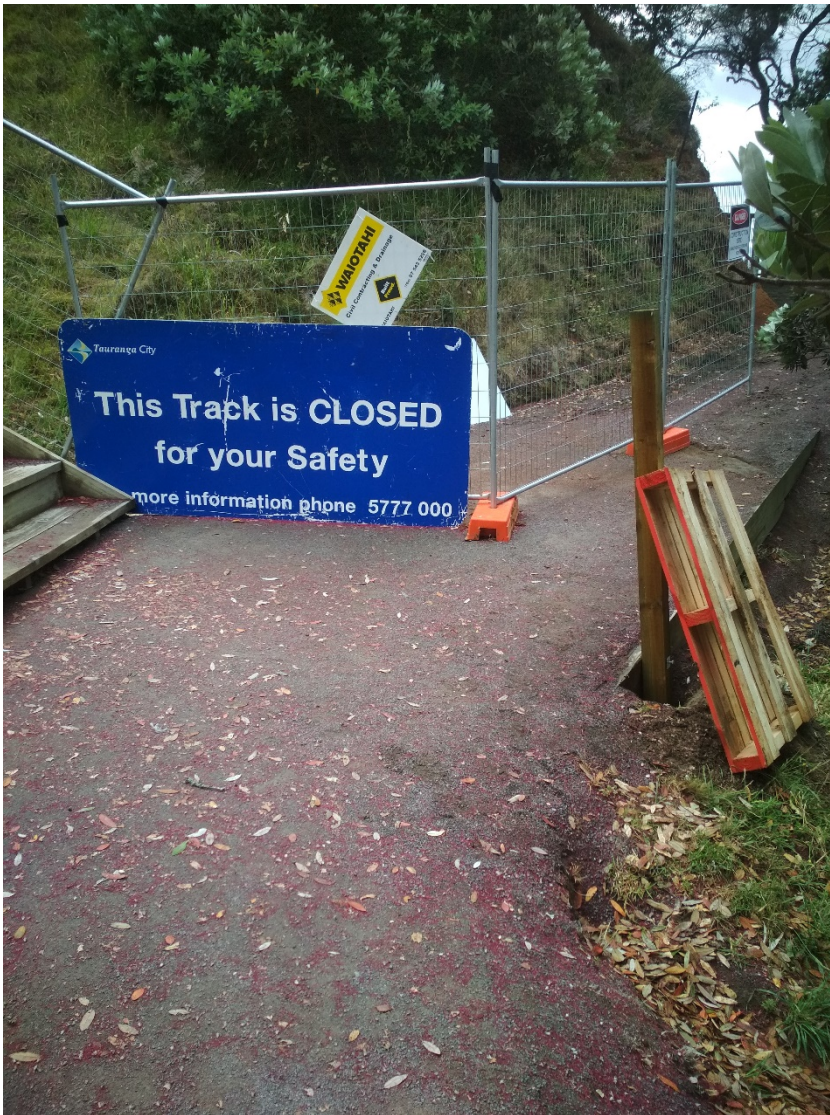
Figure 8:9: Front Facing and Hazard Board

Figure 8:10: Back Fencing

As seen in Fig. 8:9. and Fig. 8:10. the installation of safety fencing was also required, the minimum of which was 1.2m high. The installation of construction boards and signs in facility were also required.

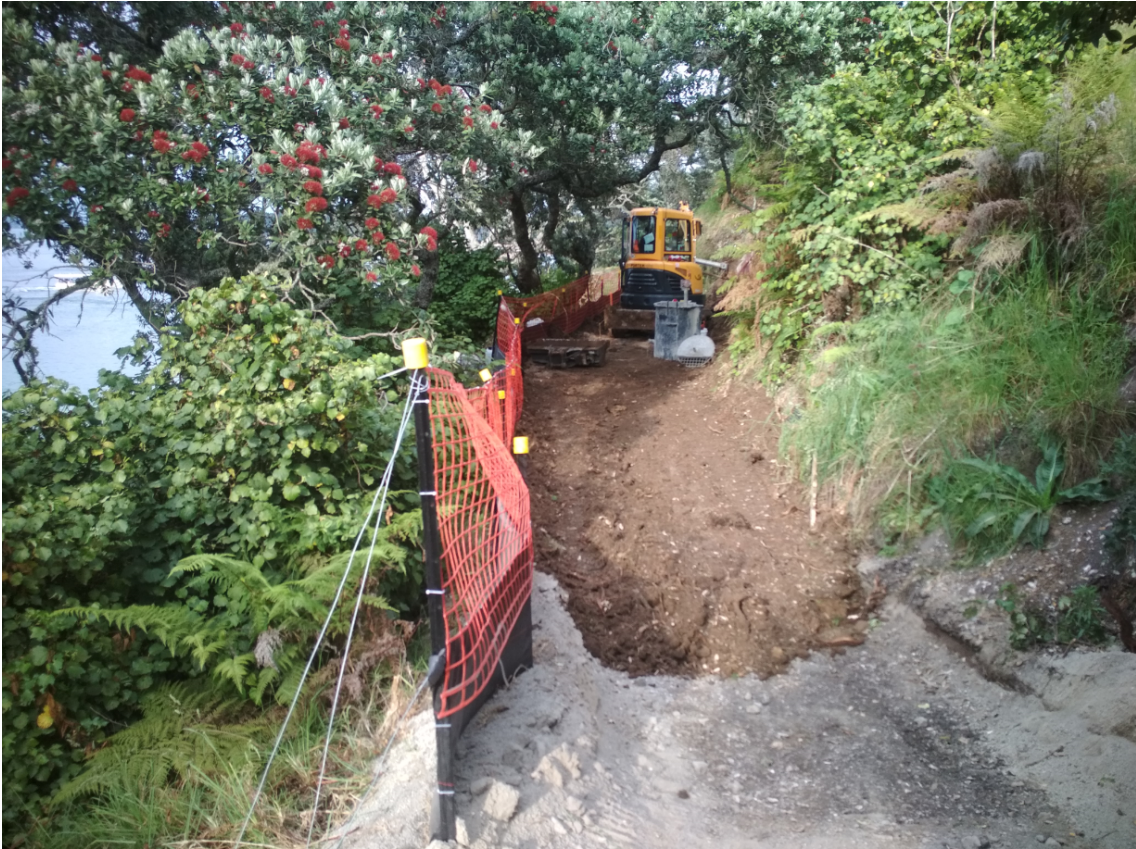
Figure 8:11: Track Works

Figure 8:11. shows the work to the track, where a skidsteer was to remove the top ~30mm and stockpile on the track to be relayed/compacted back on the track. The cut from the bank trim was to be placed on the track at a maximum height of 400mm or to an acceptable grade determined by the engineer. At the completion of works the CAP would then be relayed over the top and compacted to walking track standards.

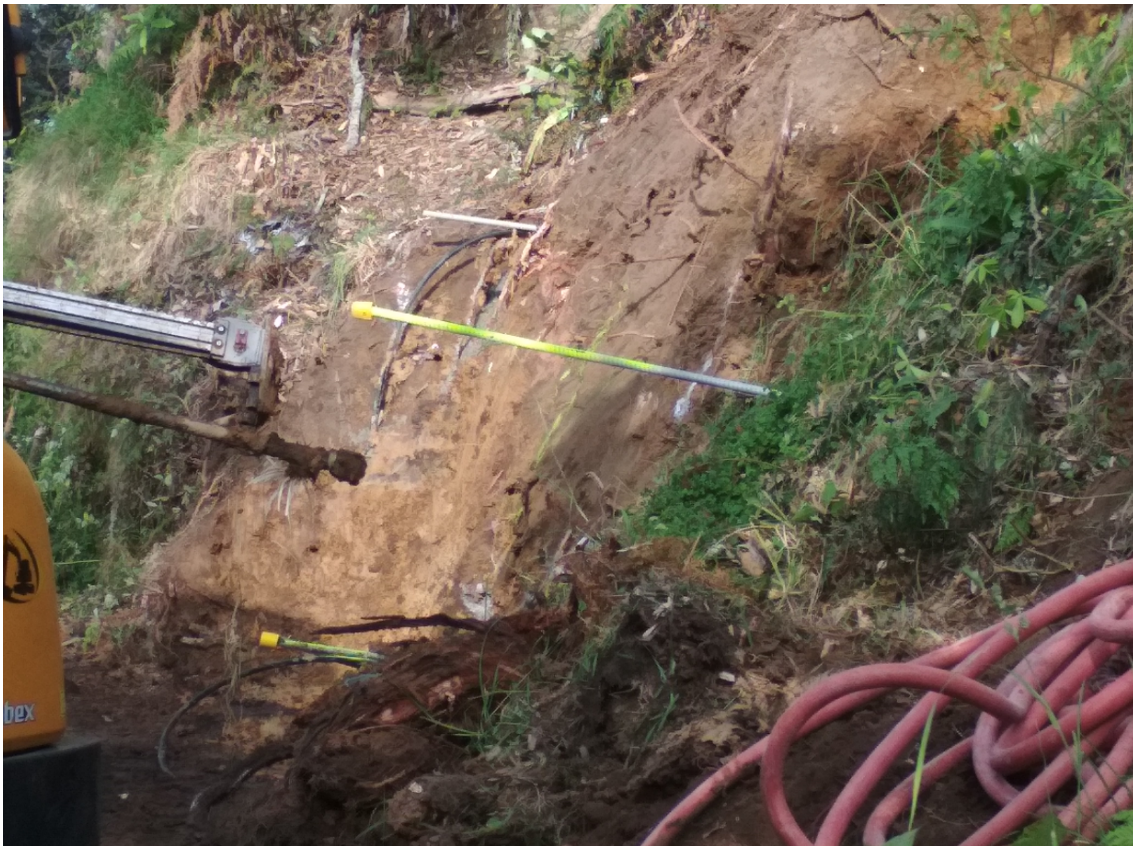
Figure 8:12: Drilling and Inserting Soil Nails

Drilling was to then be completed by use of a five tonne excavator with mast attachment in order to meet required specifications as designed by the engineer, as shown in Fig. 8:12. The mark-out of the soil nails was to be completed by the consultants, at the completion of the five meter longitudinal section, the rig would standby while grouting was completed.

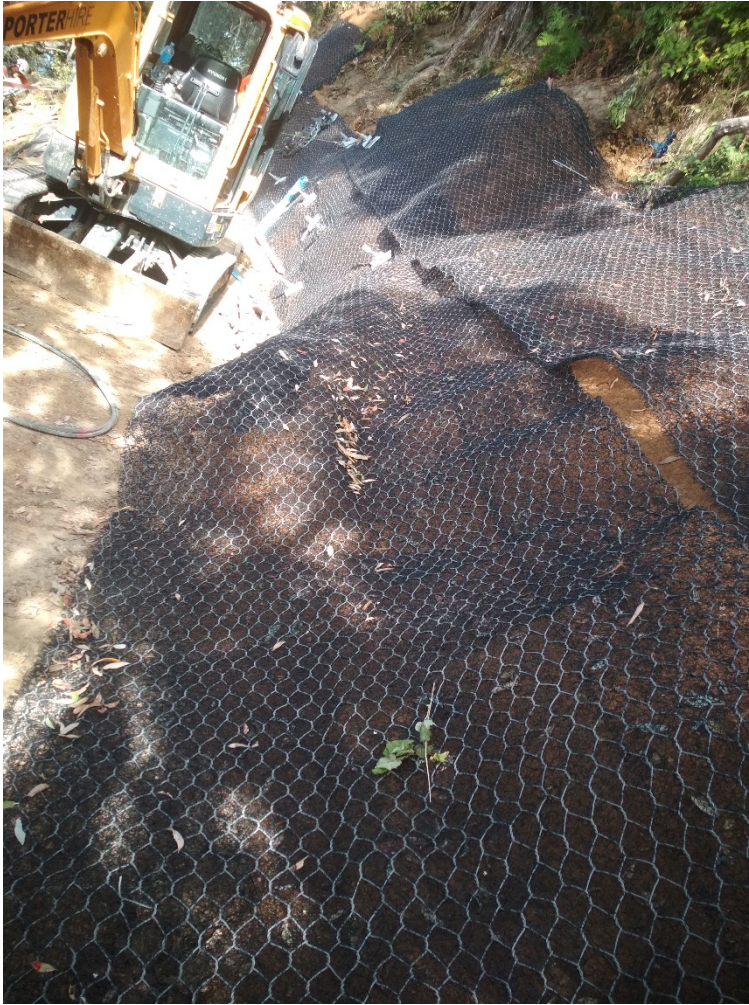
Figure 8:13: Mesh, Backing Plates

Mesh was to be placed over the extent of the upper slope face once the soil nails were installed, this can be seen by Fig. 8:13. GV Backing Plates were also to be installed to completion.

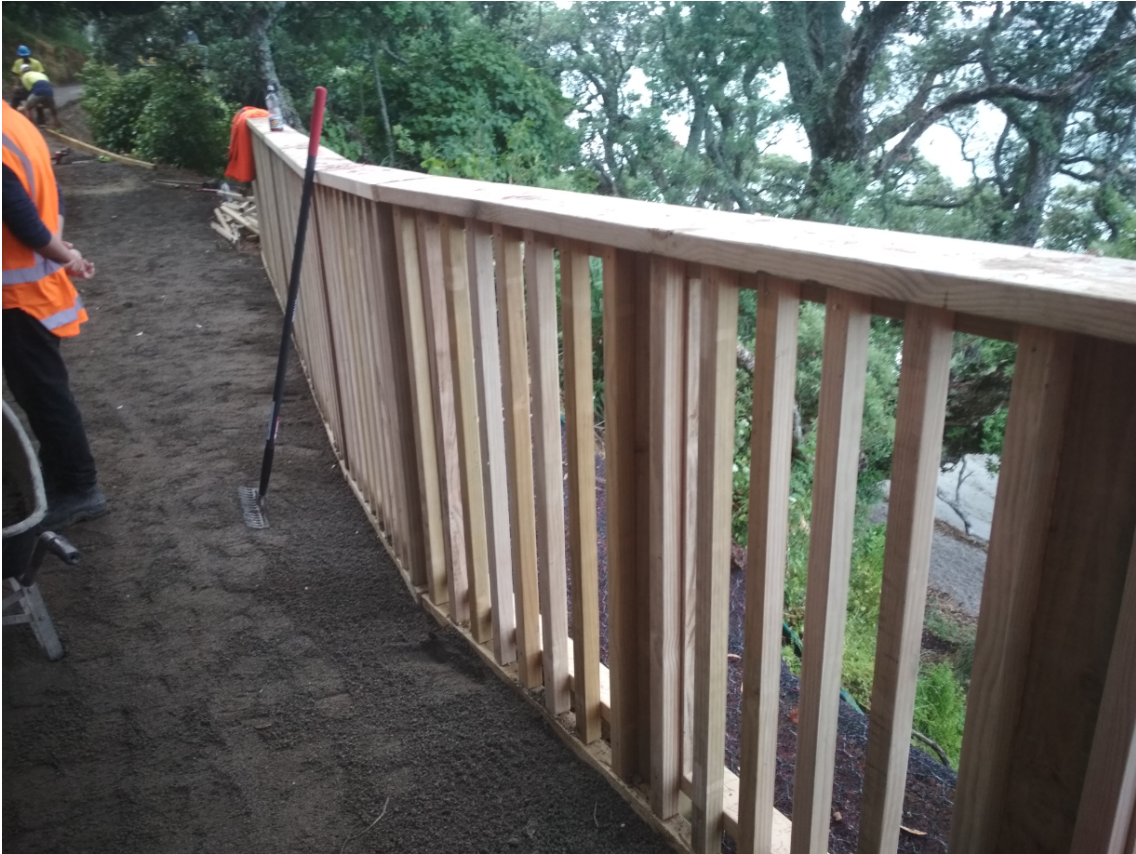
Figure 8:14: Permanent Handrail

A permanent handrail was to be completed as programmed to the design set out by the engineer, this was created based on keeping the design natural to the area. Hence, it was designed as a wooden handrail.

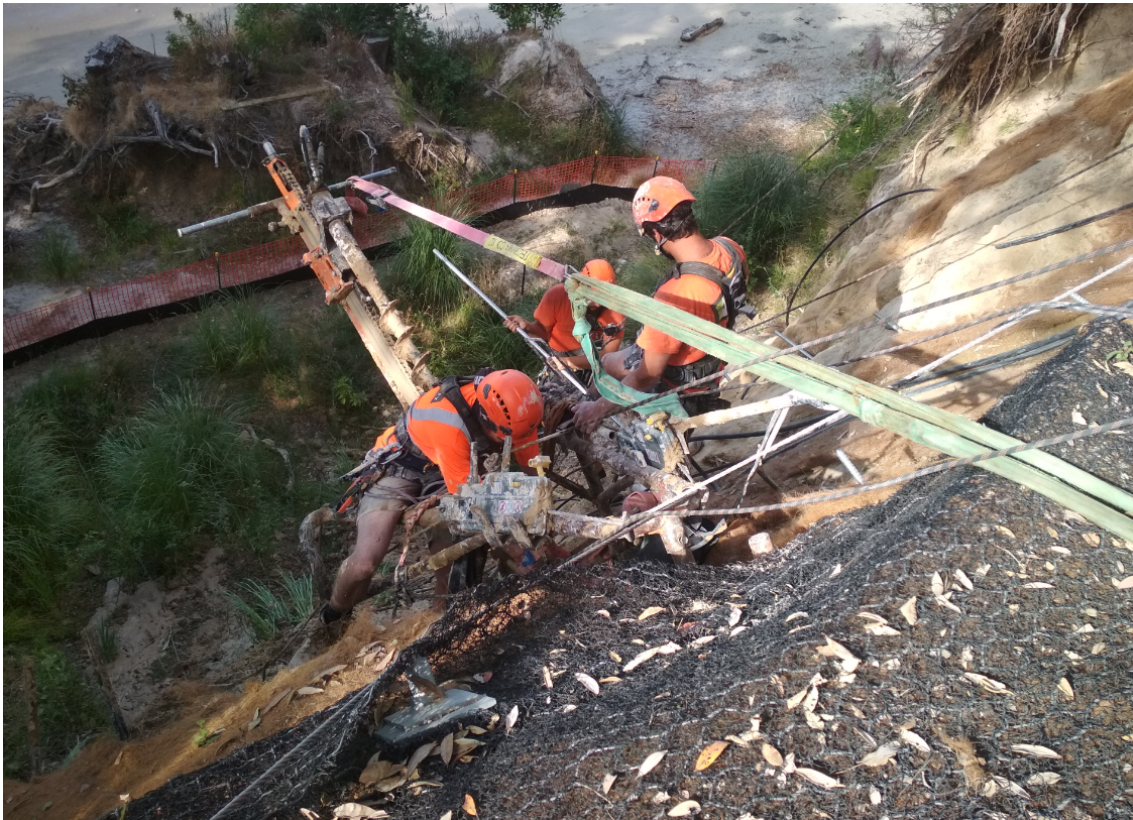
Figure 8:20: Soil Nail Drilling and Abseiling

Soil nails were a large part of the work on the slopes of Mauao at the slip site. In order to work on the lower slope, specialised abseiling sub-contractors were required, and special safety plans were also necessary. Temporary anchors points were installed to allow safe access for drill rig and crew. The proposed anchors consisted of slinging the mature Pohutukawas within the centre of the site, which had been reviewed and deemed suitable by the project's supervising arborist. After mobilisation and equipment setup was complete the drilling locations were marked out, then the drilling and installation of soil nails could commence. The drilling took place by rope access trained drillers and technicians utilising a specialist lightweight Marini drill rig designed for steep gradients, as seen in Fig. 8:20. Grouting was completed with a small Whyte hall grout plant, that could be easily operated by a small team. This grout plant was pneumatically driven. A batcher, a spotter, and a man on the nozzle was required to operate the grouter. Radios were required as they needed visual and audio communication at all times. The soil

nails were tested once the grout had cured to ensure they met specifications (Earth Stability, 2019).

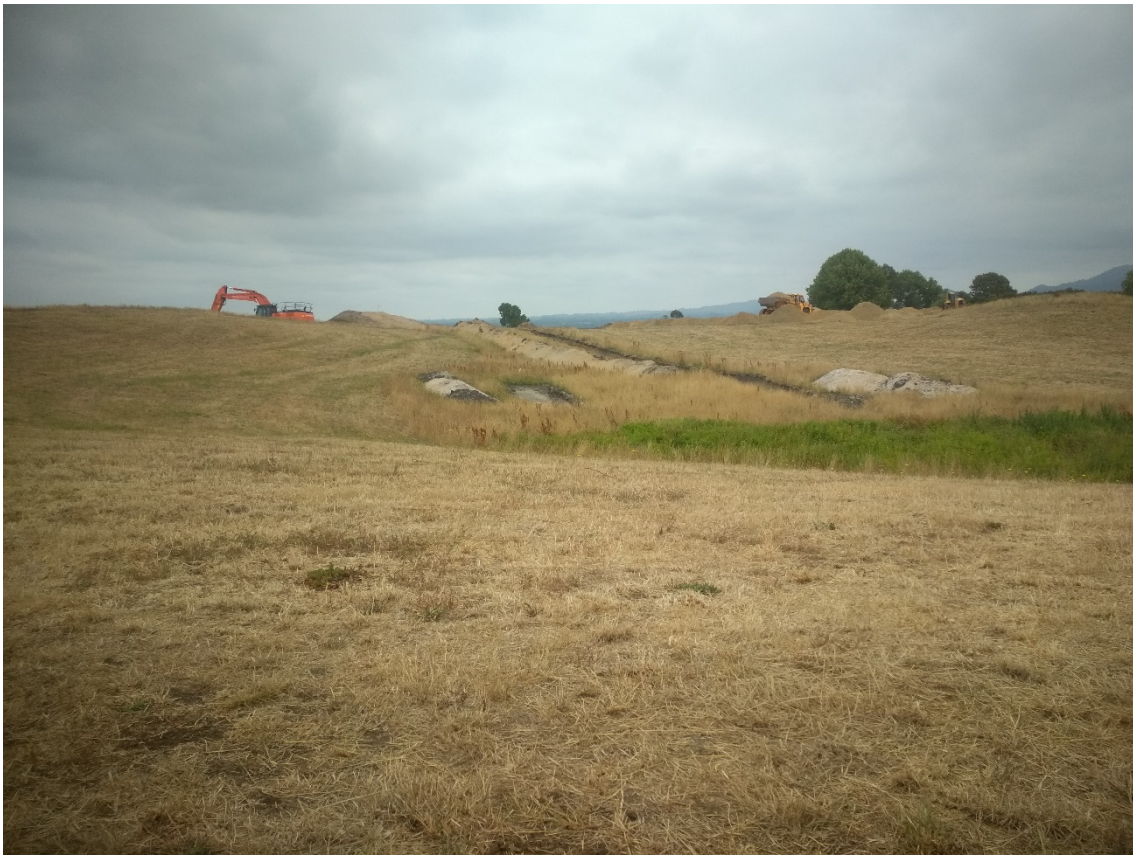
Figure 8:23: Archaeological Digging

The first thing that was required to occur before any digging commenced, was to have an archaeologist check the topsoil. This was required before any bulk earthworks could begin in the area, however, due to the size of the area being excavated the contractors were able to start once the archaeologist moved to another part of the site. That meant the contractors could work at the same time as the archaeologist so long as that area had been examined first.

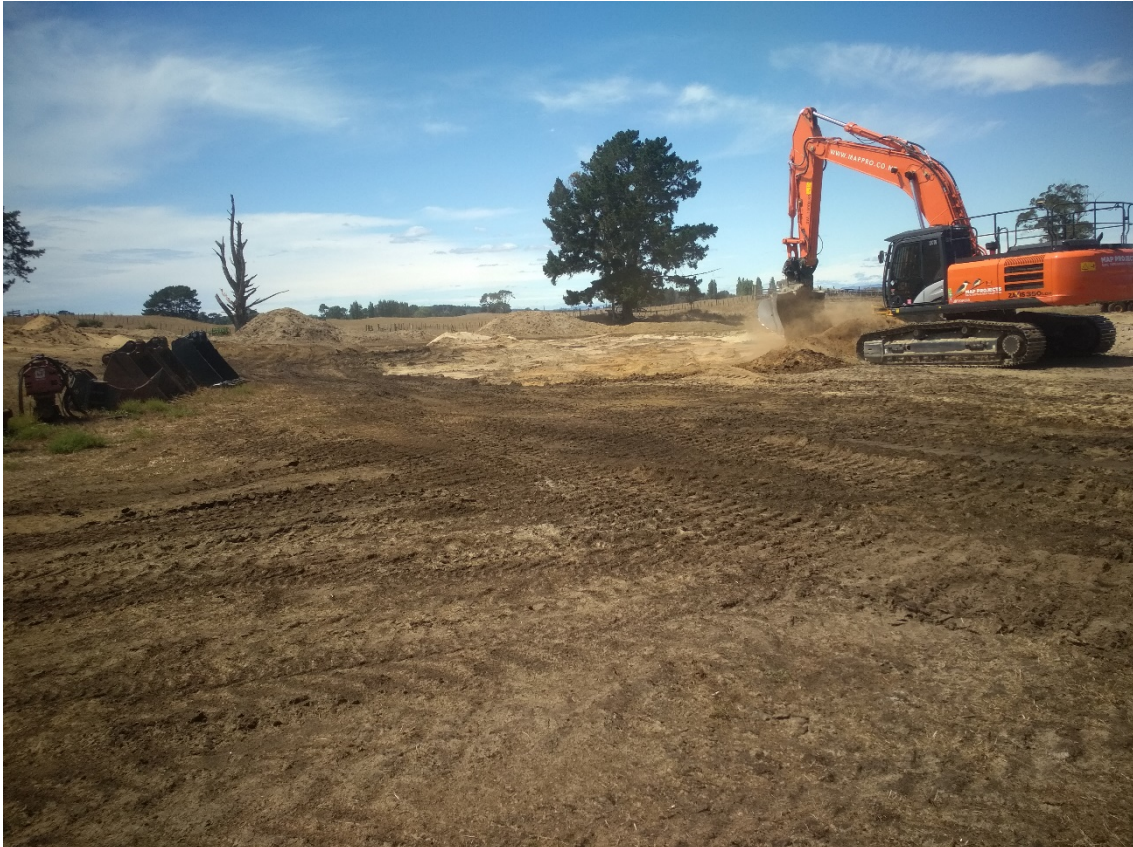
Figure 8:24: Topsoil Stripping

The topsoil strip required iwi monitoring as the works proceeded. Once a section of site was cleared, the topsoil from a section of the swale and a section of the pond was removed. Excavation sites were progressively cleared as to control dust since there would be larger unworked areas where grass would remain until work began there. Initial topsoil strips were carted to the nominated stockpile area and tipped. Topsoil was required to be stacked loosely over 4m high, so it was logical to move the topsoil to the end of the stockpile.

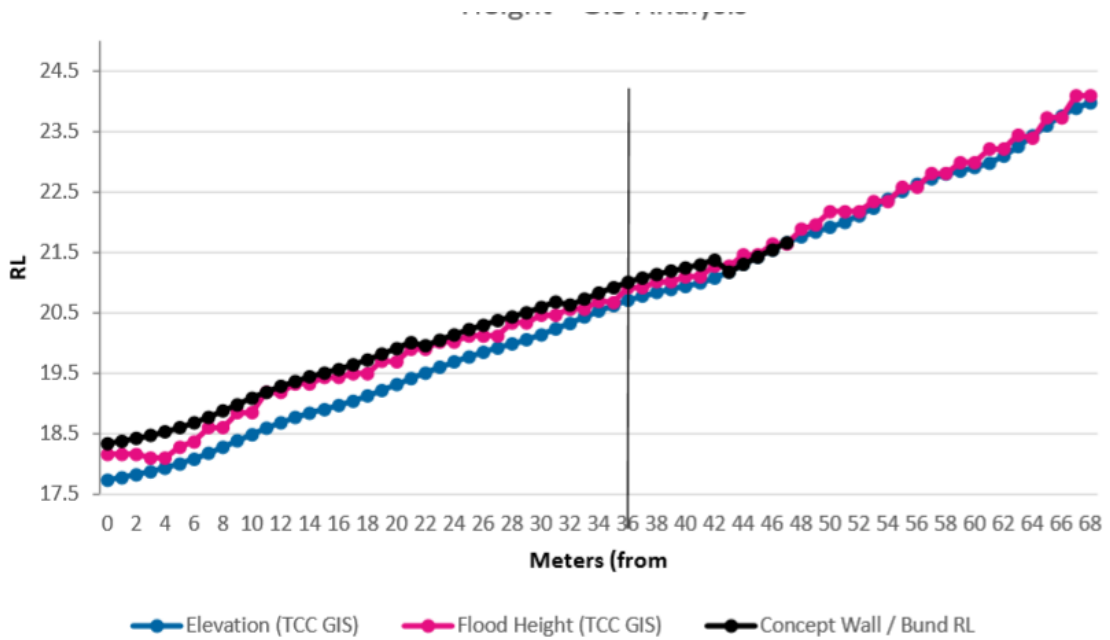
Figure 8:28: Height Analysis

Using the height analysis in Fig. 8:28. it was found that a height of 0.6m was required to divert flow away from the property. This, in turn, would reduce the DxV issue. Figure 8:28. shows the required length of the wall/bund in order to divert the flow. The length would be required to be 35.5 meters, this is only required due to the majority of flow coming from Meander Drive, down the footpath and into the current fence-line below the boundaries intersection. (GHD, 2019)

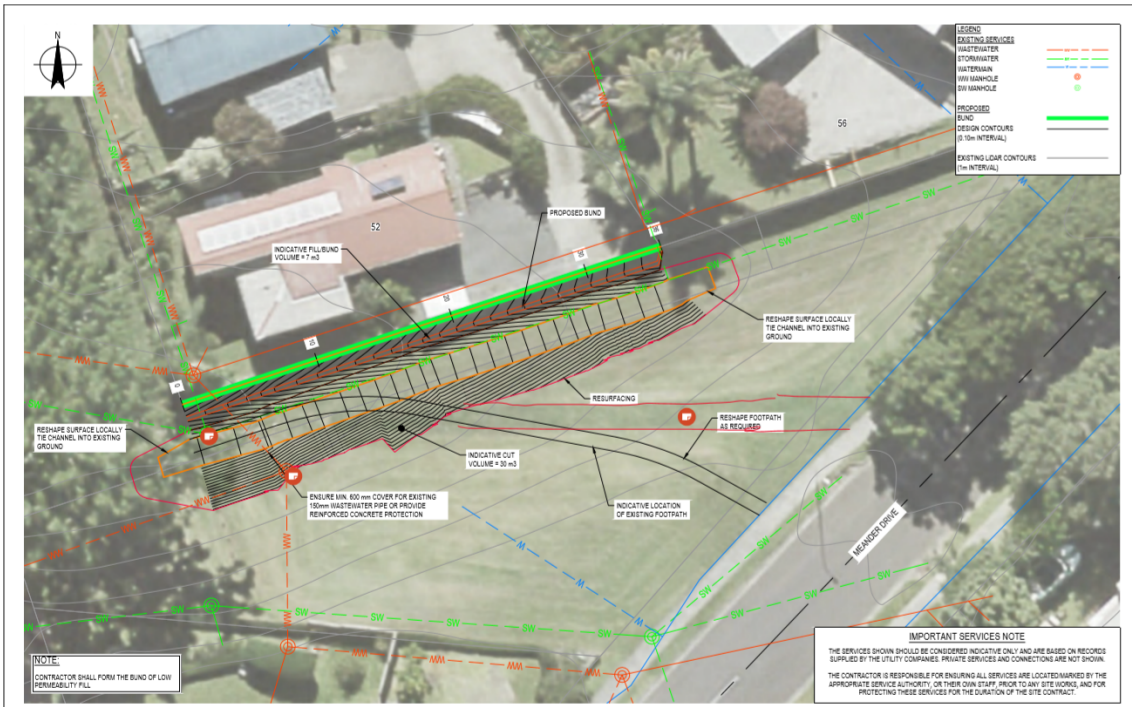
Figure 8:30: Design of Bund and Channel

After the option was chosen, a design was made for the DxV of Meander Drive. It was found that the best way to deal with the issue was to construct both a bund and build a channel to divert the flow of water away from the property fence-line. This is seen in Fig. 8:30. while the cross sections are displayed in Fig. 8:31 and 8:32. One issue in the design, seen in CH 4, shows a high service, which would need to either have enough ground above it, or to be reinforced by concrete. As can be seen by the data in Tab. 8:5. calculated by the manning equation using the data from Tab. 8:6. there is still a flow capacity above 4 cubic meters per second, however, this is on the channel, not at the property.

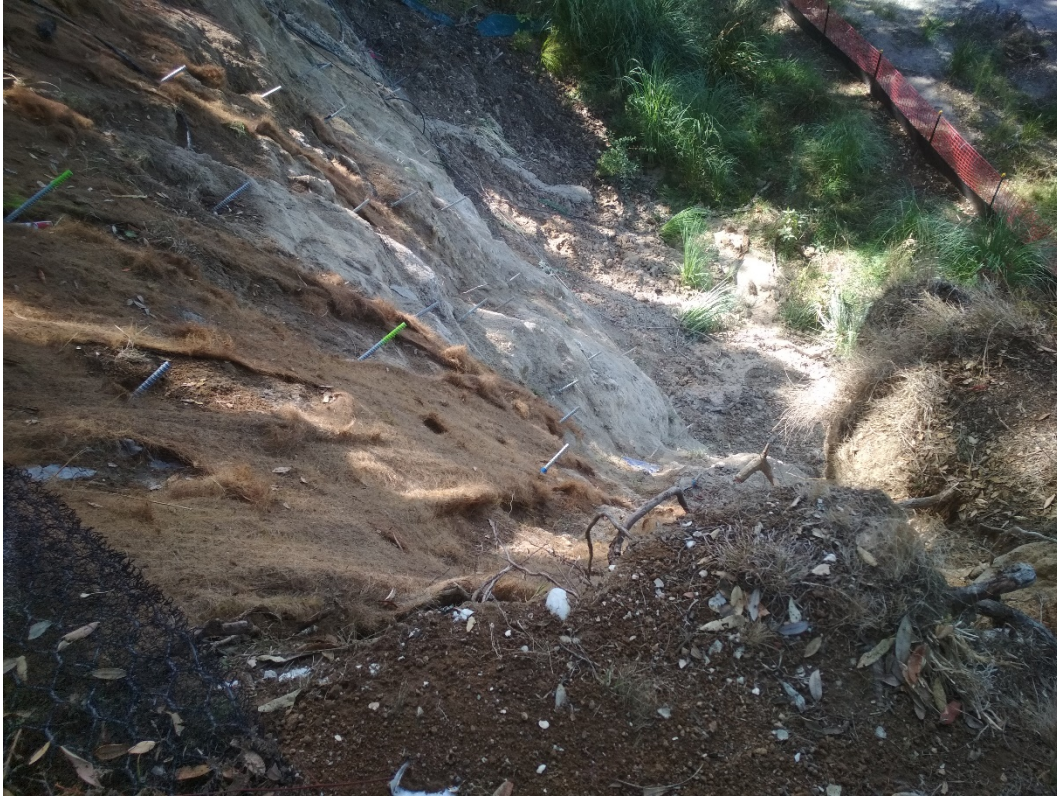
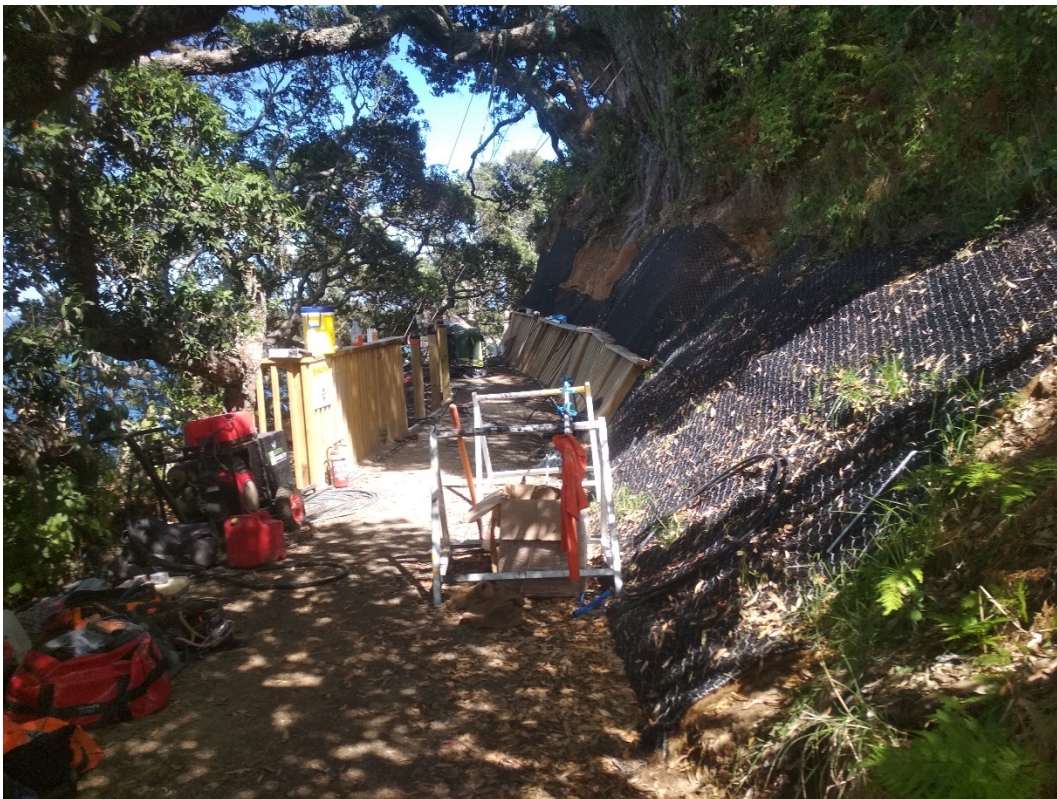
Figure 9:1: Soil Nails in Lower Bank

Figure 9:2: Track and Upper Slope

As can be seen in Fig. 9:1. and 9:2. the work for Mauao is going well. The permanent safety handrails were taken down temporarily in order for the absailers to get down to the lower slope, but it is not difficult to put back. The top slope has been fully drilled, grouted, and matted, and has a very good look ready to be hydroseeded. The bottom slope has nearly 110 nails in it, providing a great amount of structural support to the slope to protect it from a significant event. The track is fully cleaned up and compacted, more than fit for use. It is expected that the track will be finished by the end of February, either the same week, or week after the Student Project Manager finishes.

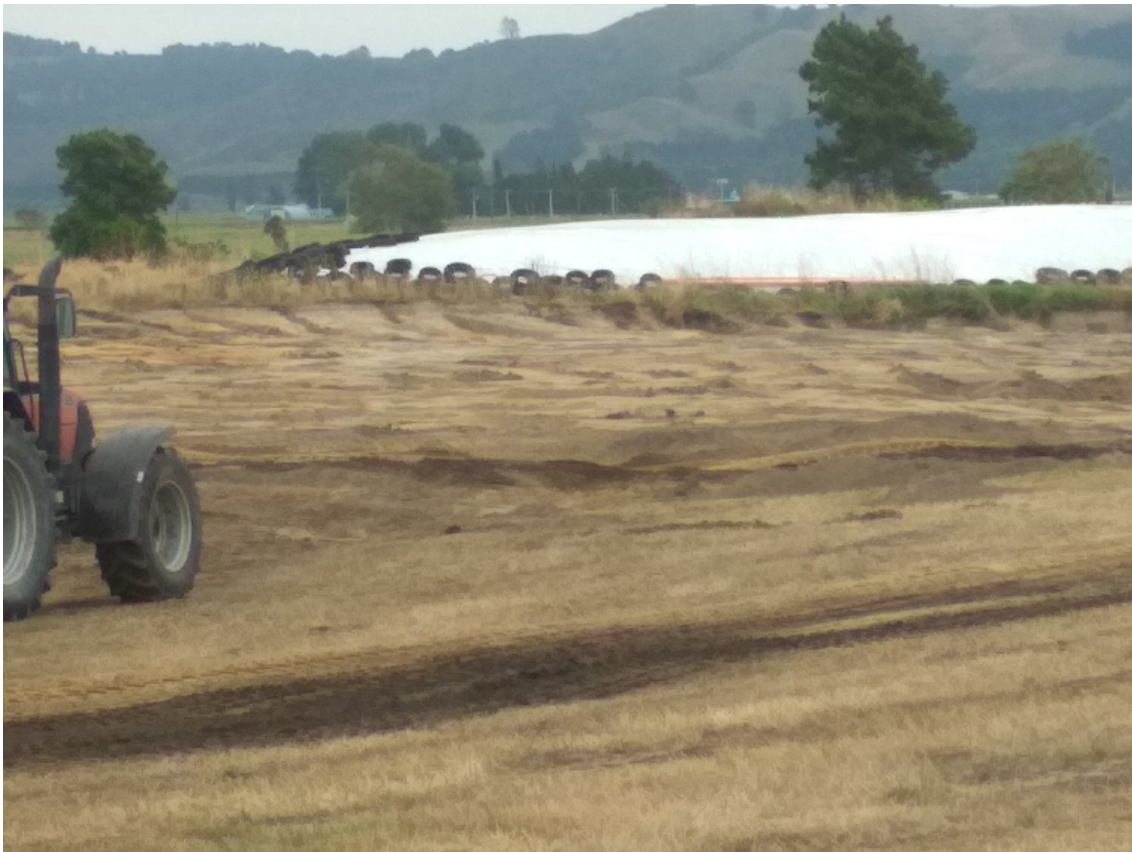
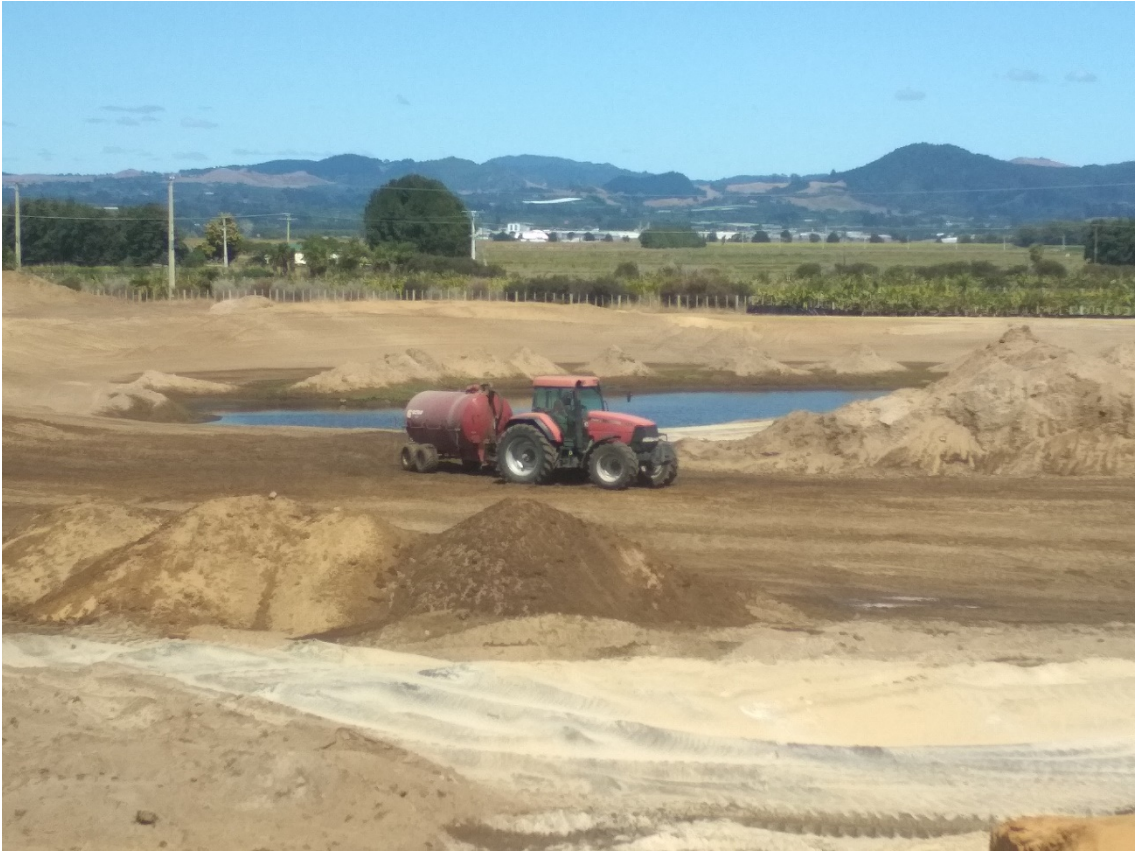
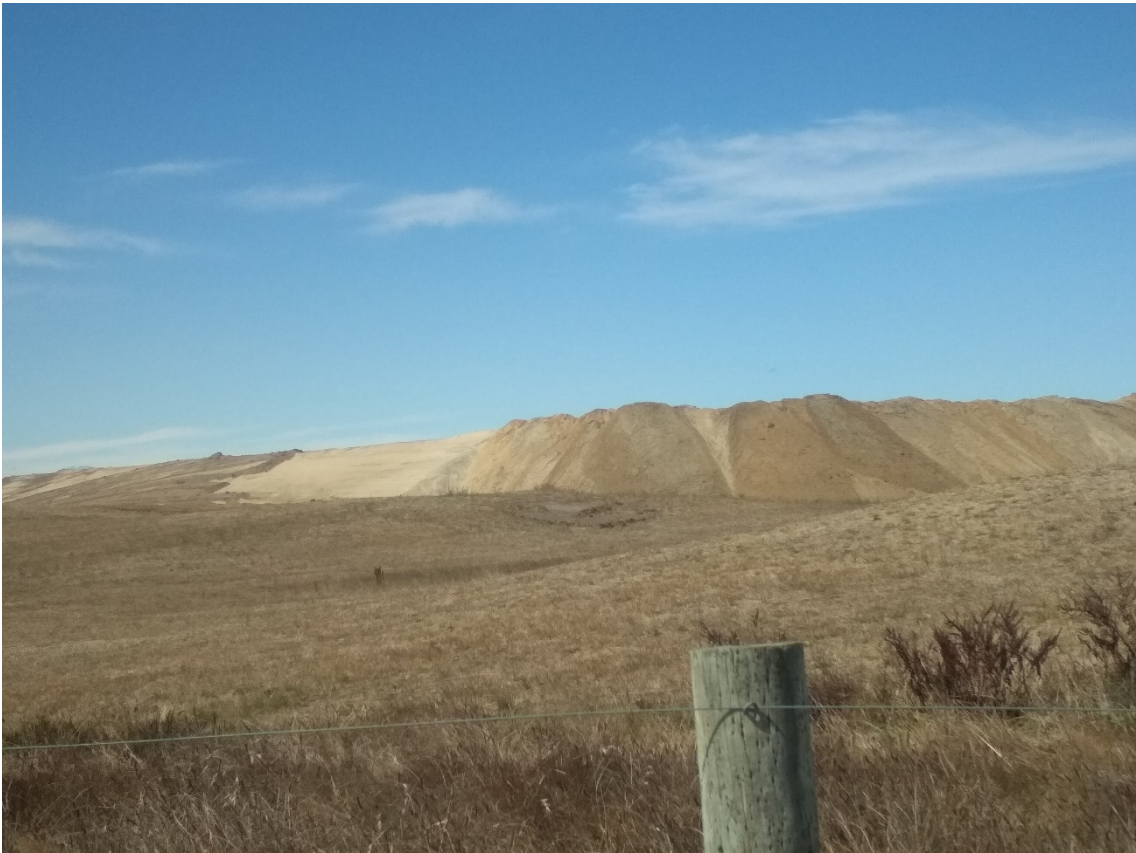
Figure 9:3: Pond G at Start of Works

Figure 9:4: Pond G Currently

Figure 9:5: Pond G Stockpile

The work on Pond G has been going smoothly since physical works started. As far as earthworks are concerned over one third has been completed, and considering the finish date being around August, and starting late January of the same year, the project is more than on track. The differences between Fig. 9:3. and Fig. 9:4. are clear, the previously hilly or flat terrain has transformed into a large excavation where shaping has already begun. Figure 9:5. shows the large stockpile that has been formed so far during the works. It is expected that this stockpile at its largest will be one kilometre long, and six meters high.

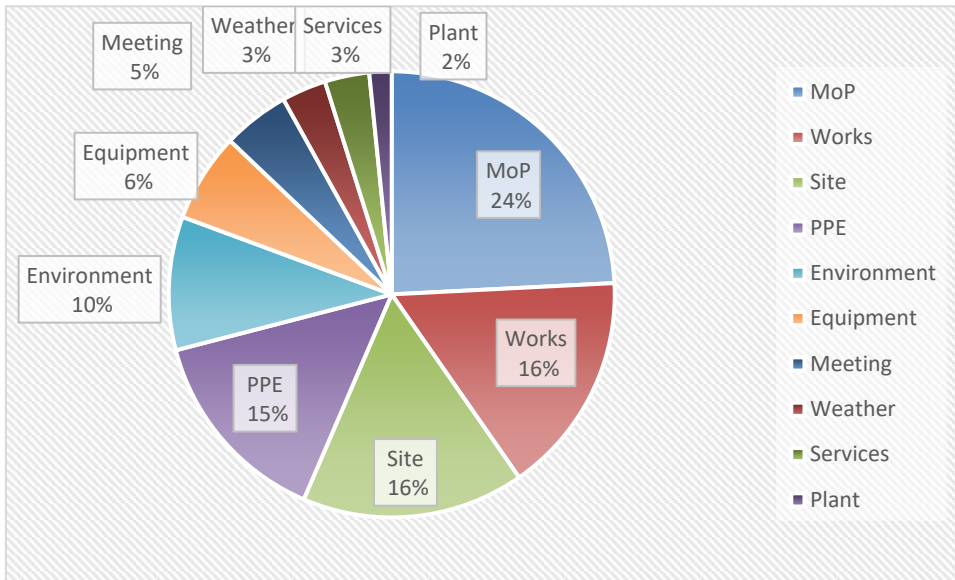
Figure 9:7: Observational Category Numbers

Figure 9:7. shows the respective amount of reports depending on the event. It can be seen from this pie chart that almost a quarter of the reports were on the members of public, with works, site, and ppe making up around 15-16% each, while equipment, meeting, weather, services, and plant are rather low. This can be explained by a lot of these lesser categories often being more likely to be involved in near misses and up, such as services and plant, or simply that they are not reported a great deal, such as meetings and weather. This pie chart gives a good deal of information about how much each event occurs on an observational basis on a job site.

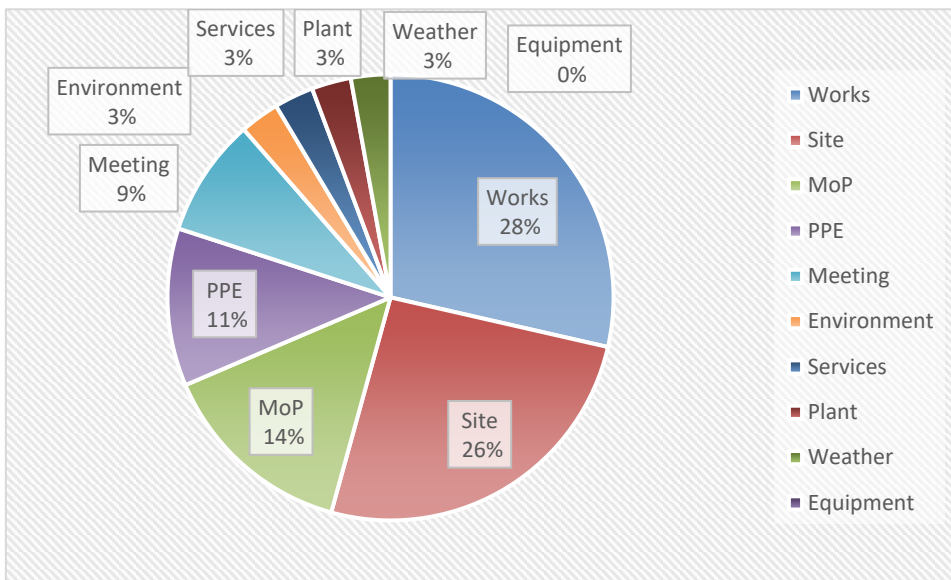
Figure 9:8: Positive Observation Events

By looking only at the positive events, like in Fig. 9:8. it can be seen that most positive reports are from the site, and works. This is often due to site inspections and walk

throughs, where a representative would see people working well, that the site has well cordoned off hazards, and people are following correct health and safety procedures.
