GEOTECHNICAL INVESTIGATION REPORT

PROPOSED ALTERATION

**1 ADAMS AVENUE,
MOUNT MAUNGANUI**

Reference: TL488
Prepared: 19 February 2020
Issued to: Tauranga City Council
Attn:

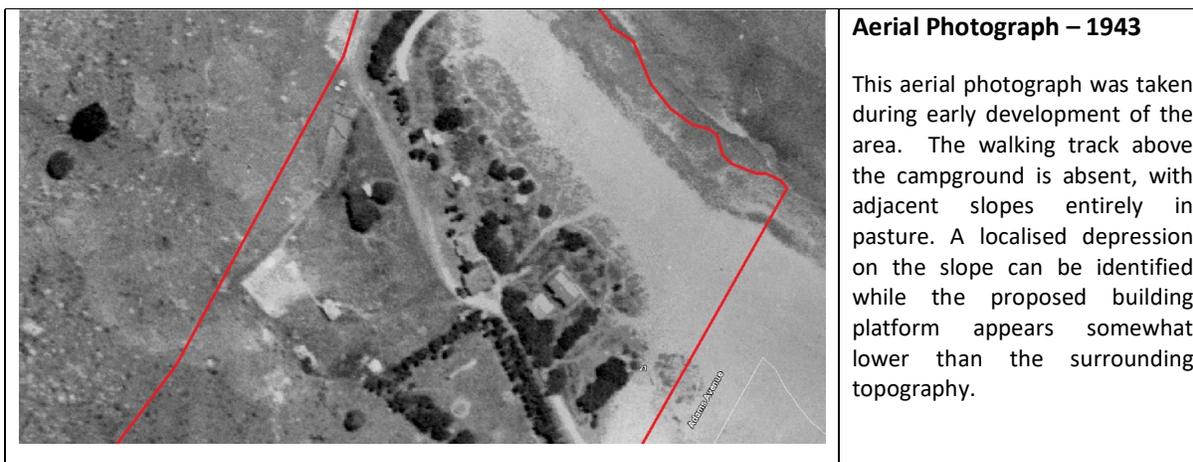
2.1 Historical Aerial Photographs

| | <p>Aerial Photograph – 1977</p> <p>This aerial photograph shows the established campground. The walking track above the campground has been formed, with adjacent slopes still in pasture. A localised depression on the slope appears to have failed at some stage post 1943. The amenities block has been constructed with ground surface presumably raised as part of the development.</p> |
| | <p>Aerial Photograph – 2011</p> <p>This aerial photograph shows the amenities block has been replaced and/or extended to the north. A retaining wall has been constructed to the east of the building forming a lower and upper level camping sites. Vegetation has been established along the lower part of the slope.</p> |
| | <p>Aerial Photograph – 2019</p> <p>This aerial photograph shows the campground in its current form. Vegetation is being further established over the lower slope where the previously reference recent instability was observed.</p> |

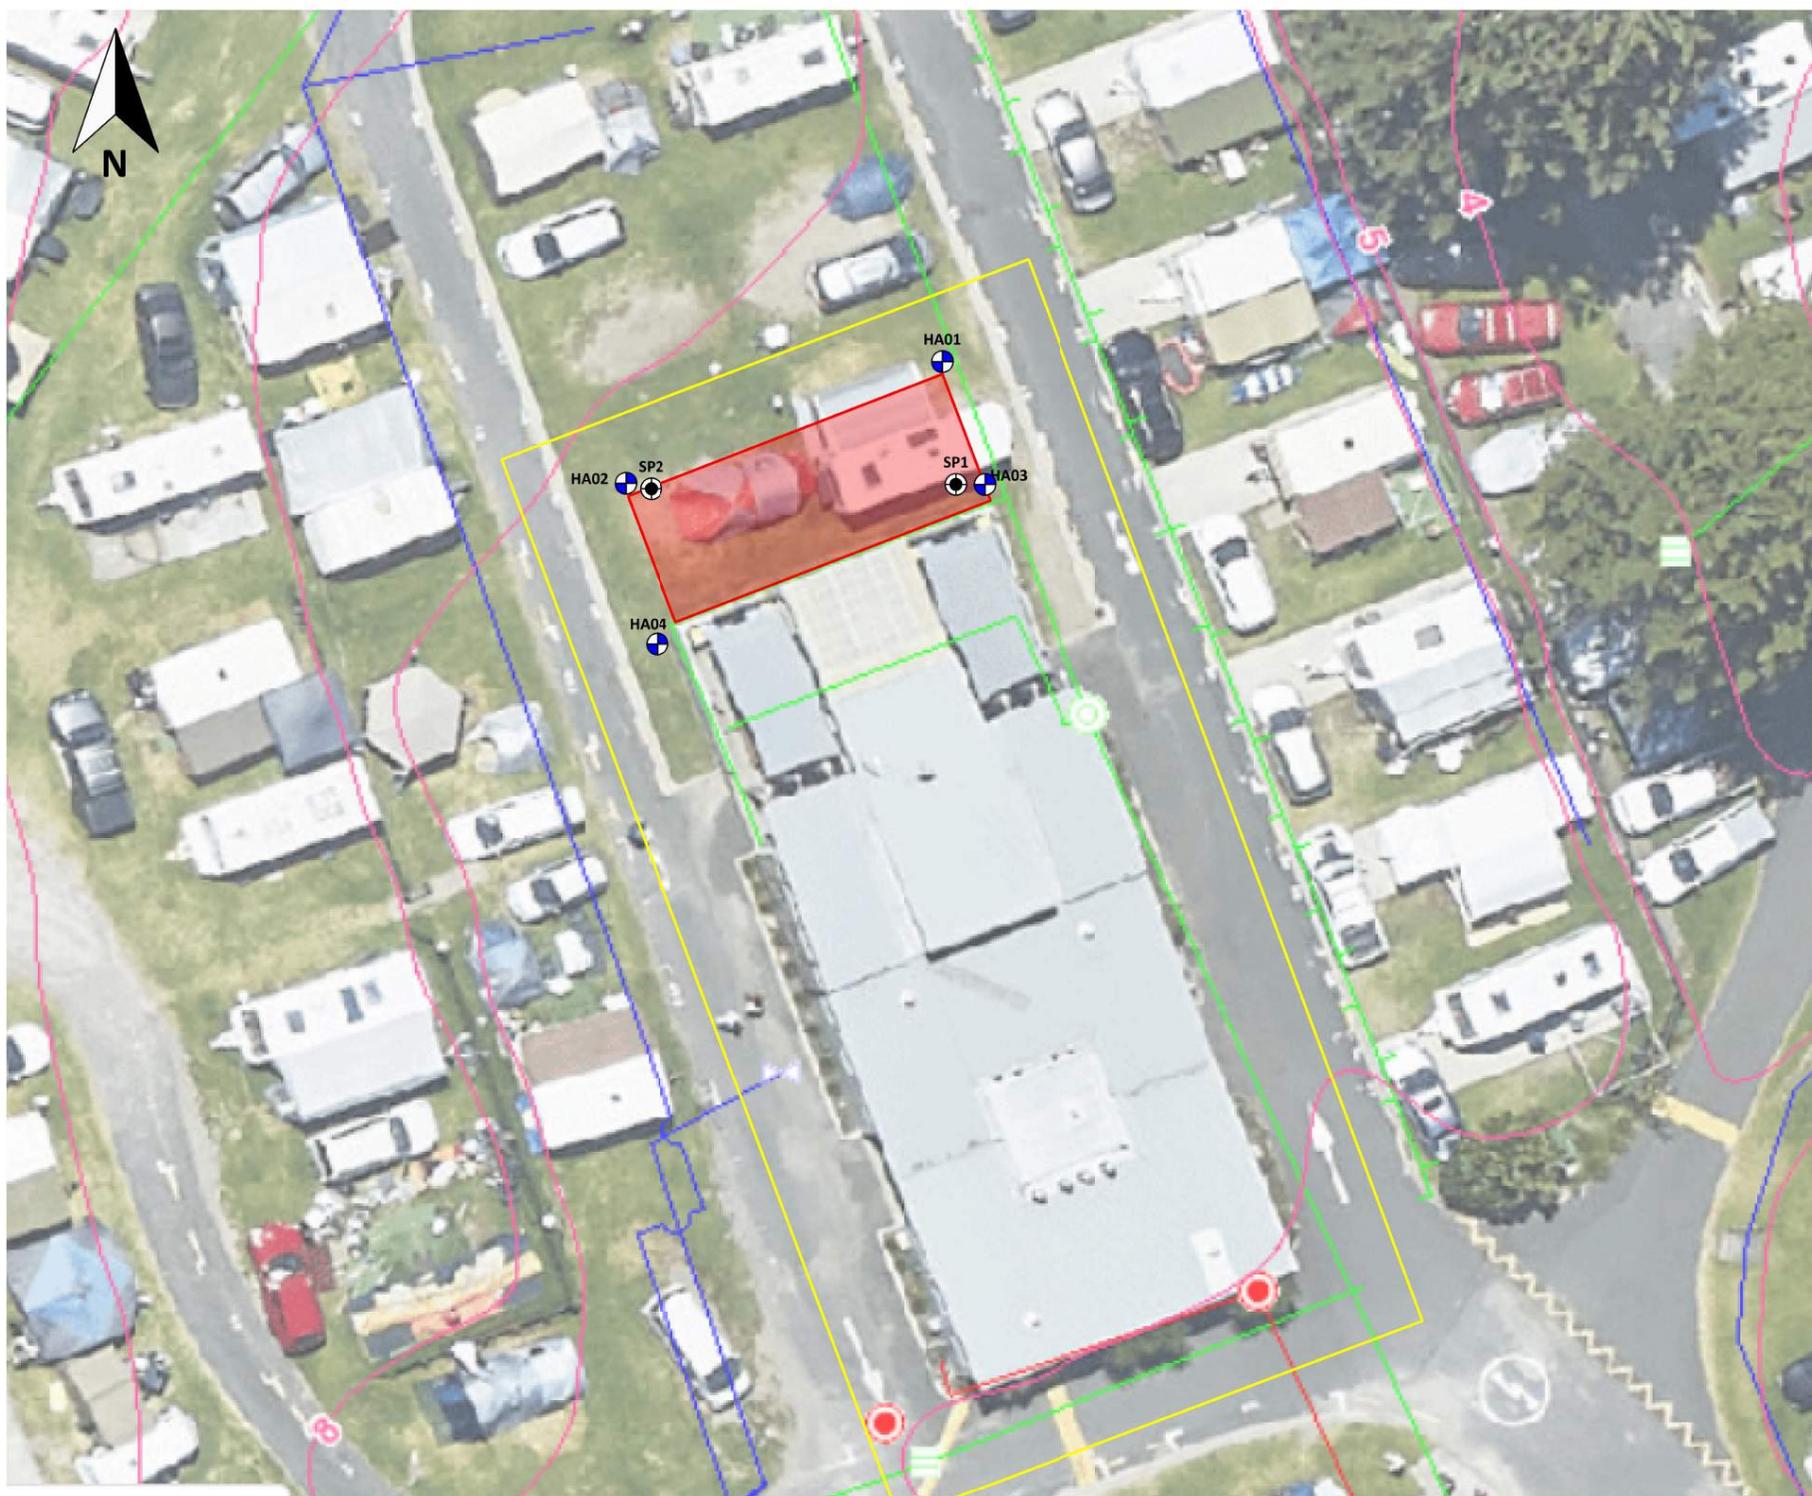
Notes:

1. LOCATIONS OF ALL FEATURES ARE APPROXIMATE ONLY.
2. THIS DRAWING IS BASED ON TAURANGA COUNCIL GIS PHOTOGRAPHY.
3. DRAWING NOT TO BE USED FOR CONSTRUCTION PURPOSES.

A site plan is attached, drawing number TL488/1.

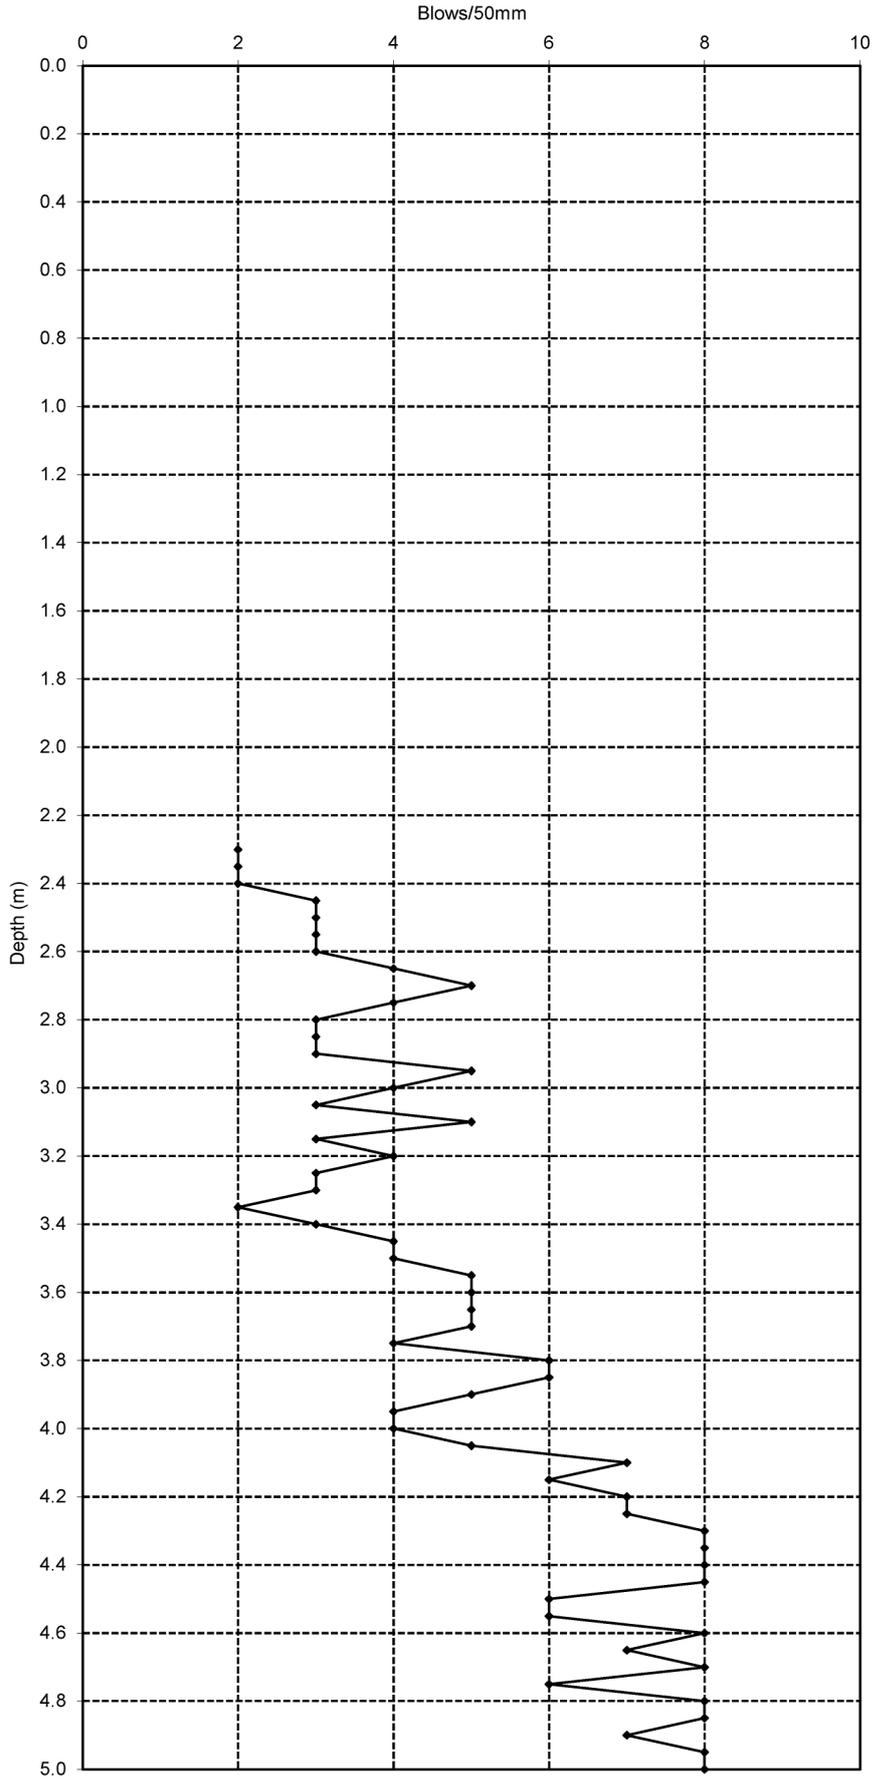
SCALA PENETROMETER TEST PROBE
