Boffa Miskell Limited  
Mauao Base Track Remediation  
Geotechnical Design Report

October 2018

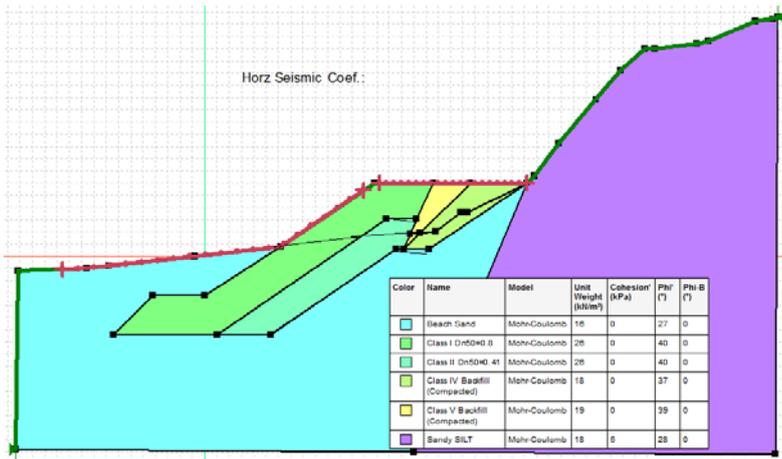
Figure 1 Full Depth Revetment -3.23MSL

- Full depth revetment design to -3.23MSL (assuming no boulders encountered at depth)
- Alternative revetment toe design to -1.0MSL (assuming boulders encountered approximately 2m below current sand level based on Scala Penetrometer information.)
- Eroded beach profile design (full depth revetment toe at -3.23MSL with sand level eroded to top of primary armour rock -1.6MSL)

Figure 1, 2 and 3 below present the three different ground models.

Figure 1	Full Depth Revetment -3.23MSL.....	5
Figure 2	Alternative Revetment design -1.0MSL .....	5

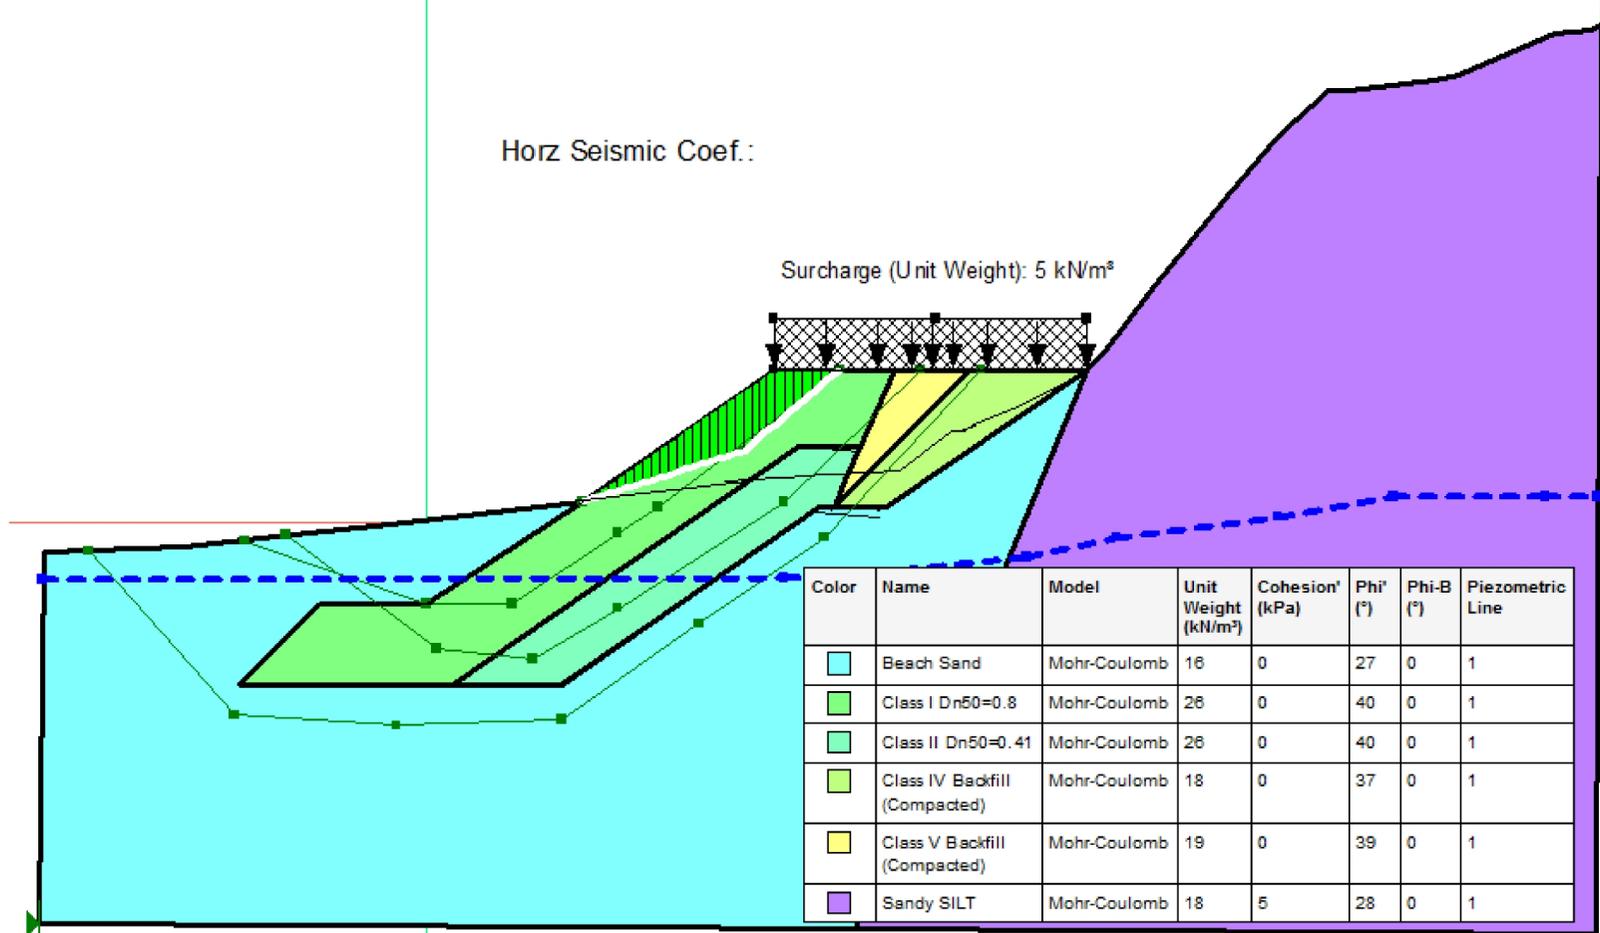
Notes:

- Showing critical slip circle

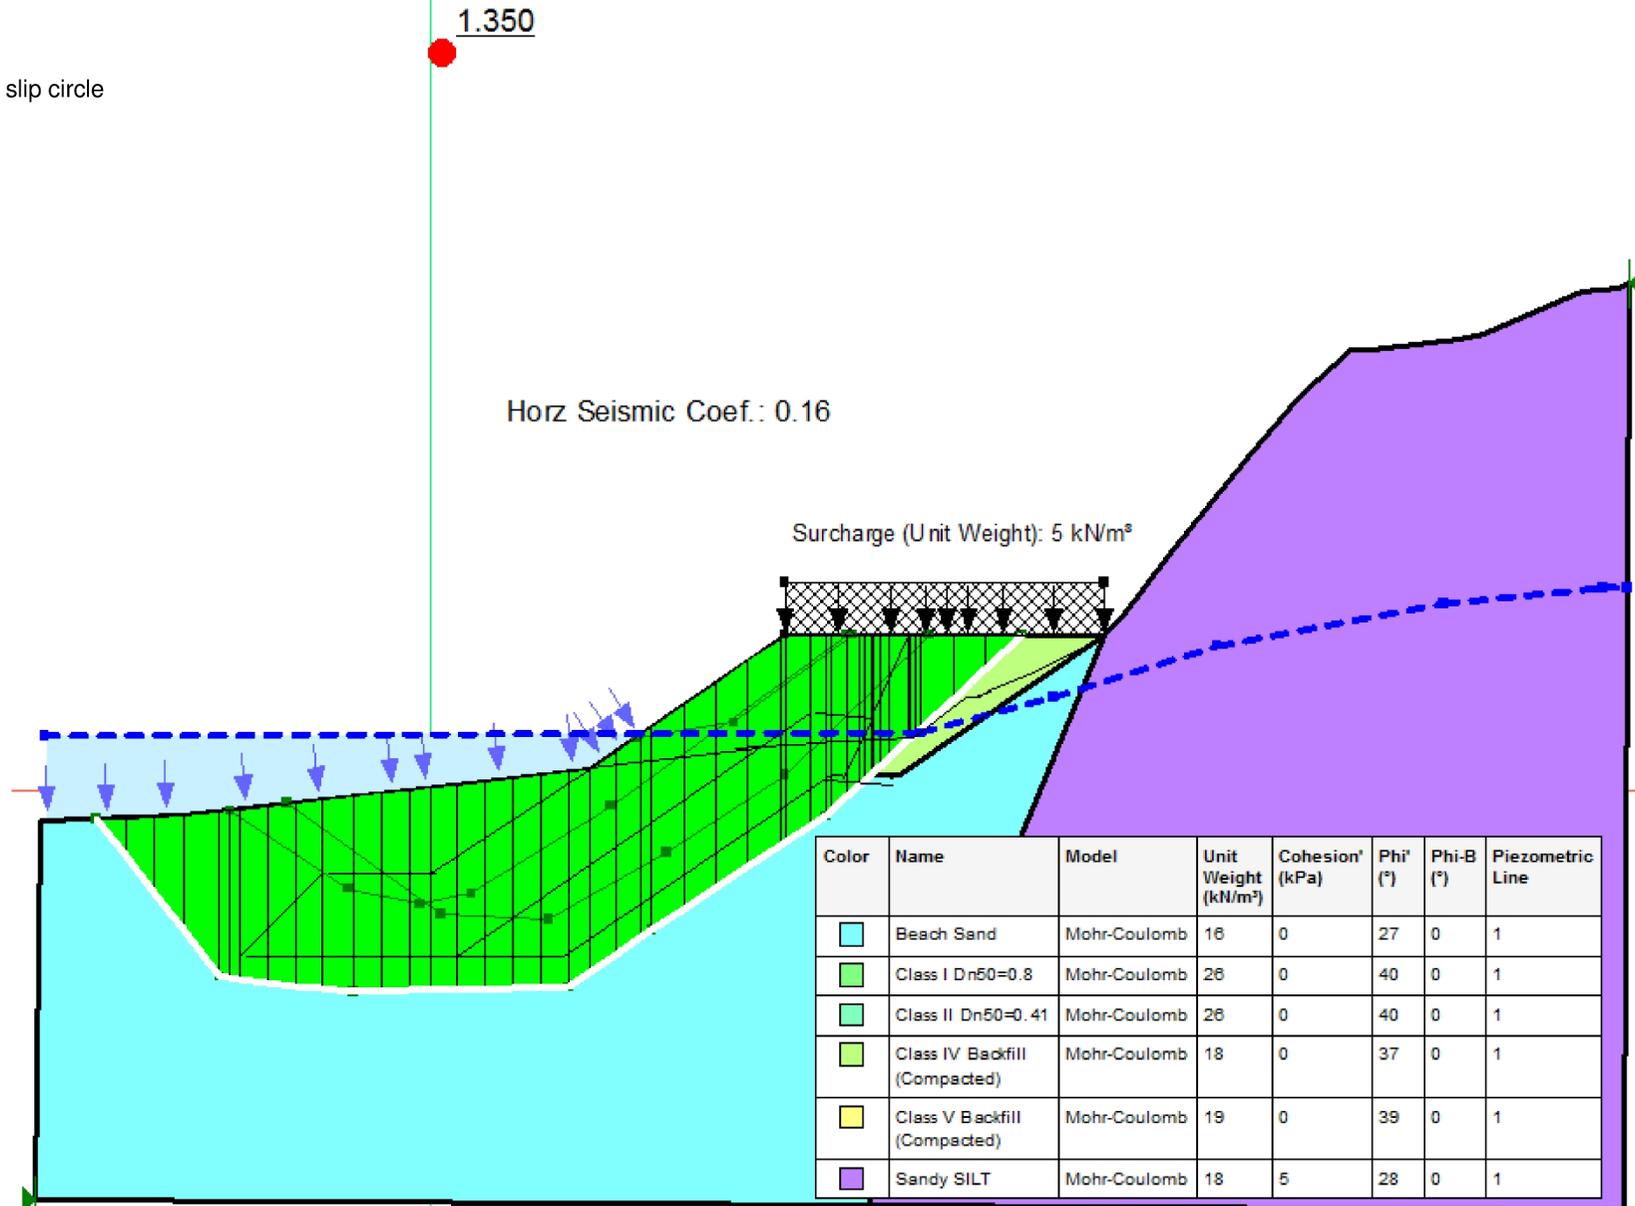
Client:			GHD Centre Level 3 27 Napier Street Freemans Bay Auckland 1011 Ph: (09) 370 8000 Fax: (09) 370 8001	Project:	<b>Mauao Base Track Remediation</b> Section C' – Full Depth Revetment Earth Quake – High Tide				
		Issued For:	Revetment Design	Project Number:	51-37691	Sheet Number:	GEO 03	Issue:	01

Horz Seismic Coef.: 0.16

Surcharge (Unit Weight): 5 kN/m<sup>3</sup>

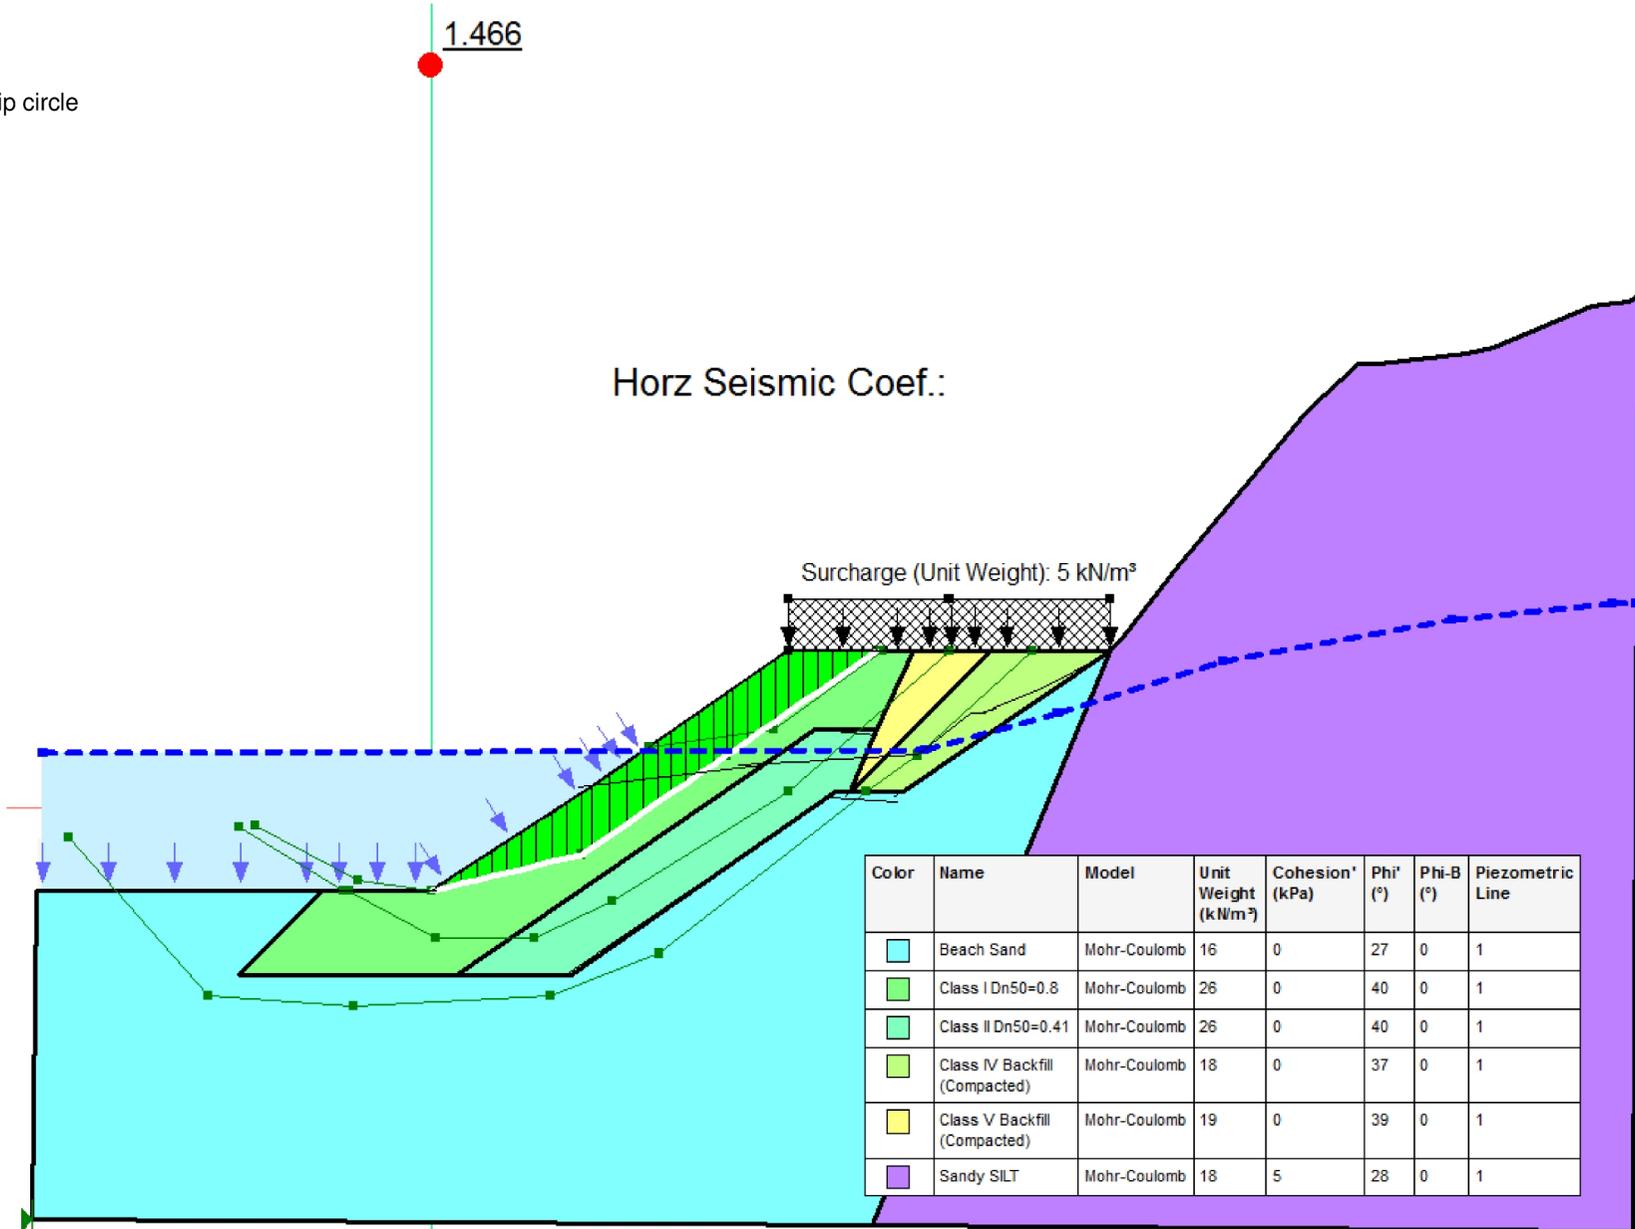
Notes:

- Showing critical slip circle

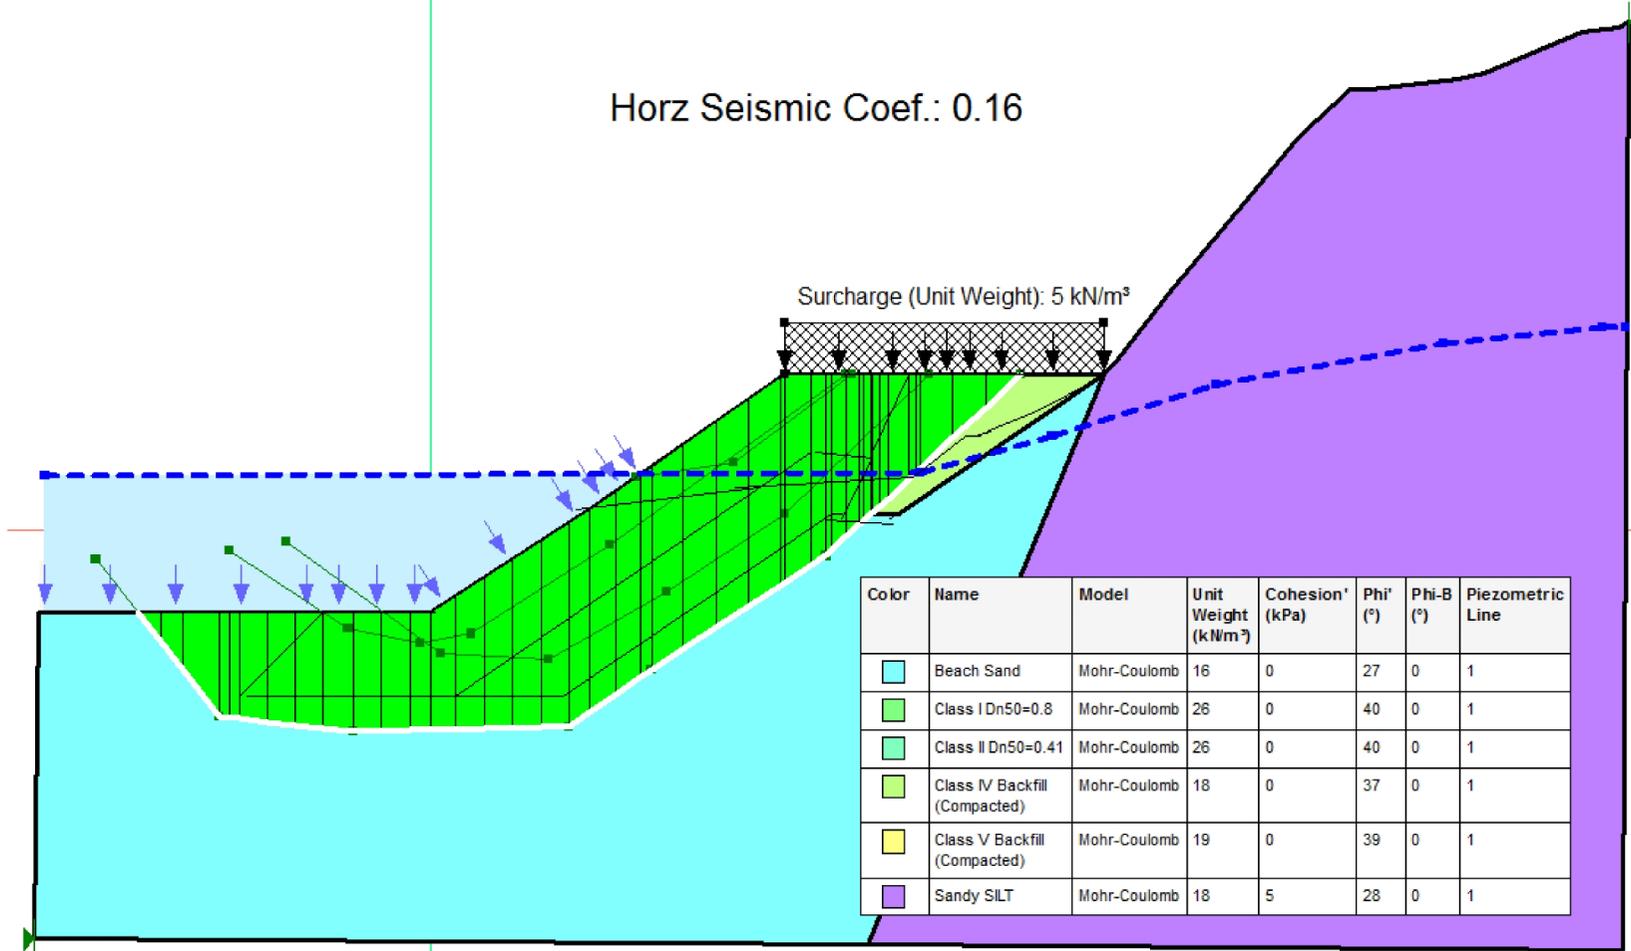
Horz Seismic Coef.: 0.16

Surcharge (Unit Weight): 5 kN/m<sup>3</sup>

Client:	Boffa Miskell	GHD Centre Level 3 27 Napier Street Freemans Bay Auckland 1011 Ph: (09) 370 8000 Fax: (09) 370 8001	Project:
<b>Mauao Base Track Remediation</b> Section C' – Eroded Beach Profile Earth Quake – High Tide			
Issued For:	Revetment Design	Project Number:	51-37691
Sheet Number:	GEO 11	Issue:	01
