Mauao Track Safety issue.

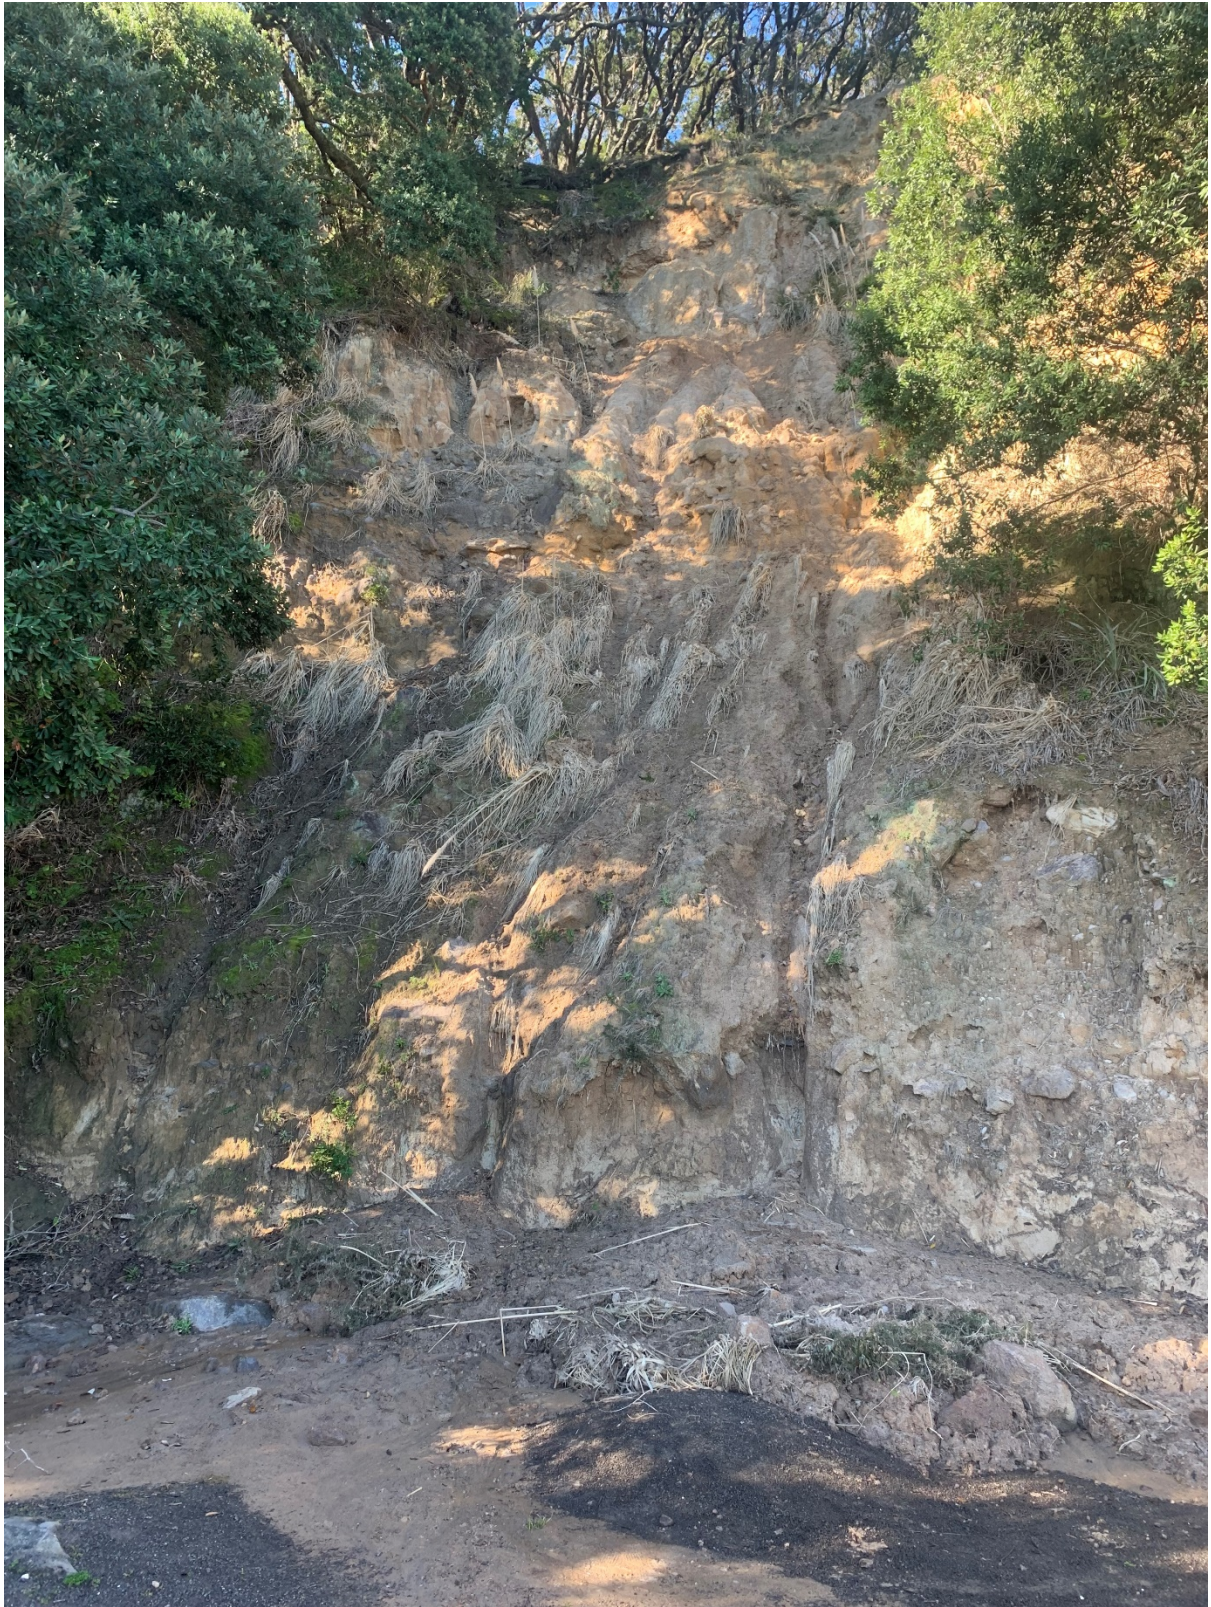
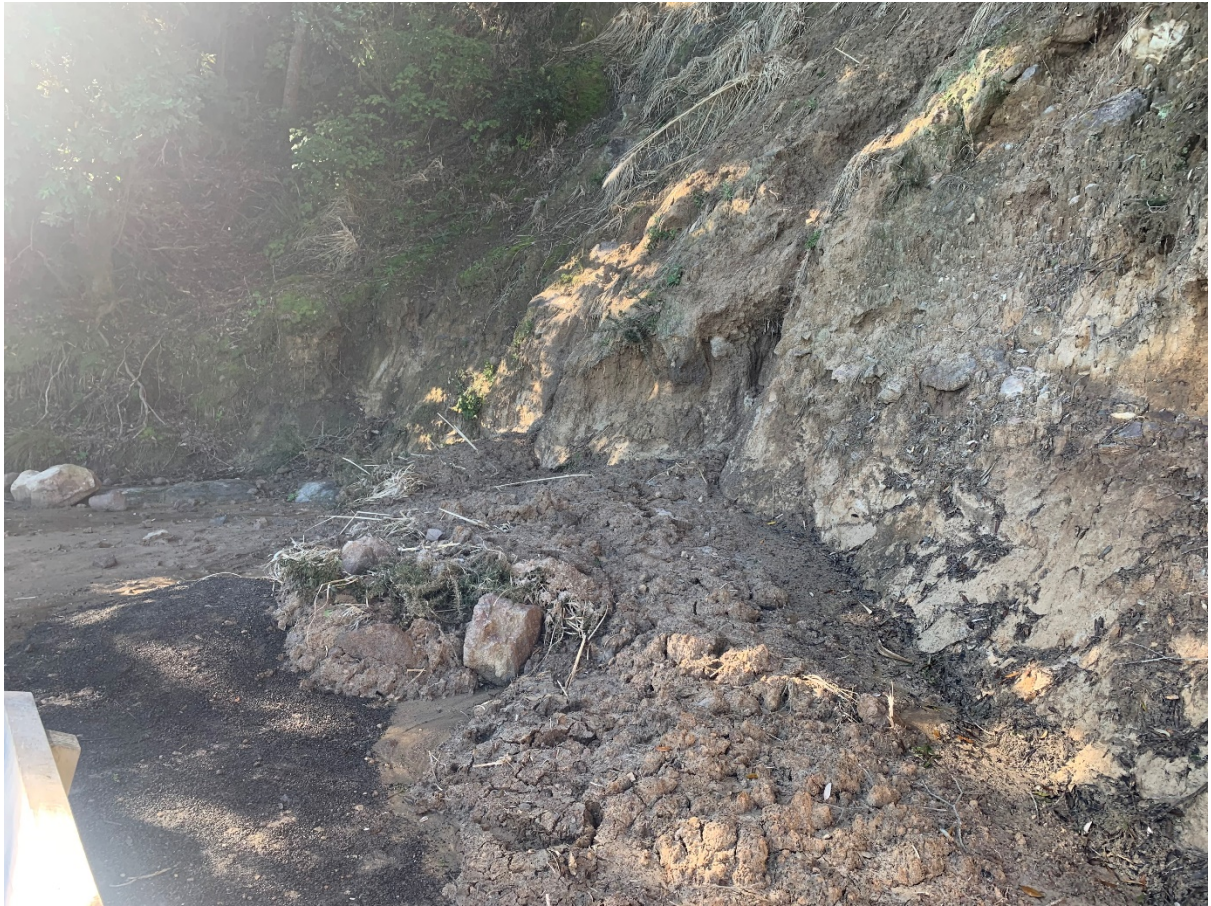
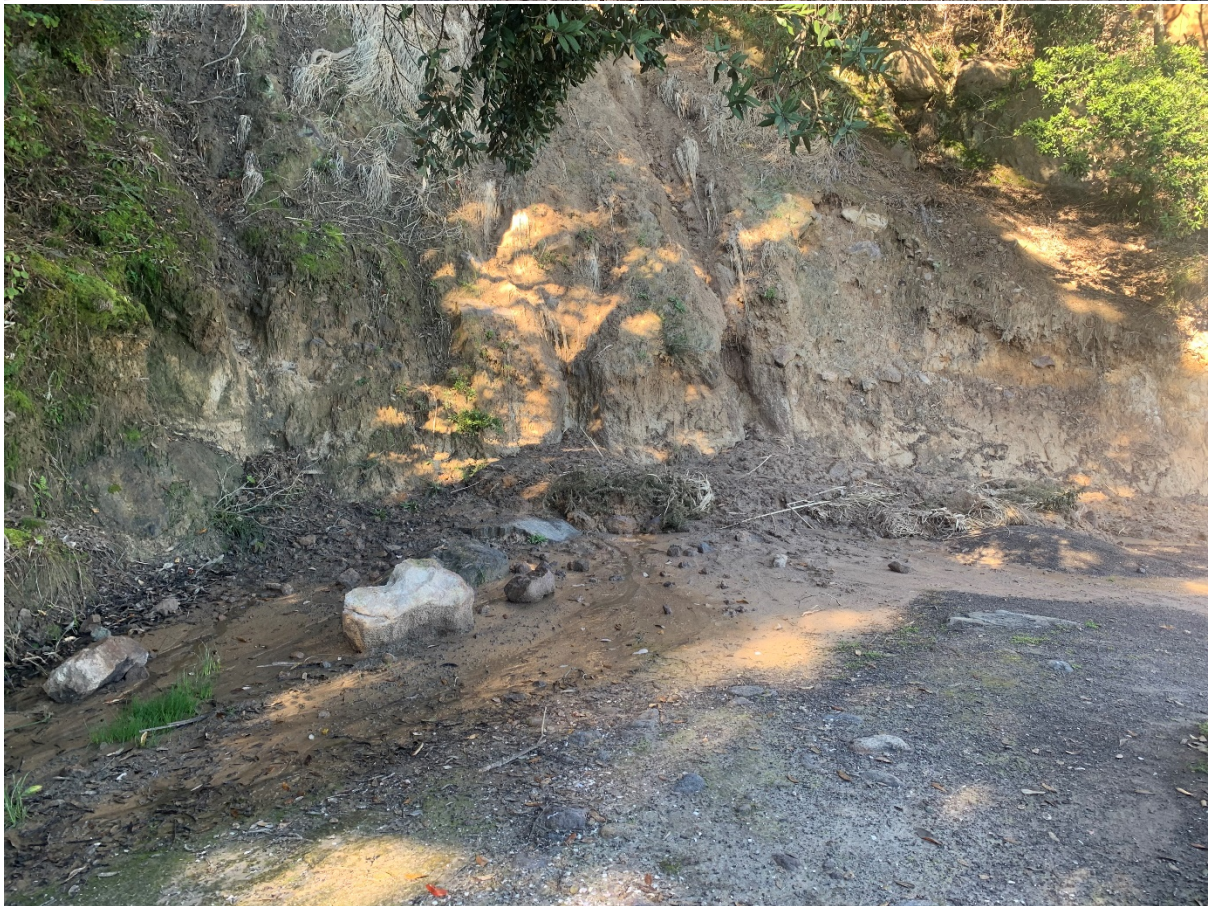
As the s 7(2)(f)(ii) I have become aware of a worsening situation in relation to an old slip site near Te Kuia rock on Te Ara Tūtanga track.

The face of this slip is steep, and amount of material regularly being dislodged is increasing with severe weather events.

This material being released from the face of the slip is reaching the track and creating an active hazard for people walking below.

Furthermore, the bottom of the slip meets Te Ara Tūtanga at a cultural significant site (Te Kuia Rock), and there are aspirations to have this site interpreted. Interpretations at this site would naturally see users spend more time at this site, increasing their risk factor.

To ensure ongoing public safety and to facilitate the aspirations of the Mauao Trust, its recommended that an engineered catch-wall is designed and constructed to stop any migrating material from reaching the track.
