InSitu Heritage Ltd.

24 February 2012

**REPORT ON ARCHAEOLOGICAL AUTHORITY No. 2012/486:
ORUAHINE TRACK REPAIRS, MAUAO HISTORIC RESERVE,
MT MAUNGANUI**

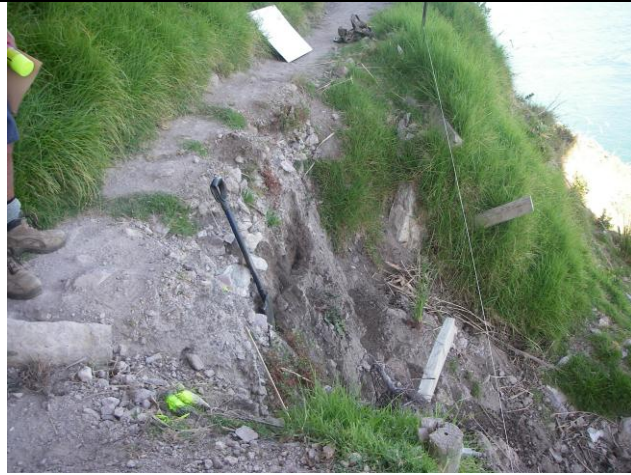
Photo 1 Oruahine Track repair work site prior to removal of existing track bed and slip debris.

On 7 February 2012 prior to any ground disturbance being undertaken, I visited the site and briefed the contractors that were engaged by Tauranga City Council to complete the work. It was immediately apparent that it was highly unlikely that intact archaeological deposits would be encountered during the proposed work. The work area was entirely confined to either previously disturbed ground, consisting of land slip debris and the existing walking track bed, or the natural rock substrata.

The only material that could possibly be interpreted as being of archaeological origin were occasional fragments of marine shell present in the track fill material under the existing track bed. However, as marine shell has previously been extensively used to surface walking tracks within the reserve it was impossible to determine the source of the shell.

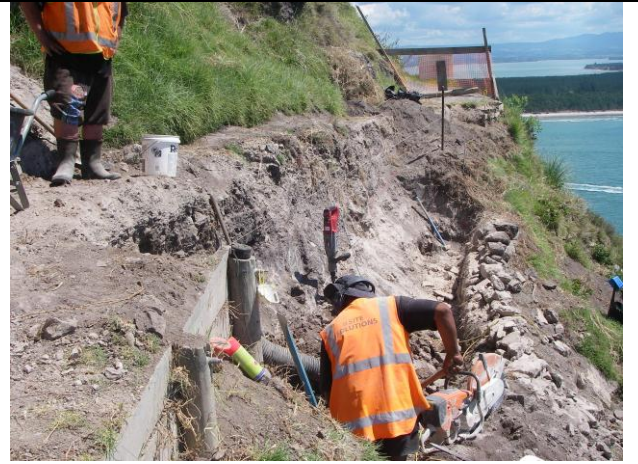
Photo 2 Oruahine Track repair work site after removal of existing track bed and slip debris. Rock substrata in process of being excavated.

On 9 February 2012 I carried out a second site visit as the track fill and slip debris material had been removed and the contractors were at the stage of excavating the rock substrata using a mechanical cutting saw and a rock drill. No further ground disturbance within any area likely to contain any archaeological material was proposed. No archaeological material was encountered during the removal of the track fill material and slip debris. I have attached photography illustrating the work area.
