Mauao Track Safety issue.

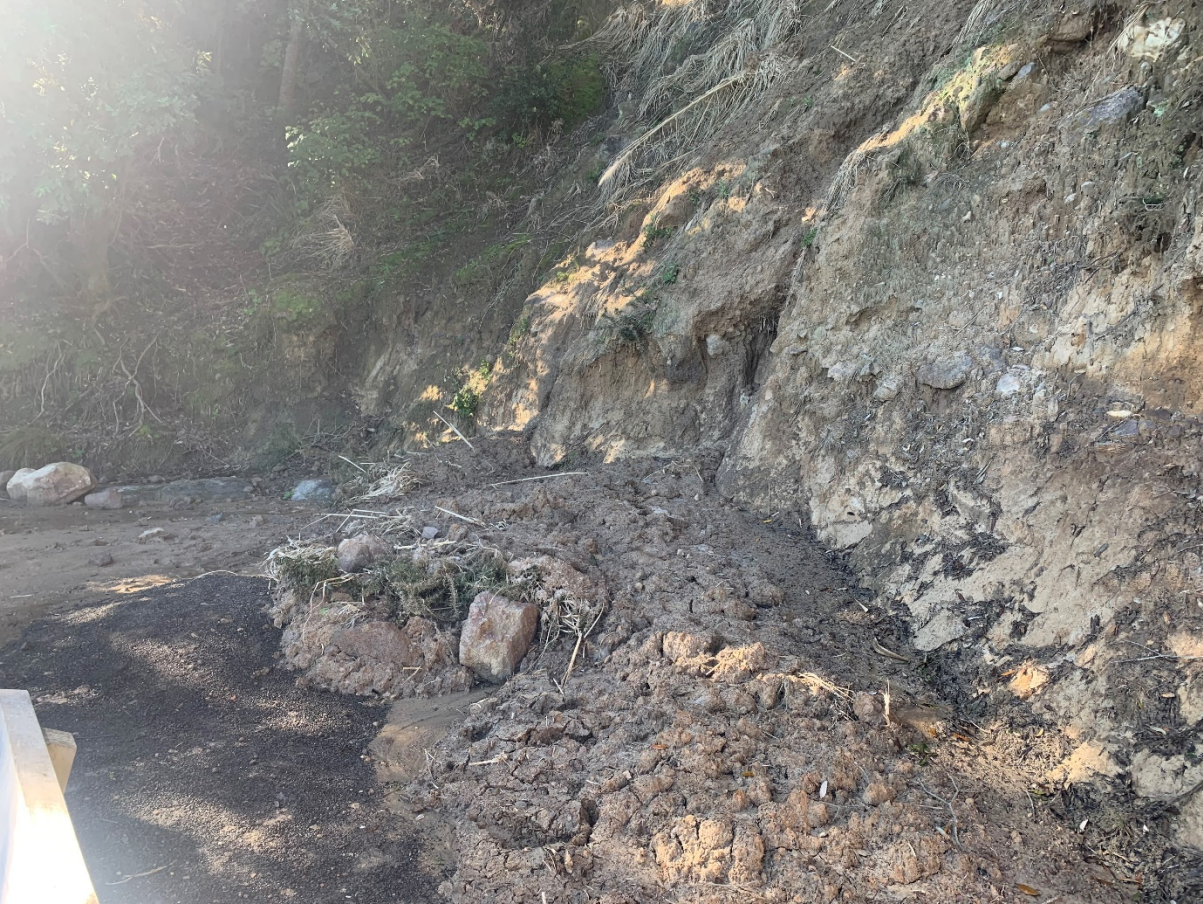
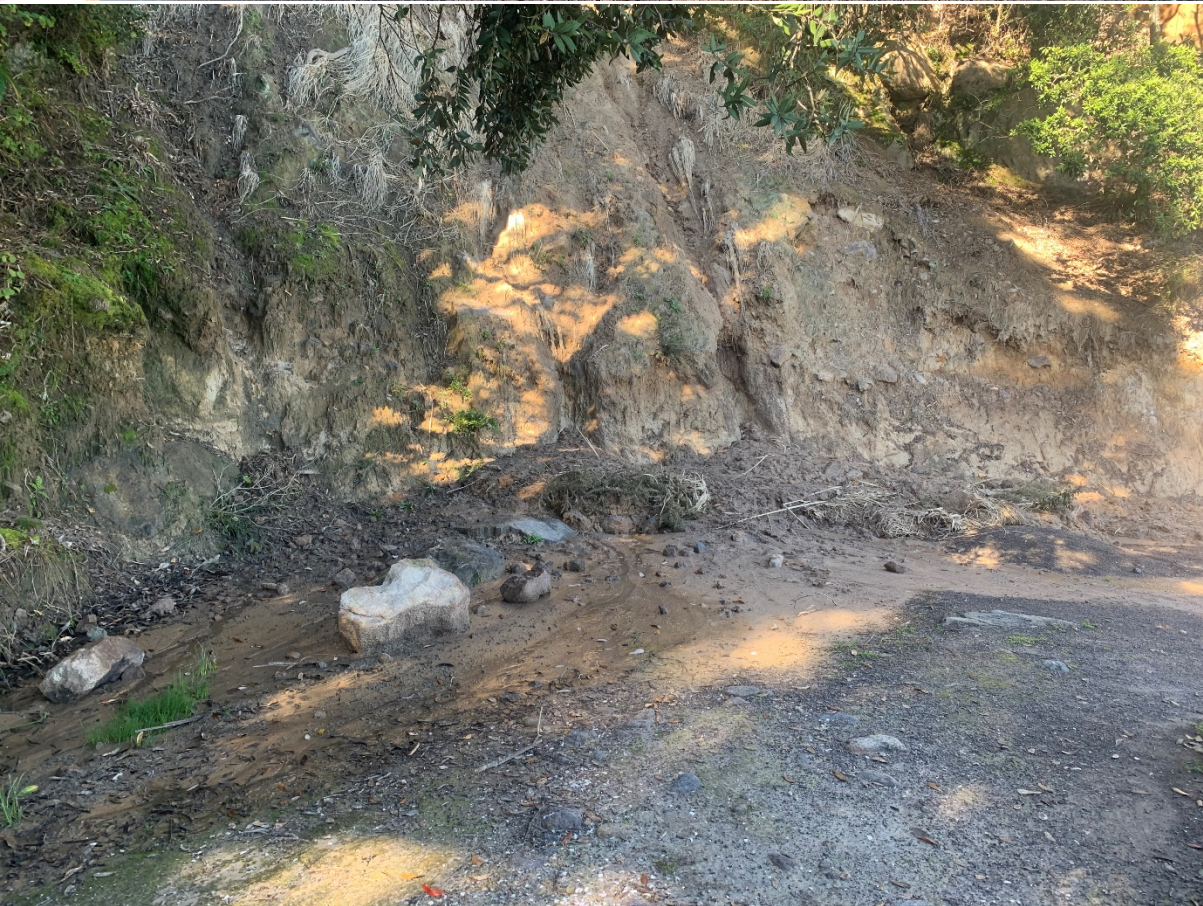
As the s 7(2)(f)(ii) I have become aware of a worsening situation in relation to an old slip site near Te Kuia rock on Te Ara Tūtanga track.

The face of this slip is steep, and amount of material regularly being dislodged is increasing with severe weather events.

This material being released from the face of the slip is reaching the track and creating an active hazard for people walking below.

Furthermore, the bottom of the slip meets Te Ara Tūtanga at a cultural significant site (Te Kuia Rock), and there are aspirations to have this site interpreted. Interpretations at this site would naturally see users spend more time at this site, increasing their risk factor.

To ensure ongoing public safety and to facilitate the aspirations of the Mauao Trust, its recommended that an engineered catch-wall is designed and constructed to stop any migrating material from reaching the track.
