Tauranga City Council
Private bag 12022
Tauranga

7 May 2009

Rockfall on Mauao; Risk to proposed campground development

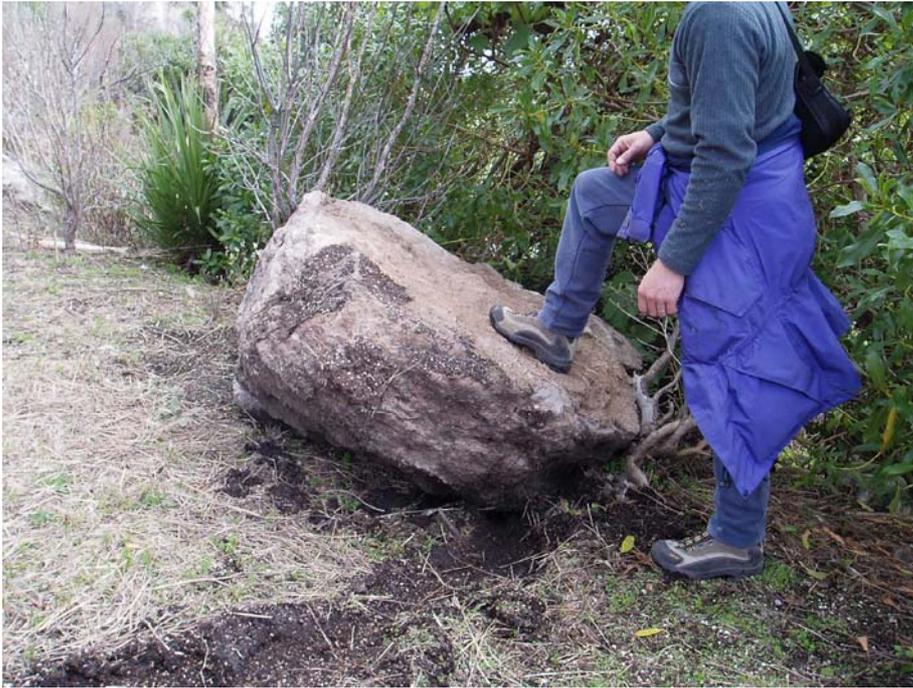
A series of minor earthquakes (10 year return period magnitude) triggered many small rockfalls and slips. 15 slips were greater than 1m³, at least one of which released an easily identifiable boulder, which travelled a few hundred metres and can be seen in the photograph below.

Photo' 1. Boulder travelled 300m on Northern slopes of Mauao.

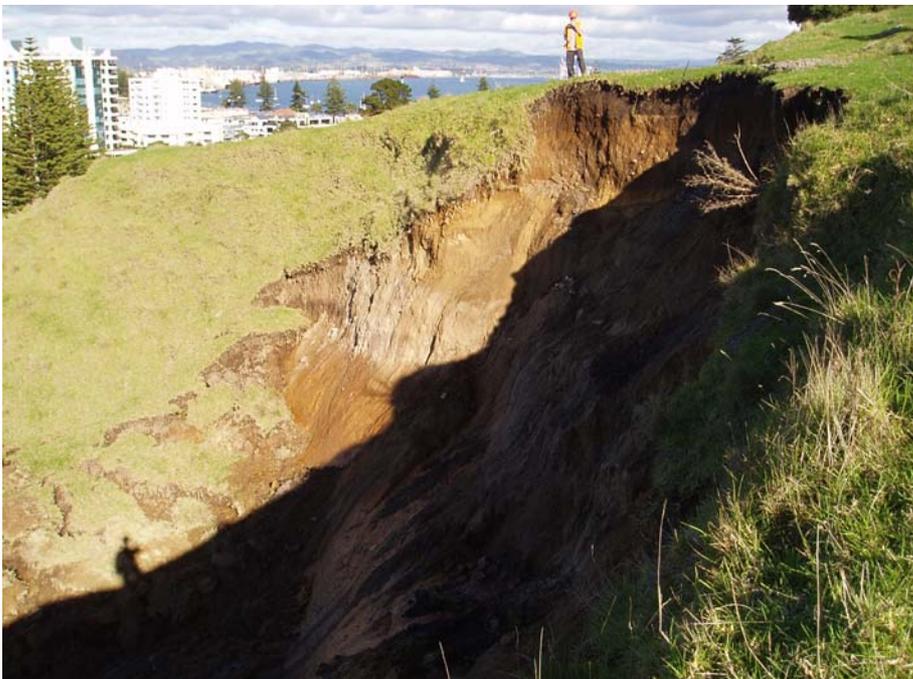
350mm of rain fell within 24hrs, a predicted 1 in 100 year event. Around thirty significant soil slips were triggered, three of which marginally affected the campground.

Photo' 2. 250m³ slip near campground.

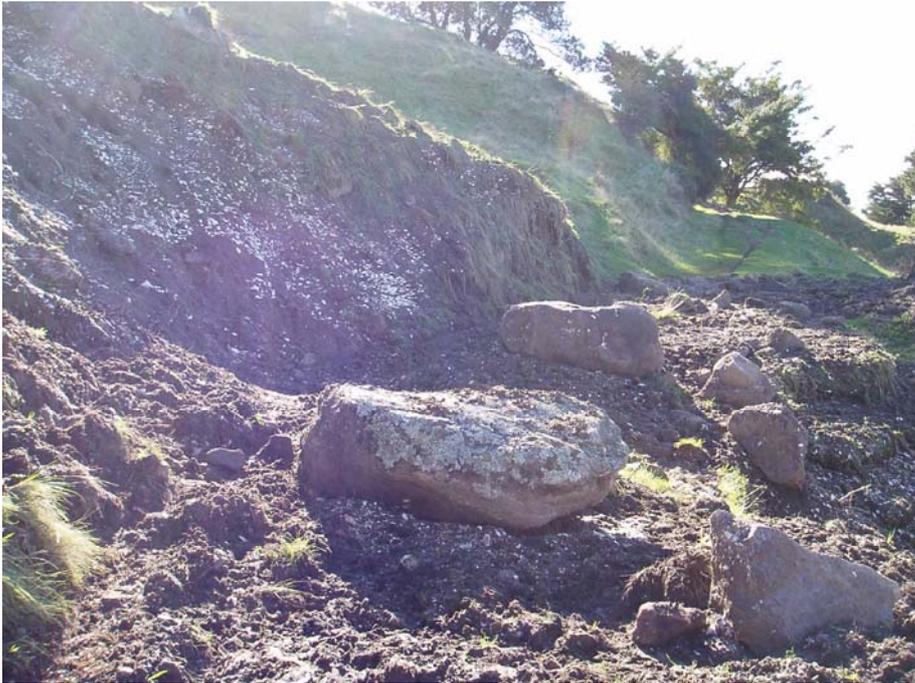
Boulder falls were triggered although none were in the vicinity of the campground.

Photo' 3. Boulders which fell on the south west slopes.

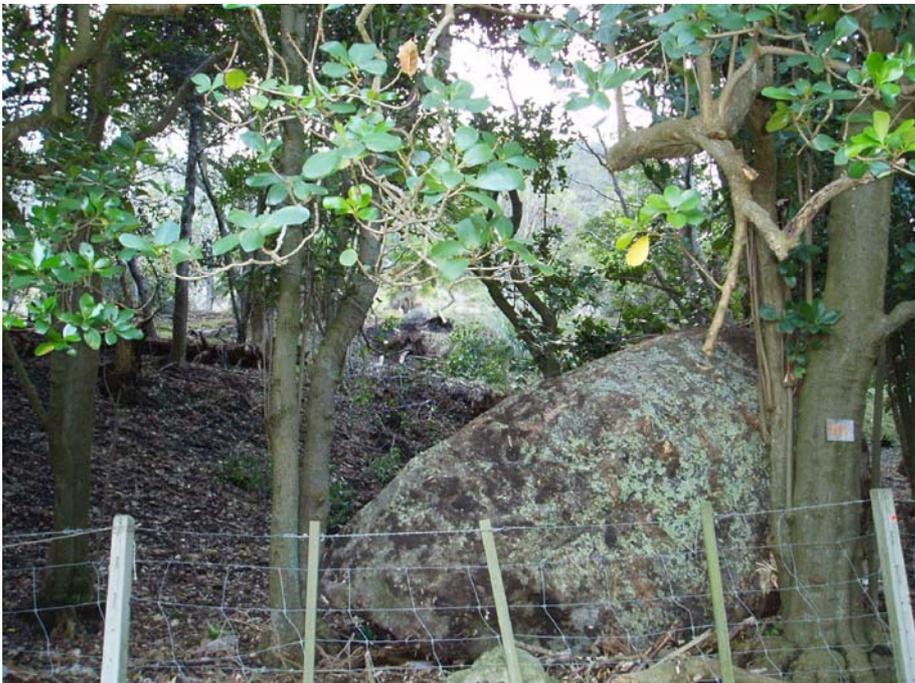
After further intense rain a 20 tonne boulder fell 25m and came to rest against the campground boundary fence.

Photo' 3. Large boulder stopped at camp fence.

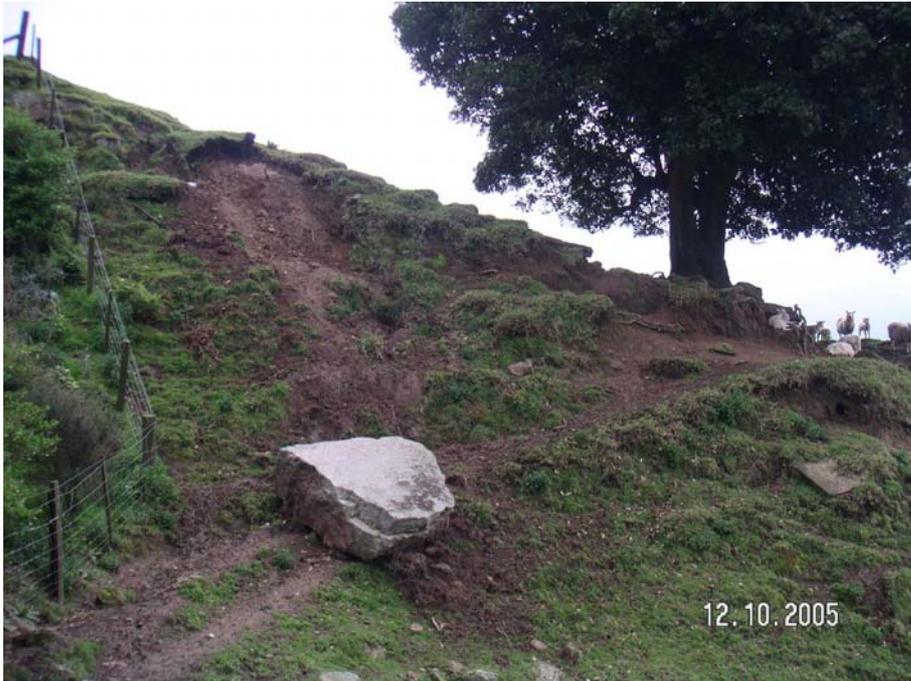
A boulder above the campground slid a short distance during rain and killed two sheltering lambs. On steep enough terrain such a boulder could have gained speed and travel much further.

Photo' 4. Boulder movement above campground.

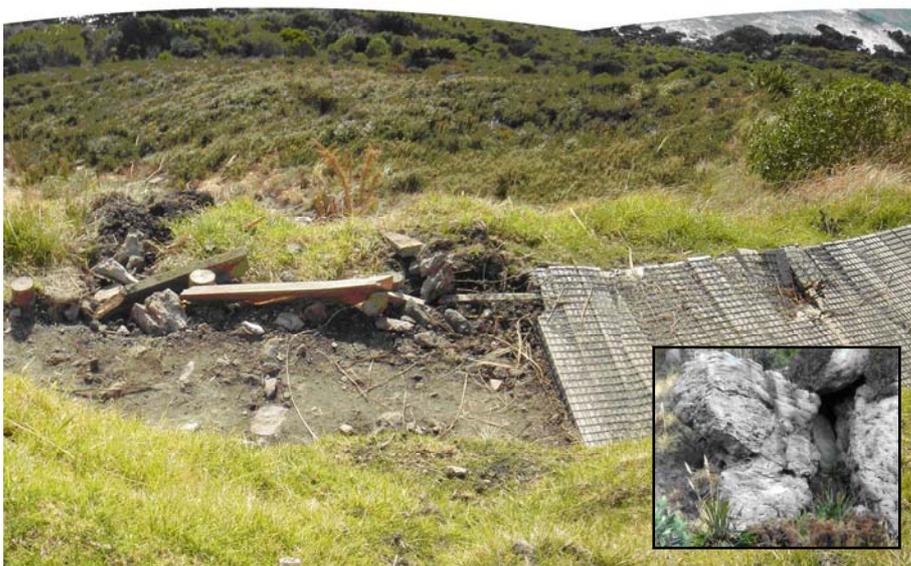
Photo' 4. Northern slopes boulder fall; damage to Oruahine track (outcrop inset).

A rock outcrop high on the northern slopes collapsed releasing 7.5 tonnes of boulders. These boulders travelled to the shoreline, narrowly missing a walker on the base track. There was no obvious trigger other than natural erosion to the point of collapse.

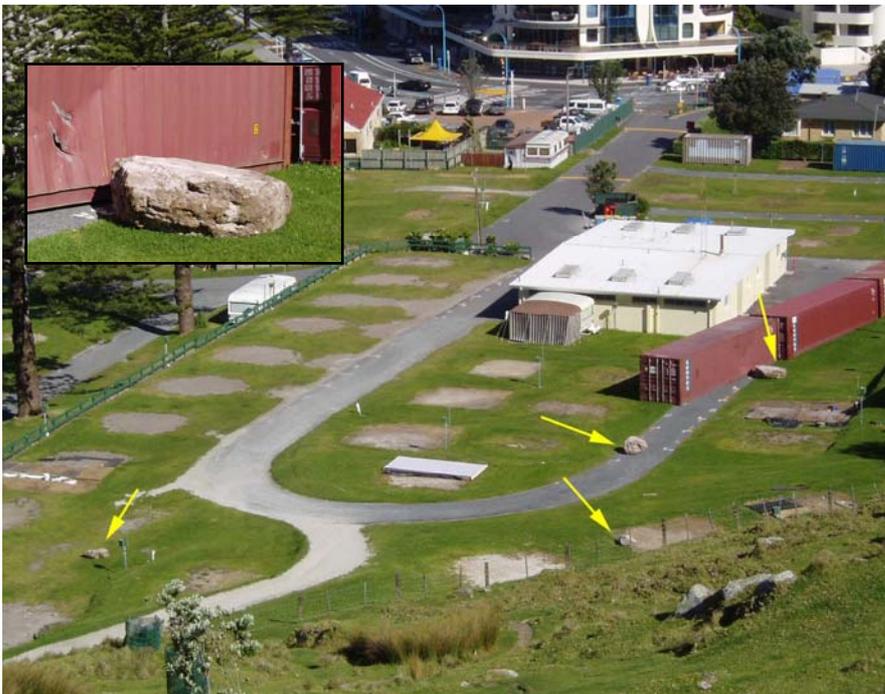
We have excellent evidence on travel distances, recorded during blasting work carried out in 2003 to remove boulders on the bluff high above the campground:

Photo' 5. Blasted boulders reaching campground.

For boulders of around 1m³ falling from the upper bluff, around 10% made it through the boundary fence. Four can be seen in the photograph above.

An engineered, energy absorbing, rockfall catch fence could be installed at the campground boundary.
